Project
 23-00280_Lake County_Media 011

Inspection report

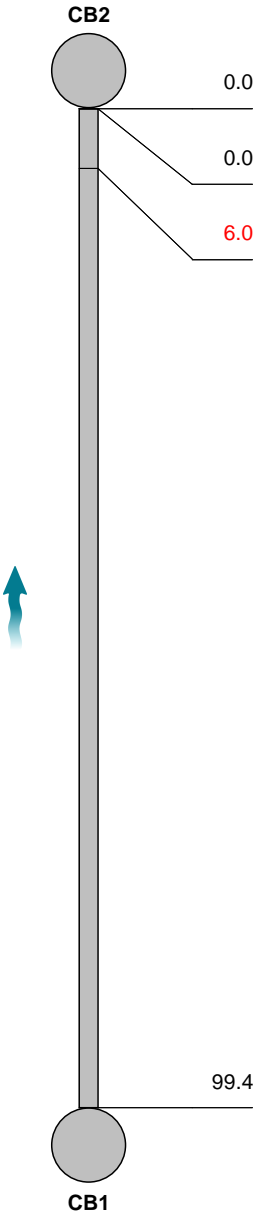
0.0	ACB	Catch Basin / CB2	00:00:00				
	0.0	MWL	Water Level, 5% of the vertical dimension					
	6.0	MMS	Mortar Missing Small at 10 o'clock	00:02:43		S2		
	99.4	ACB	Catch Basin / CB1	00:13:14				
QSR 2100	QMR 0000	QOR 2100	SPR 2.0	MPR 0.0	OPR 2.0	SPRI 2.0	MPRI 0.0	OPRI 2.0

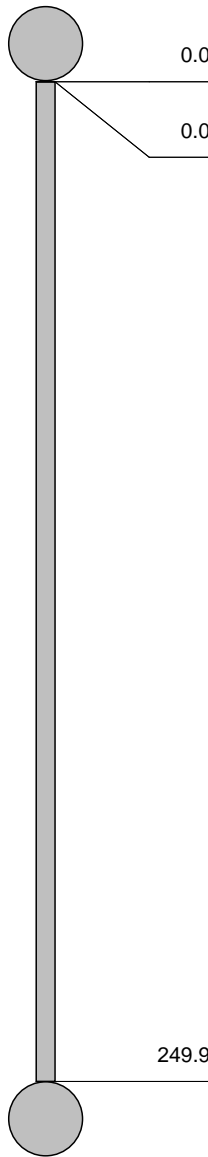
0.0	ACB	Catch Basin / CB2	00:00:00				
	0.0	MWL	Water Level, 5% of the vertical dimension					
	249.9	ACB	Catch Basin / CB3	00:32:25				
	QSR 0000	QMR 0000	QOR 0000	SPR 0.0	MPR 0.0	OPR 0.0	SPRI 0.0	MPRI 0.0

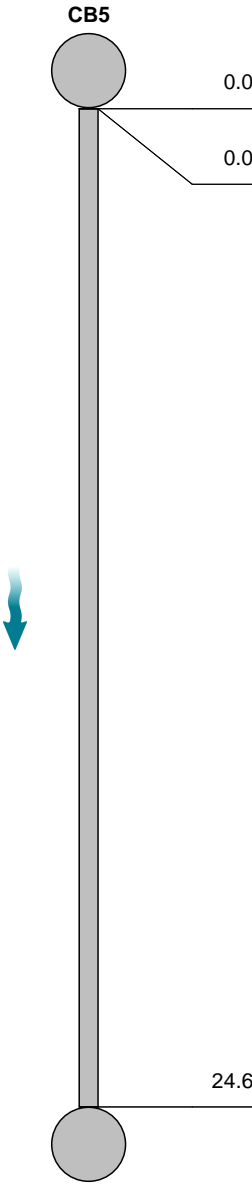
0.0	ACB	Catch Basin / CB5	00:00:00				
	0.0	MWL	Water Level, 5% of the vertical dimension					
	24.6	ACB	Catch Basin / CB6	00:07:58				
QSR	QMR	QOR	SPR	MPR	OPR	SPRI	MPRI	OPRI
0000	0000	0000	0.0	0.0	0.0	0.0	0.0	0.0

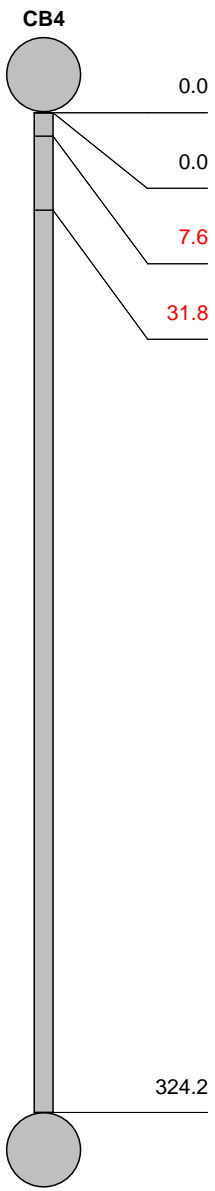
0.0	AMH	Manhole / CB4	00:00:00		
	0.0	MWL	Water Level, 5% of the vertical dimension			
	7.6	CC	Crack Circumferential from 2 o'clock to 5 o'clock	00:04:13		S1
	31.8	MMS	Mortar Missing Small at 2 o'clock	00:06:43		S2
	324.2	ACB	Catch Basin / CB5	00:34:30		
QSR 2111	QMR 0000	QOR 2111	SPR 3.0	MPR 0.0	OPR 3.0	SPRI 1.5
						MPRI 0.0
						OPRI 1.5

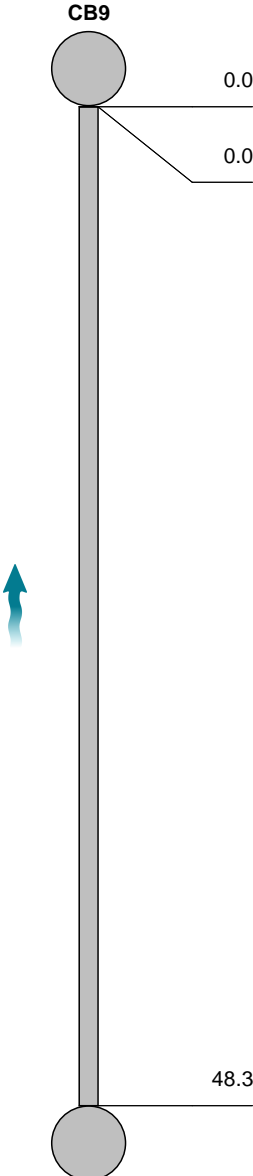
0.0	AMH	Manhole / CB9	00:00:00				
	0.0	MWL	Water Level, 5% of the vertical dimension					
	48.3	ACB	Catch Basin / CB8	00:07:54				
	QSR 0000	QMR 0000	QOR 0000	SPR 0.0	MPR 0.0	OPR 0.0	SPRI 0.0	MPRI 0.0

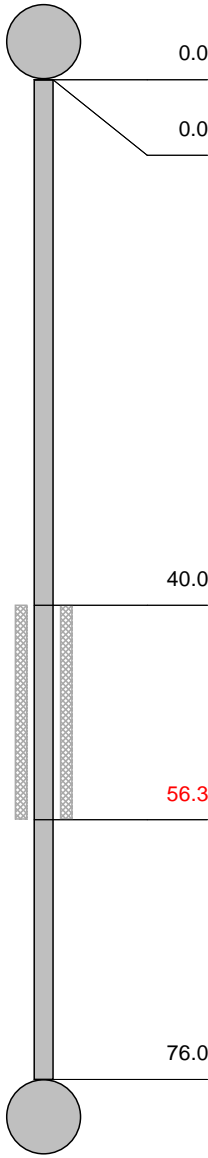
0.0	ACB	Catch Basin / CBE#3	00:00:00		
	0.0	MWL	Water Level, 5% of the vertical dimension			
	40.0	S01 JAM	Joint Angular Medium, Start	00:04:24		
	56.3	F01 JAM	Joint Angular Medium, Finish	00:05:48		S1
	76.0	ACB	Catch Basin / CBE#3A	00:08:13		
CBE#3A						
QSR	QMR	QOR	SPR	MPR	OPR	SPRI
1300	0000	1300	3.0	0.0	3.0	1.0

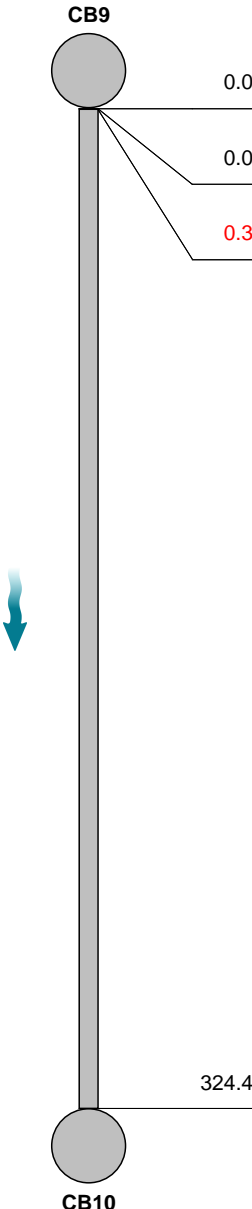
0.0	ACB	Catch Basin / CB9		00:00:00			
	0.0	MWL	Water Level, 5% of the vertical dimension					
	0.3	CC	Crack Circumferential from 11 o'clock to 1 o'clock	00:01:23		S1		
	324.4	ACB	Catch Basin / CB10		00:38:01			
QSR	QMR	QOR	SPR	MPR	OPR	SPRI	MPRI	OPRI
1100	0000	1100	1.0	0.0	1.0	1.0	0.0	1.0

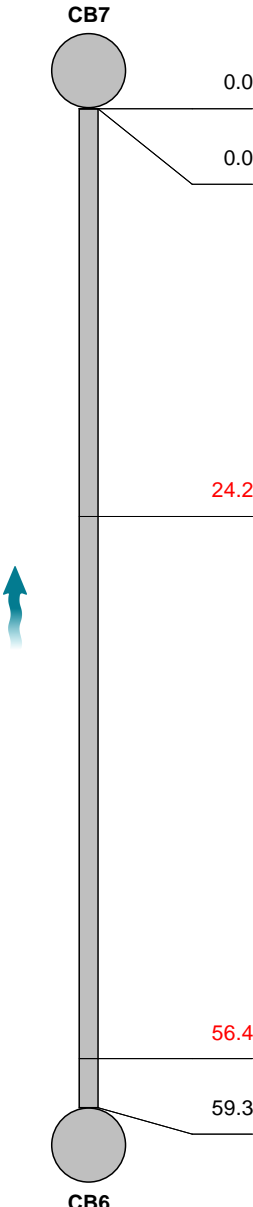
0.0	ACB	Catch Basin / CB7	00:00:00				
	0.0	MWL	Water Level, 5% of the vertical dimension					
	24.2	CC	Crack Circumferential from 4 o'clock to 5 o'clock	00:03:49		S1		
	56.4	JAM	Joint Angular Medium	00:07:19	CB6 CB7_0e63 21c1-814d	S1		
	59.3	ACB	Catch Basin / CB6	00:09:21				
QSR	QMR	QOR	SPR	MPR	OPR	SPRI	MPRI	OPRI
1200	0000	1200	2.0	0.0	2.0	1.0	0.0	1.0

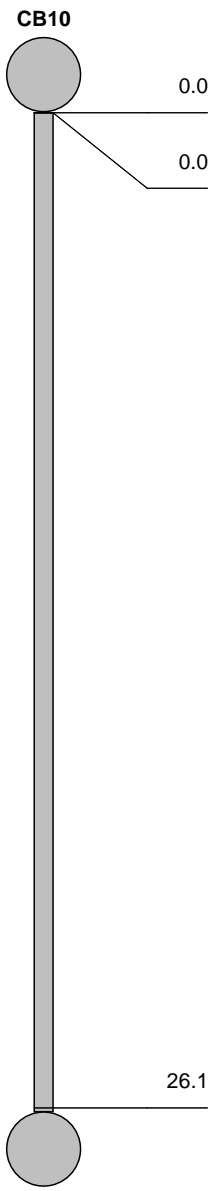
0.0	ACB	Catch Basin / CB10	00:00:00		
	0.0	MWL	Water Level, 5% of the vertical dimension			
	26.1	ACB	Catch Basin / CB11	00:06:26		
QSR 0000	QMR 0000	QOR 0000	SPR 0.0	MPR 0.0	OPR 0.0	SPRI 0.0
						MPRI 0.0
						OPRI 0.0

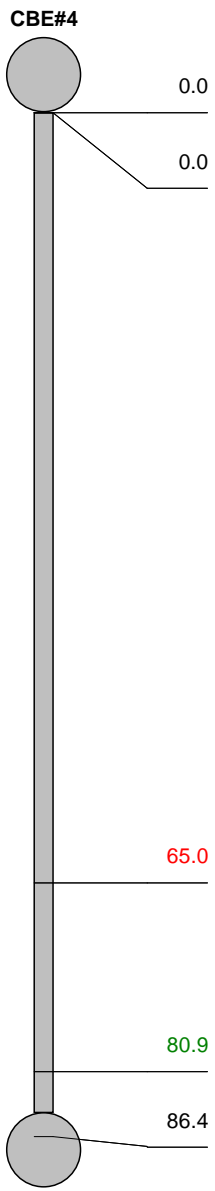
0.0	ACB	Catch Basin / CBE#4	00:00:00		
	0.0	MWL	Water Level, 5% of the vertical dimension		CBE#4A CBE#4_dc e9f470-ef8	
	65.0	CC	Crack Circumferential from 6 o'clock to 7 o'clock	00:11:21		S1
	80.9	IR	Infiltration Runner at 6 o'clock	00:13:46		M4
	86.4	ACB	Catch Basin / CBE#4A	00:16:15		
QSR	QMR	QOR	SPR	MPR	OPR	SPRI
1100	4100	4111	1.0	4.0	5.0	1.0
						MPRI
						OPRI
						4.0
						2.5

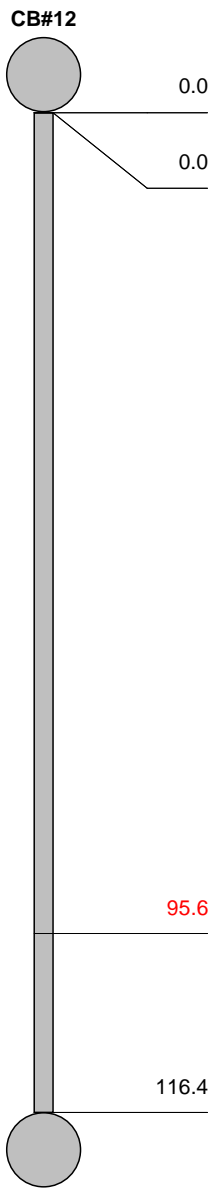
0.0	AMH	Manhole / CB#12	00:00:00		
	0.0	MWL	Water Level, 5% of the vertical dimension			
	95.6	CM	Crack Multiple from 7 o'clock to 11 o'clock	00:11:39		S3
	116.4	ACB	Catch Basin / CBE#5	00:14:11		
QSR	QMR	QOR	SPR	MPR	OPR	SPRI
3100	0000	3100	3.0	0.0	3.0	3.0
