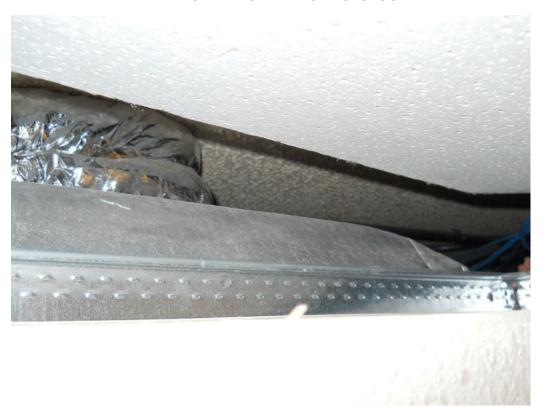
PHOTO 7 - 9/29/21 - APPARENT AIR EROSION OF CEILING TREATMENT IN THE EASTERN HALLWAY

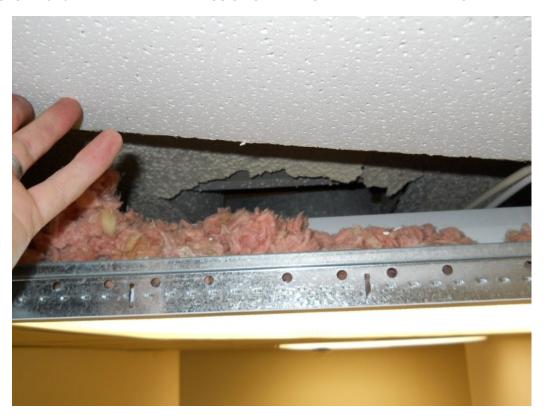
PHOTO 8 - 9/29/21 - LOCALIZED PEELING CEILING TREATMENT IN THE EASTERN HALLWAY

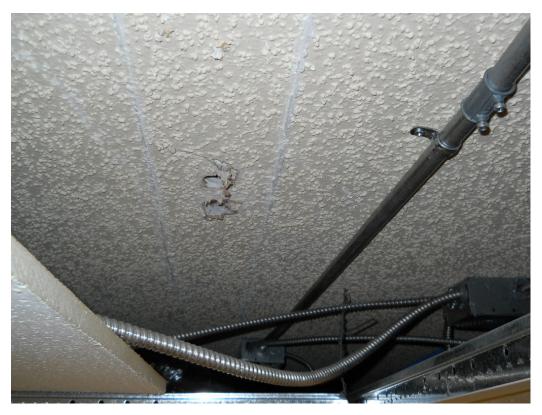
PHOTO 9 – 9/29/21 – LOCALIZED DAMAGE AND AIR EROSION OF CEILING TREATMENT ABOVE ROOM 15

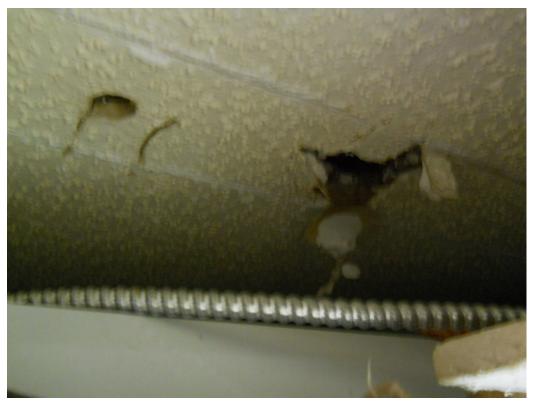
PHOTO 10 – 9/29/21 – LOCALIZED DAMAGE AND AIR EROSION OF CEILING TREATMENT ABOVE CUBICLE 31

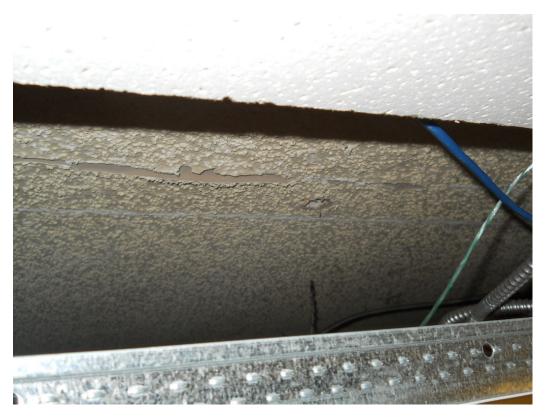
PHOTO 11 - 9/29/21 – PEELING CEILING TREATMENT SOUTHERN PORTION OF THE BUILDING

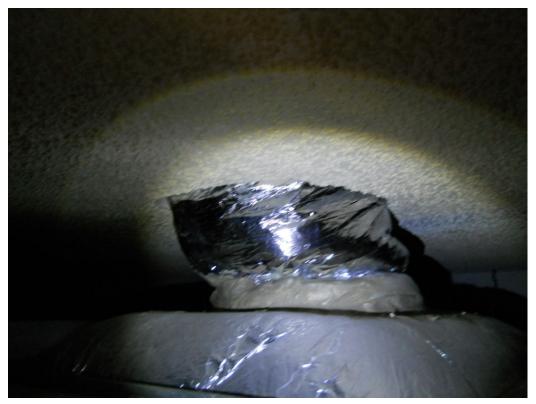
PHOTO 12 – 9/29/21 – PEELING CEILING TREATMENT CEILING TREATMENT ABOVE ROOM 23

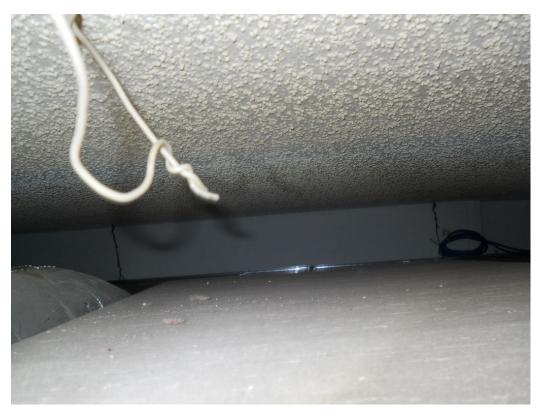
PHOTO 13 – 9/29/21 – APPARENT AIR EROSION AND DELAMINATION CEILING TREATMENT ABOVE ROOMS 24 AND 25

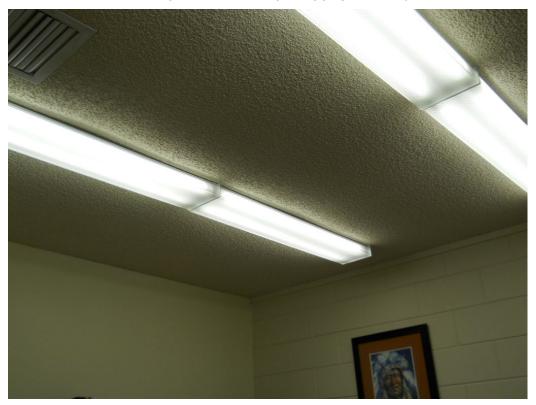
PHOTO 14 – 9/29/21 – INTACT EXPOSED CEILING TREATMENT ROOM 4
