Limited Indoor Air Quality Assessment

Lake County

Umatilla Community Center

APTIM Project 631023227
December 2022

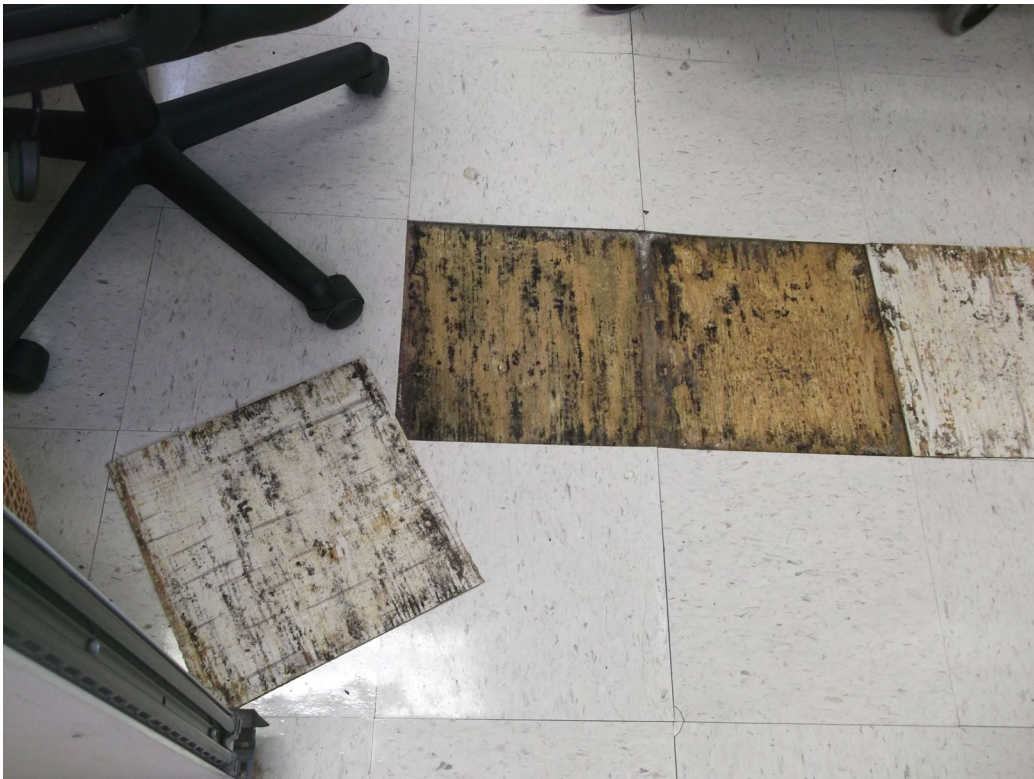
PHOTO 2 – 11/29/2022
PHOTO SHOWING MOLD-IMPACTED PLYWOOD SUBFLOOR IN THE OFFICE CUBICLE.

- Have a Florida-licensed mold remediator clean and seal the mold-impacted and water-damaged plywood subfloor with a commercial grade biocide paint or replace the wood, as needed, in the south and north modular sections of the building. As this will require the removal of existing mold impacted VFT, a Florida-licensed contractor or in-house maintenance staff should replace the removed VFT once remediation is complete.
- Have a Florida-licensed mold remediator clean the interior of the ice machine using non-toxic cleaners. Custodial personnel for the county should check the unit weekly for potential mold growth after cleaning.
- Have a Florida-licensed mold remediator clean the interior of the ductwork located in the UCC.
- Have a Florida-licensed mold remediator clean the exterior of the metal air diffuser vents located throughout the UCC.

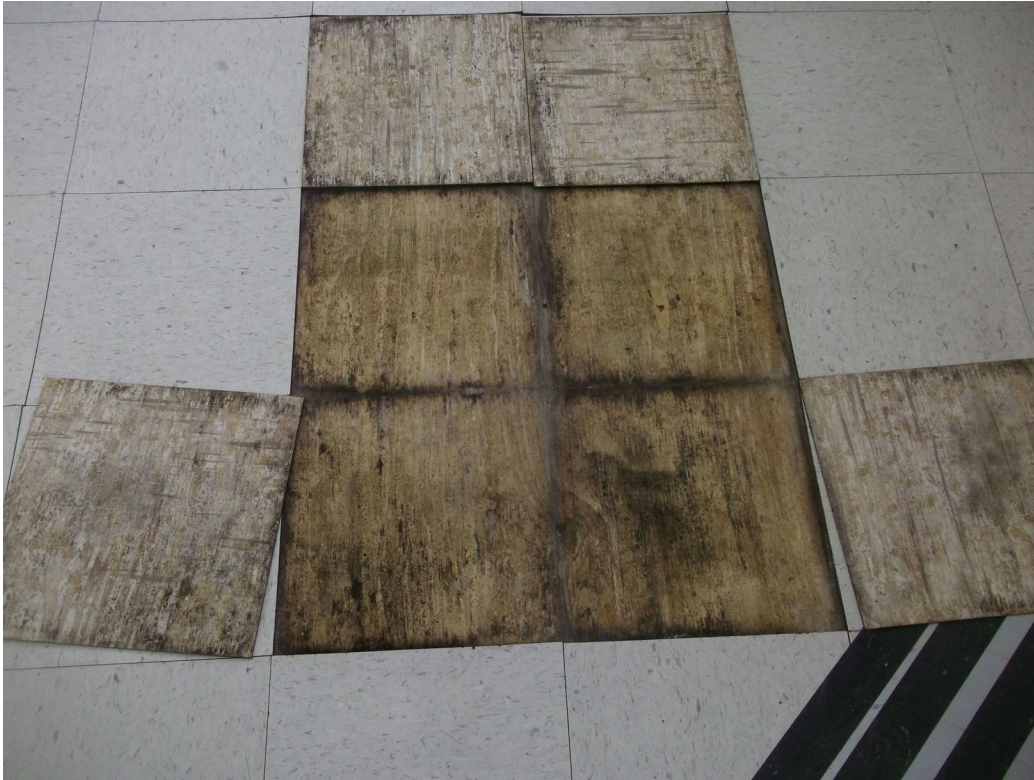
PHOTO 3 – 11/29/2022
PHOTO SHOWING MOLD-IMPACTED PLYWOOD SUBFLOOR IN THE SOUTHEAST SIDE OF
THE MAIN ACTIVITY ROOM.

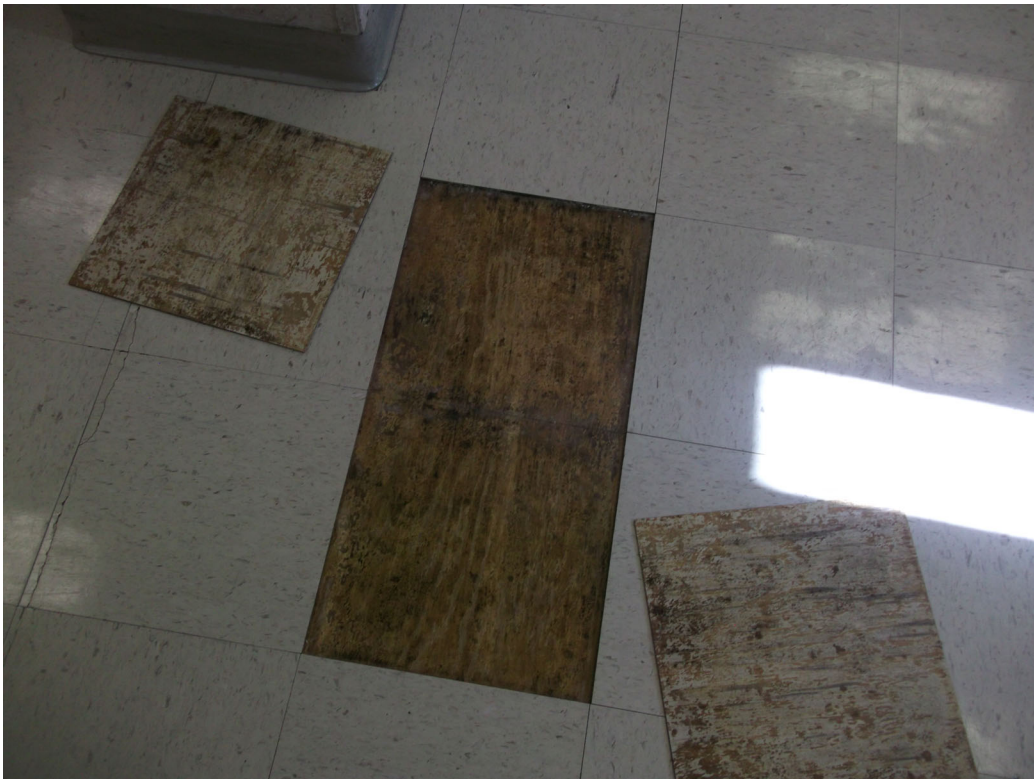
PHOTO 4 – 11/29/2022
PHOTO SHOWING MOLD-IMPACTED PLYWOOD SUBFLOOR IN THE SOUTH CENTER SIDE
OF THE MAIN ACTIVITY ROOM.

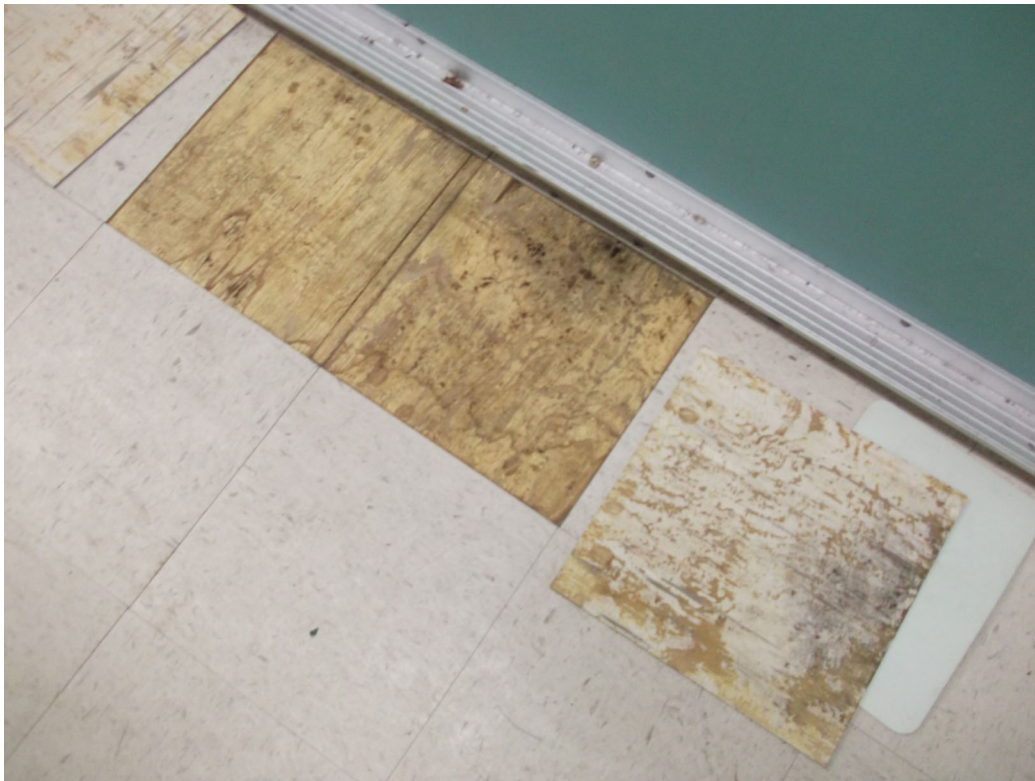
PHOTO 5 – 11/29/2022
PHOTO SHOWING MOLD-IMPACTED PLYWOOD SUBFLOOR IN THE STOREROOM.

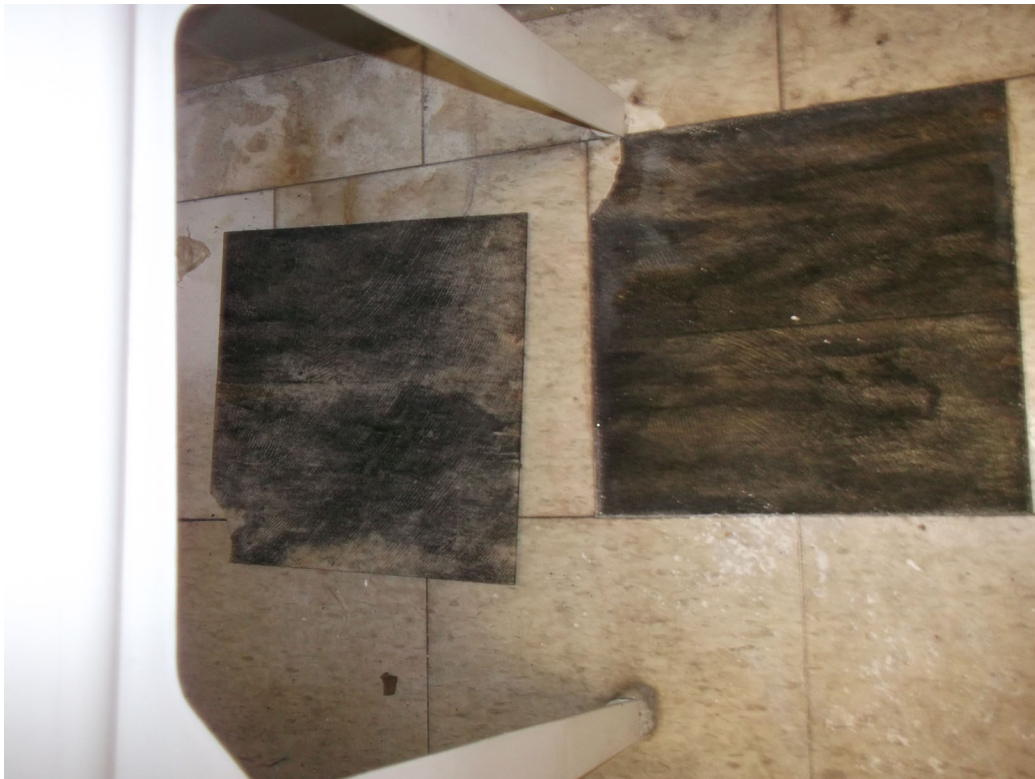
Tape-lift sample (112922-12TL) results for microbial analysis collected inside the UCC (janitor's closet floor) indicated fungal levels from the rare range (1 to 10), the low range (11 to 100) and up to the high range (> 1,000). The rare spore concentrations consisted primarily of *Basidiospores*. The low spore concentrations consisted primarily of *Aspergillus/Penicillium*. The high spore concentrations consisted primarily of *Humicola* and *Monodictys*. Additionally, there were high (>1,000) levels of pollen found in the sample. Concentrations of fungal spores in the high range indicate an area that is highly contaminated with fungal spores.

PHOTO 6 – 11/29/2022
PHOTO SHOWING MOLD-IMPACTED PLYWOOD SUBFLOOR IN THE JANITOR'S CLOSET.

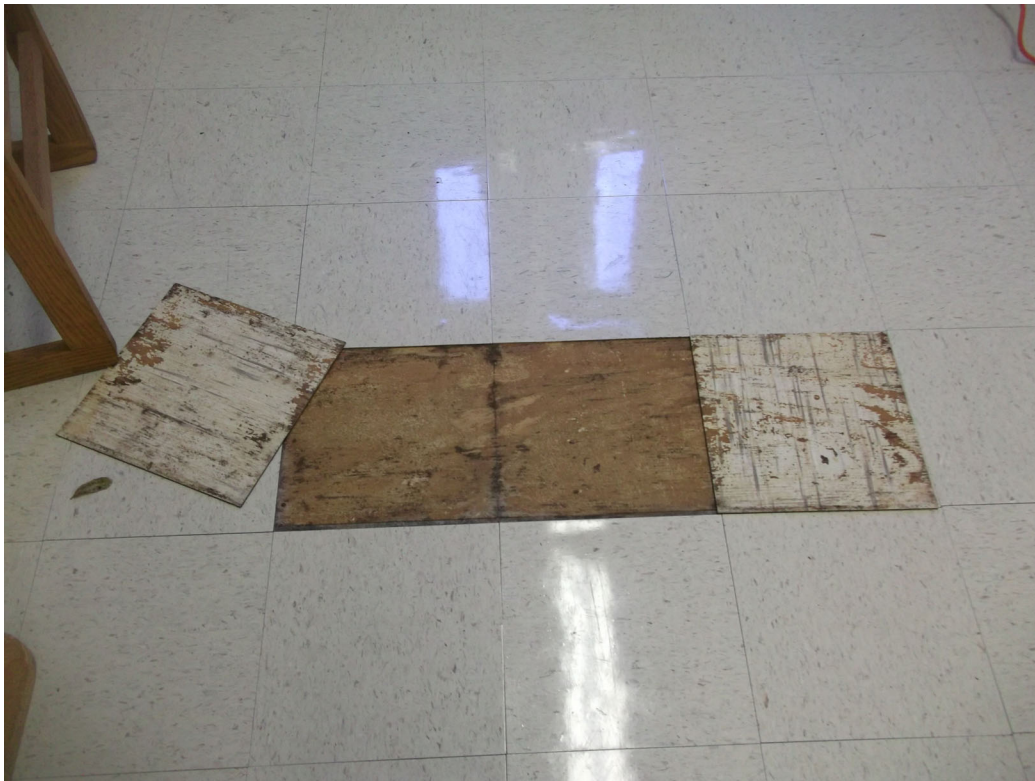
**PHOTO 7 – 11/29/2022
PHOTO SHOWING MOLD-IMPACTED PLYWOOD SUBFLOOR IN THE LOBBY.**

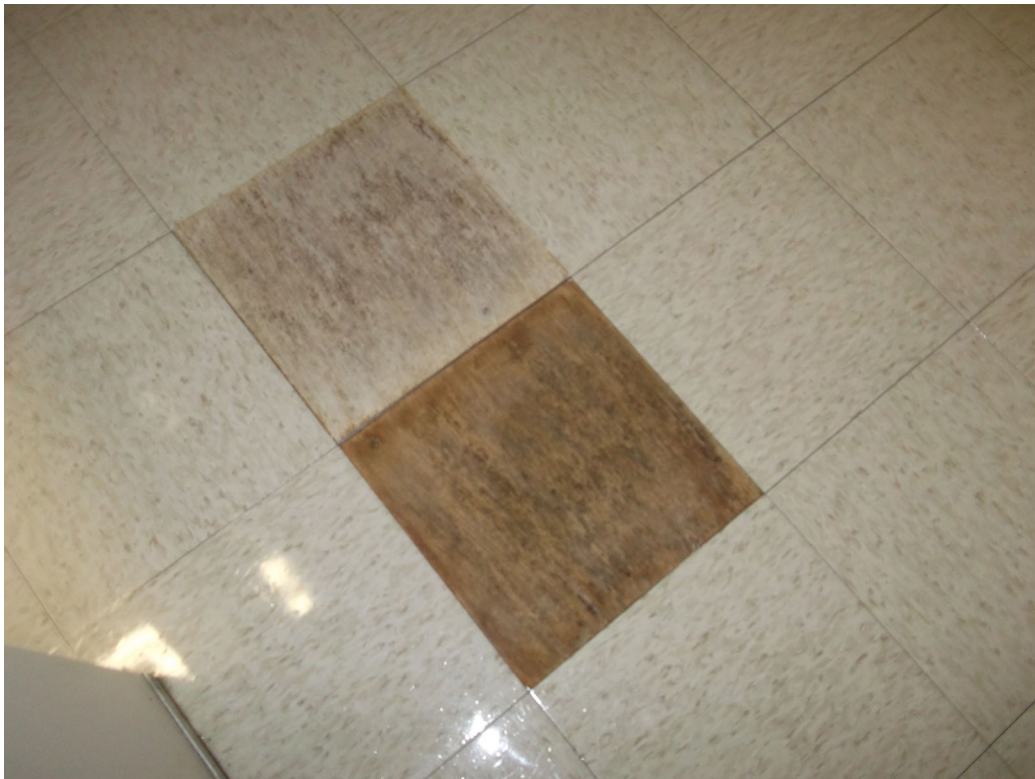
**PHOTO 8 – 11/29/2022
PHOTO SHOWING THE PLYWOOD SUBFLOOR IN THE CENTER OF THE MAIN ACTIVITY
ROOM.**

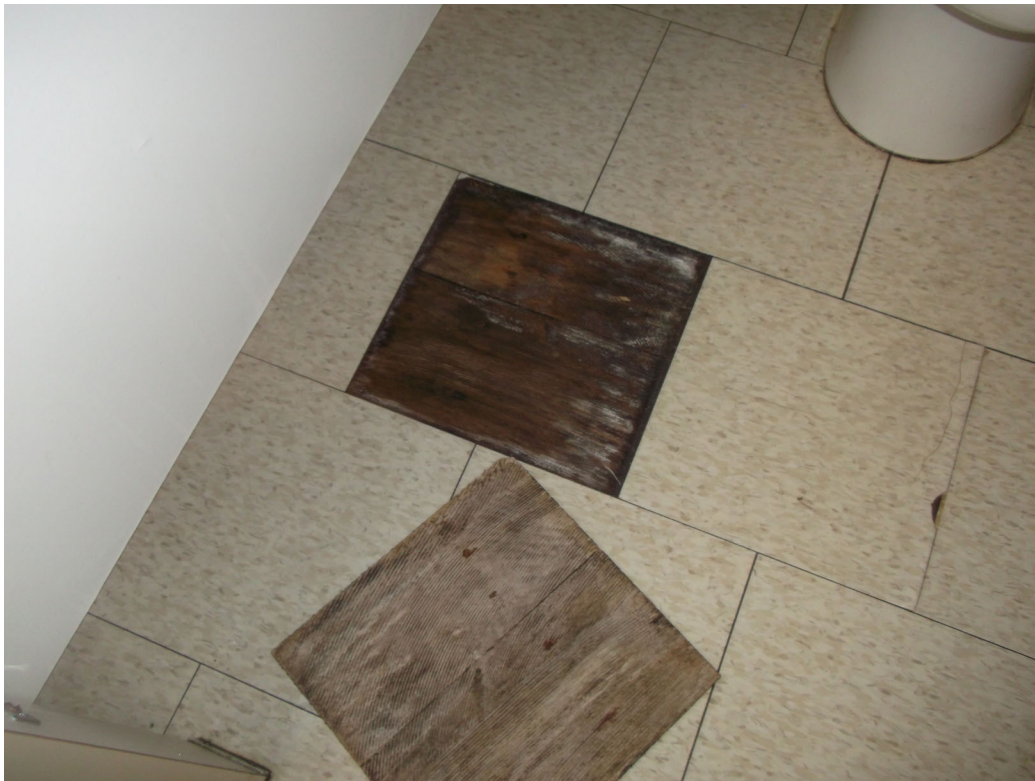
**PHOTO 9 – 11/29/2022
PHOTO SHOWING MOLD-IMPACTED PLYWOOD SUBFLOOR IN THE WOMEN'S
RESTROOM.**

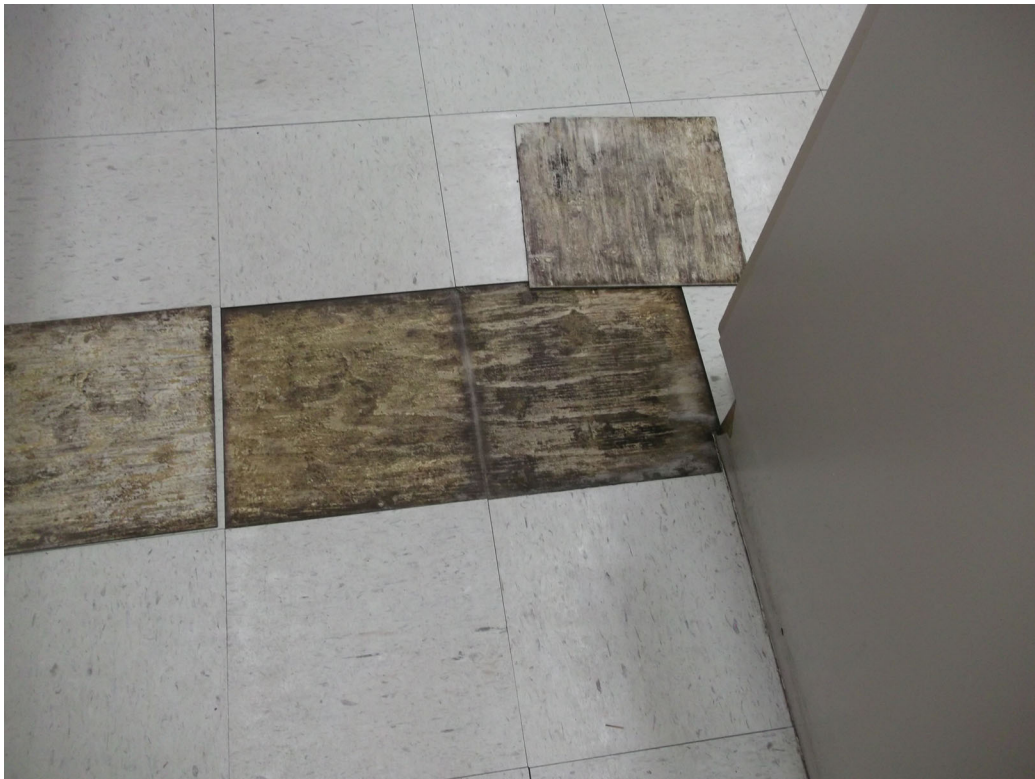
**PHOTO 10 – 11/29/2022
PHOTO SHOWING MOLD-IMPACTED PLYWOOD SUBFLOOR IN THE KITCHEN.**

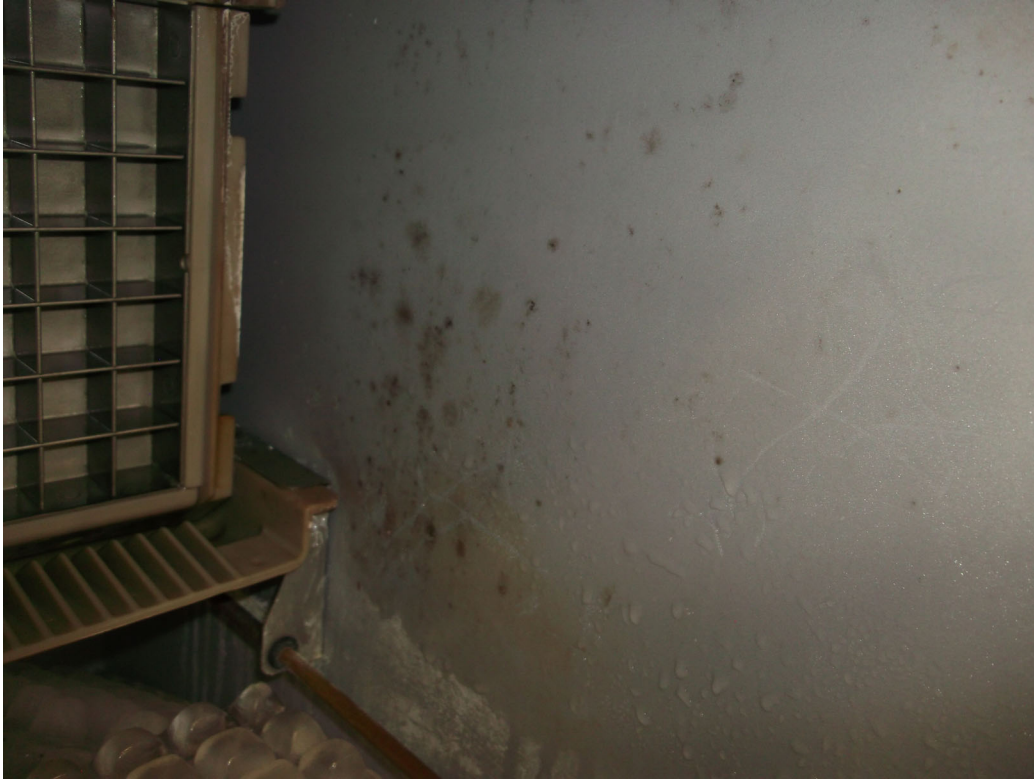
PHOTO 11 – 11/29/2022
PHOTO SHOWING VISIBLE MOLD GROWTH ON TH METAL WALLS OF THE ICE MACHINE.

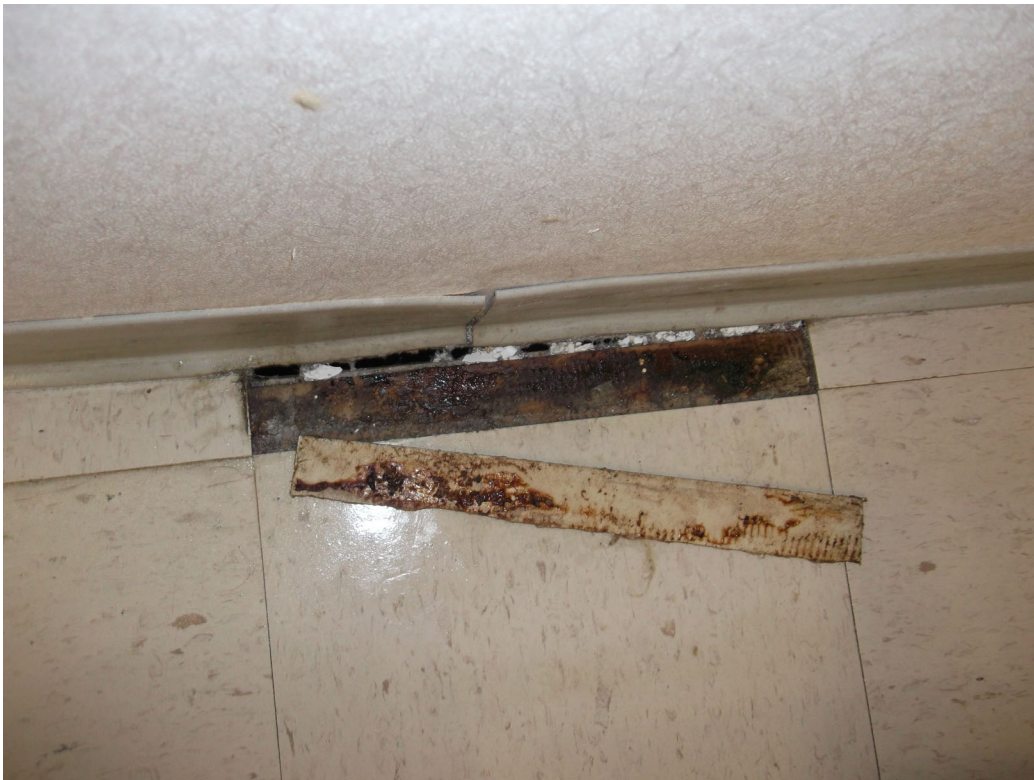
- There was an opening in the floor along the east side of the main room, the ground under the building was visible through the gap.
- There are eight drains located on the roof (two in each corner). Each drain was blocked by leaf and organic debris allowing standing water to build-up on the flat deck membrane roof system.
- The plastic moisture barriers located under the UCC were damaged from previous plumbing and repair activities.

PHOTO 12 – 11/29/2022
PHOTO SHOWING AN OPENING IN THE FLOOR OF THE EAST SIDE OF THE MAIN ACTIVITY ROOM.

- Have in-house maintenance staff repair the opening in the floor along the east wall of the building.
- Have in-house maintenance staff repair the damaged moisture barriers under the building to prevent mold growth and moisture intrusion.

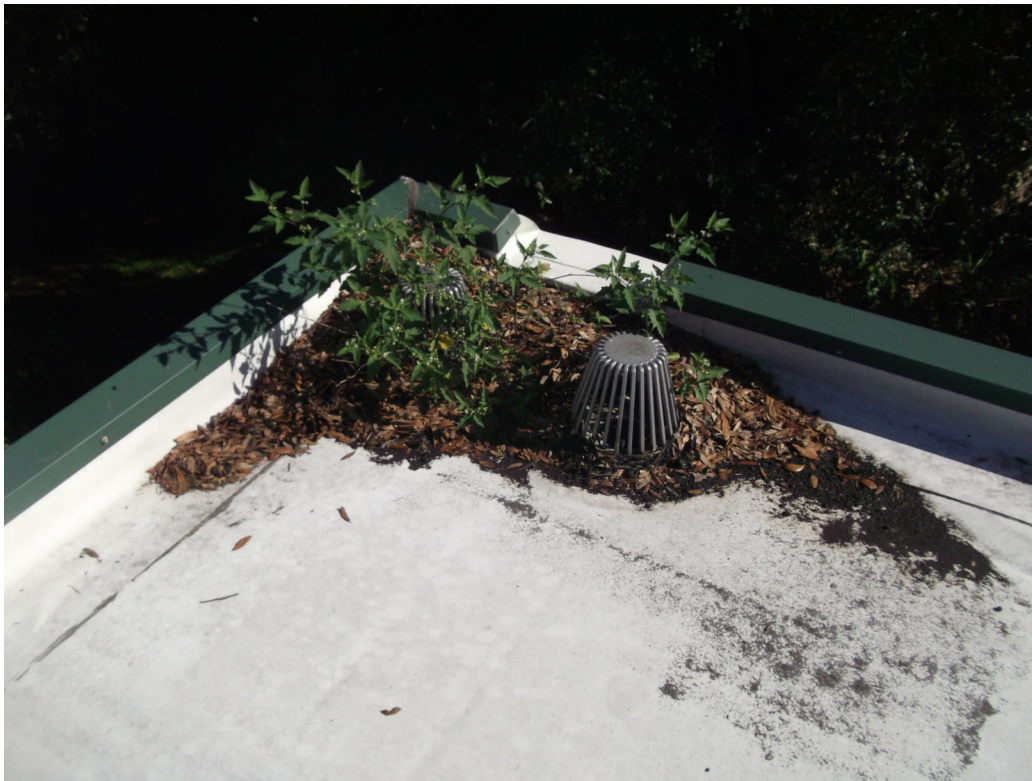
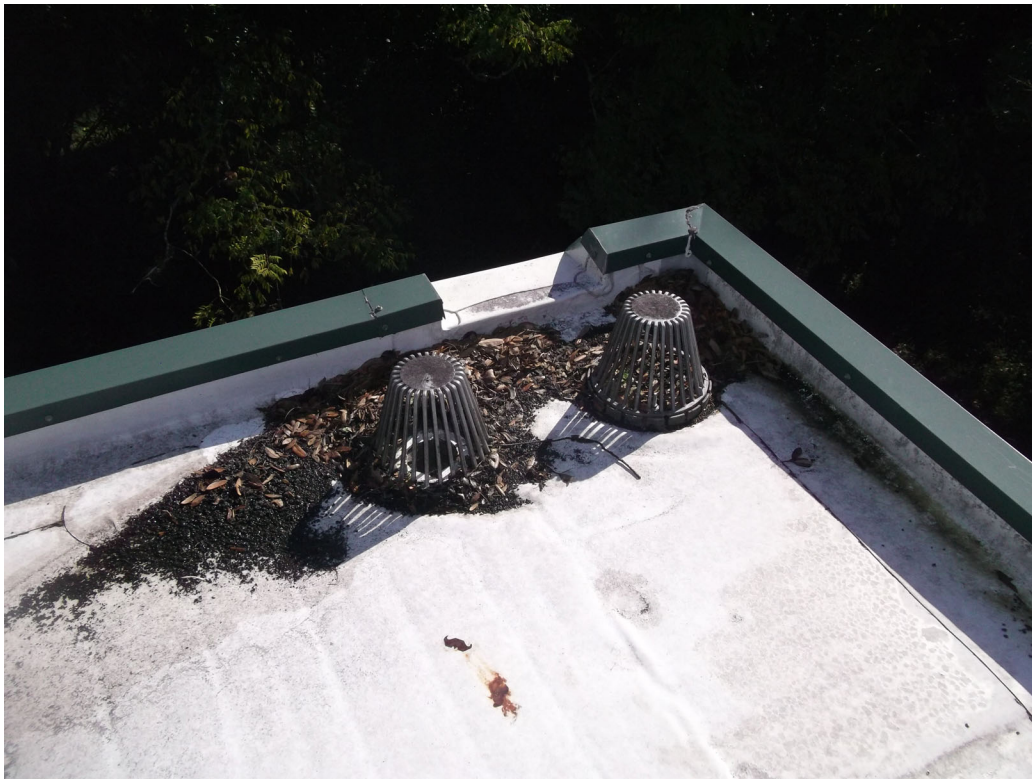
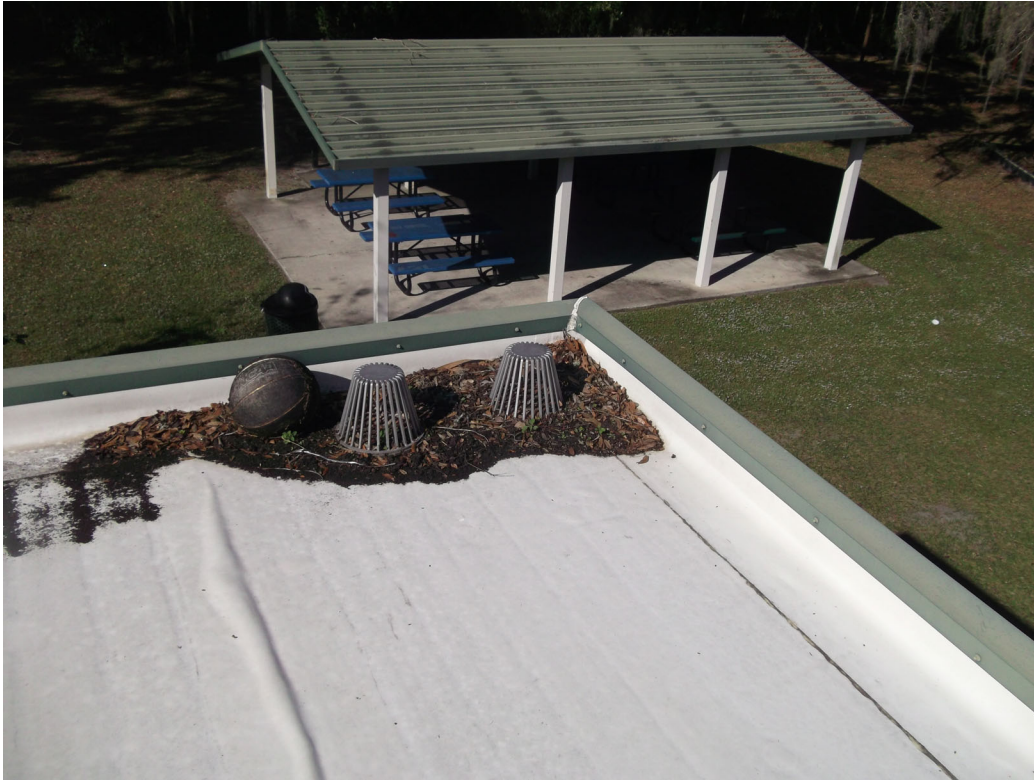
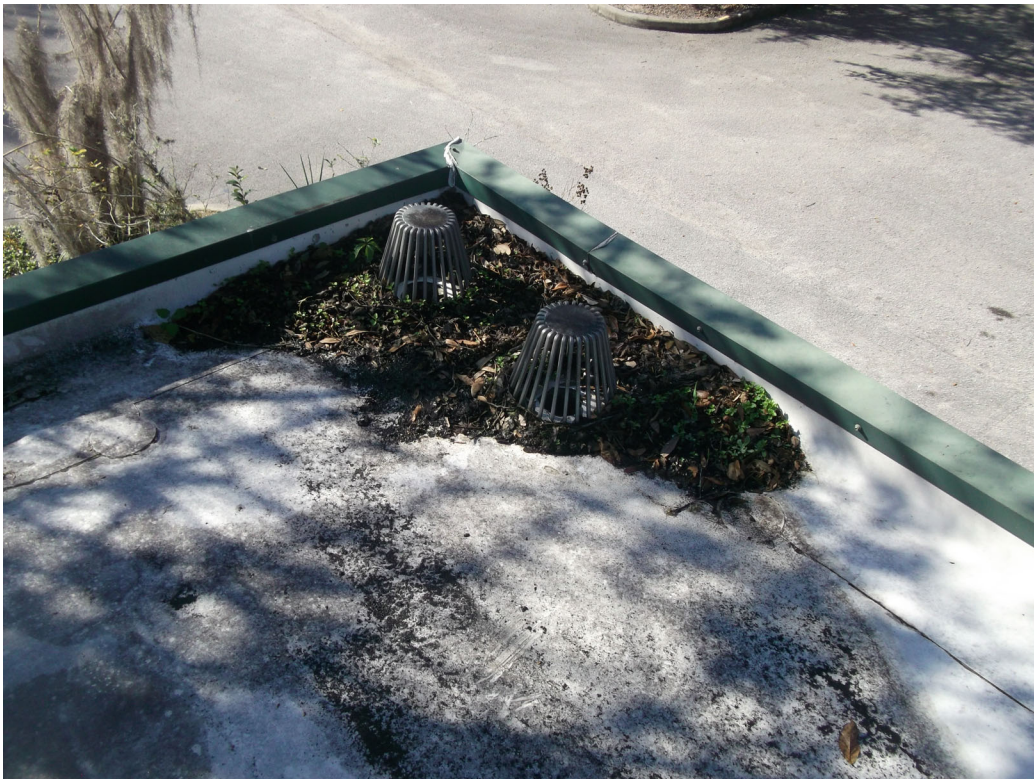
PHOTO 13 – 11/29/2022
PHOTO SHOWING THE BLOCKED DRAINS AT THE NORTHEAST CORNER OF THE ROOF.

PHOTO 14 – 11/29/2022
PHOTO SHOWING THE BLOCKED DRAINS AT THE SOUTHEAST CORNER OF THE ROOF.

PHOTO 15 – 11/29/2022
PHOTO SHOWING THE BLOCKED DRAINS AT THE NORTHWEST CORNER OF THE ROOF.

PHOTO 16 – 11/29/2022
PHOTO SHOWING THE BLOCKED DRAINS AT THE SOUTHWEST CORNER OF THE ROOF.

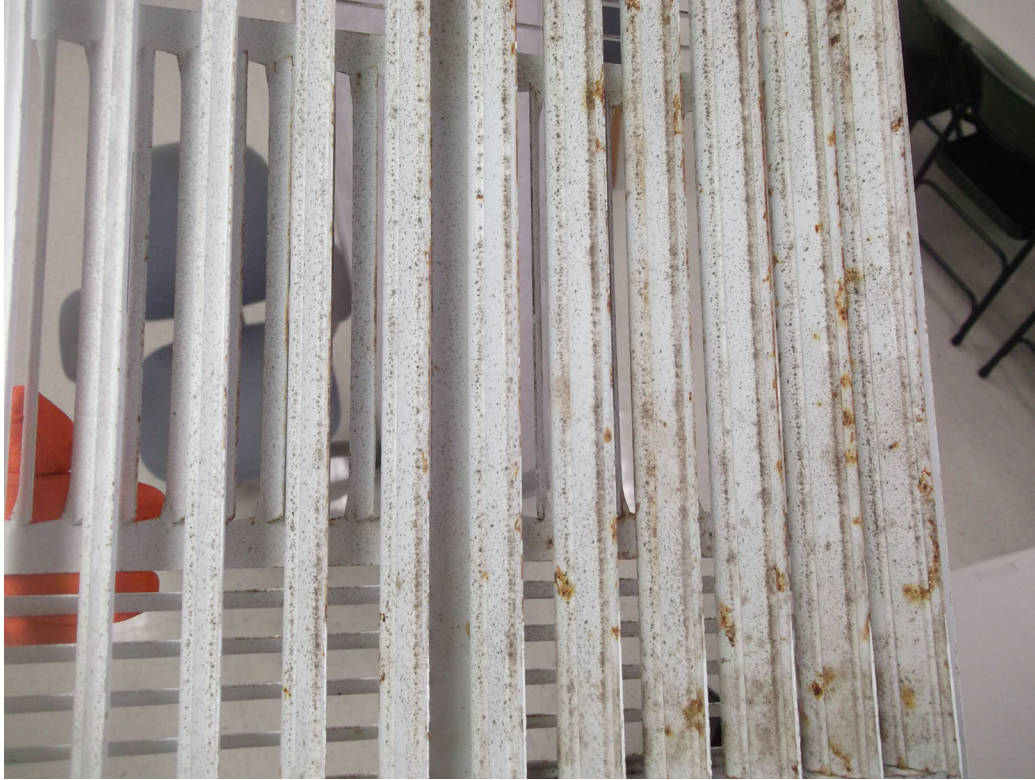
- There was moderate visible dust and debris build-up on the air diffuser vents located throughout the building. (Photo No. 17)
- There was moderate to heavy dust and debris build-up observed within the HVAC ductwork. (Photos No. 18).

The air diffuser vents, and the return air vents within the subject area noted to have moderate build-up of dust and debris.

PHOTO 177 – 11/29/2022
PHOTO SHOWING DUST AND CORROSION ON THE METAL AIR DIFFUSER VENTS.

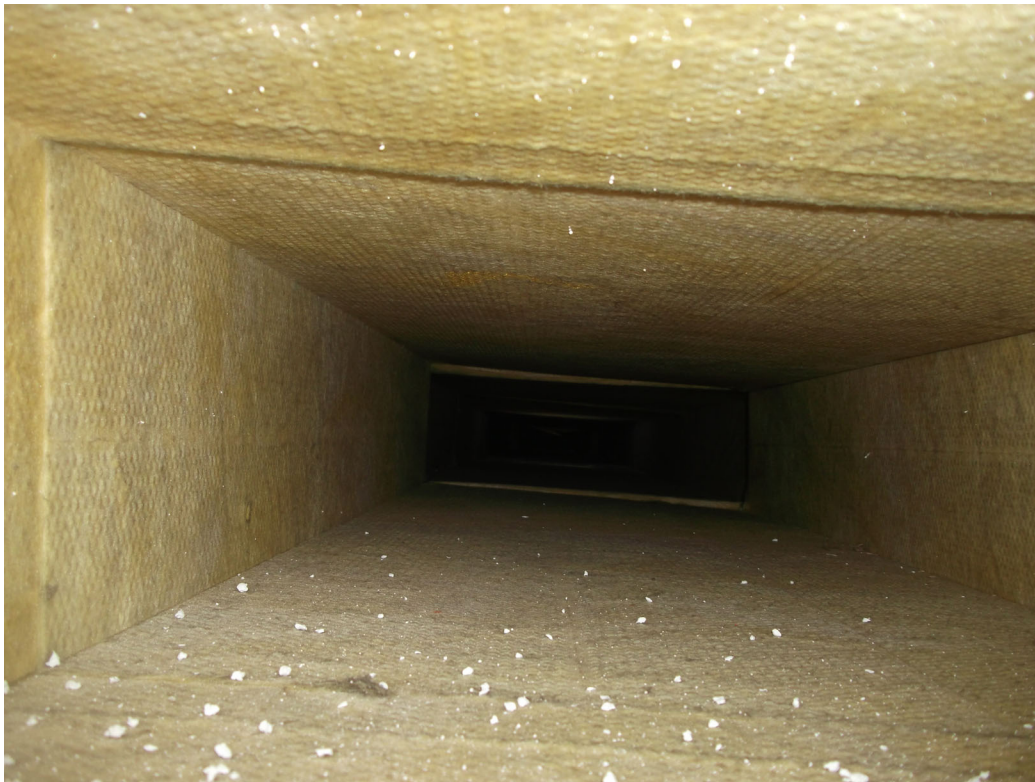
Using a boroscope, the interior of the HVAC ductwork was observed to contain moderate to heavy dust and debris buildup.

PHOTO 18 – 11/29/2022
PHOTO SHOWING DUST AND DEBRIS BUILD-UP INSIDE THE FIBERGLASS DUCTWORK.

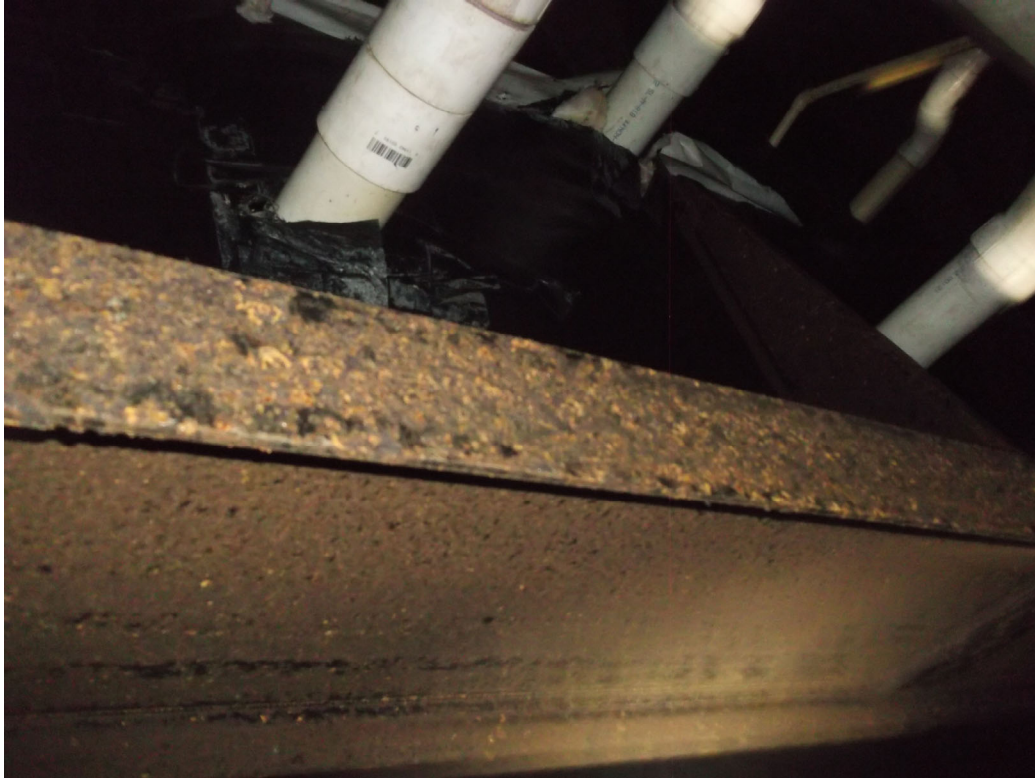
- The plastic moisture barriers located under the UCC were damaged from previous plumbing and repair activities. (Photo No. 19)
- There was moderate visible dust build-up on flat surfaces (countertops, cabinets, shelving, etc.) within the subject area. This indicates that custodial services are adequate.

PHOTO 189 – 11/29/2022
PHOTO SHOWING OPENINGS IN THE MOISTURE BARRIER UNDER THE NORTH
MODULAR SECTION OF THE BUILDING.

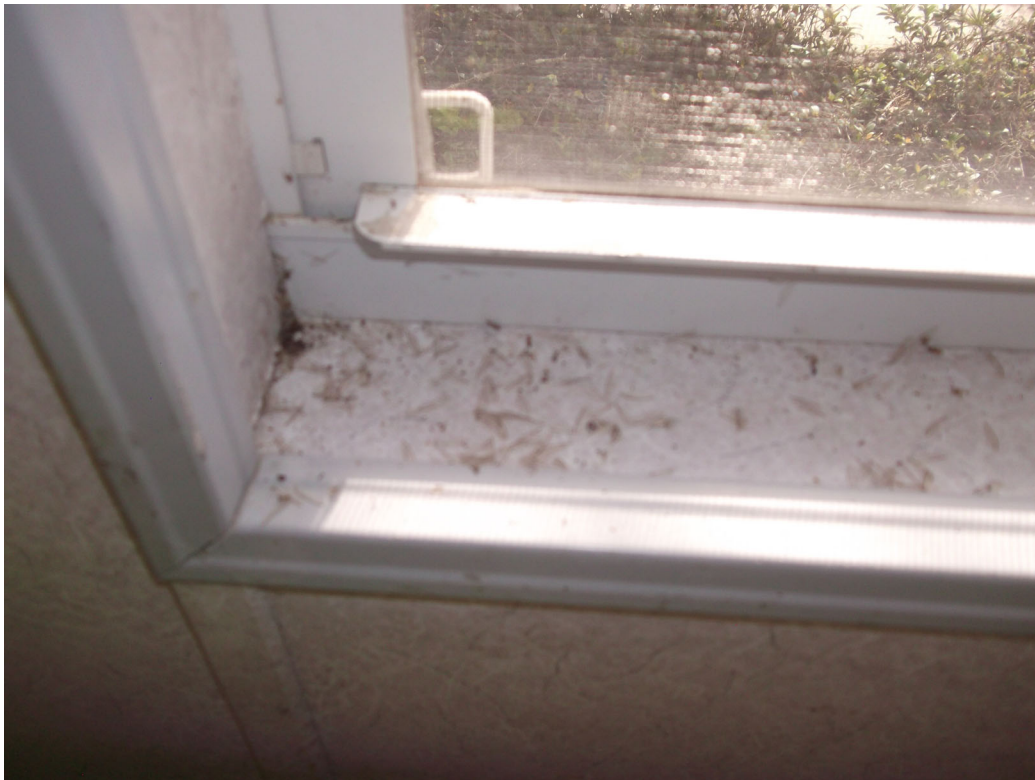
- There was evidence of insect intrusion observed during the assessment. Insect fragments located on the windowsills throughout the building. (Photo No. 20).

PHOTO 190 – 11/29/2022
PHOTO SHOWING INSECT FRAGMENTS ON THE WINDOWSILL.
