# Estep Construction, Inc.

# Invoice

Subject: Project Order Form  
Contract No. 13-0607, Storm Water Pipe/Water Quality Unit  
Cleaning, Video Recording and Related Services  
Purchase Order No. 20150035

PROJECT NAME: 17-15/G	CREATED: 2018.01.22	CATALOG NAME: NASSCO PACP-4
CUSTOMER: Lake County	PROJECT LEADER: James Rash	CONTRACTOR: Estep Construction Inc

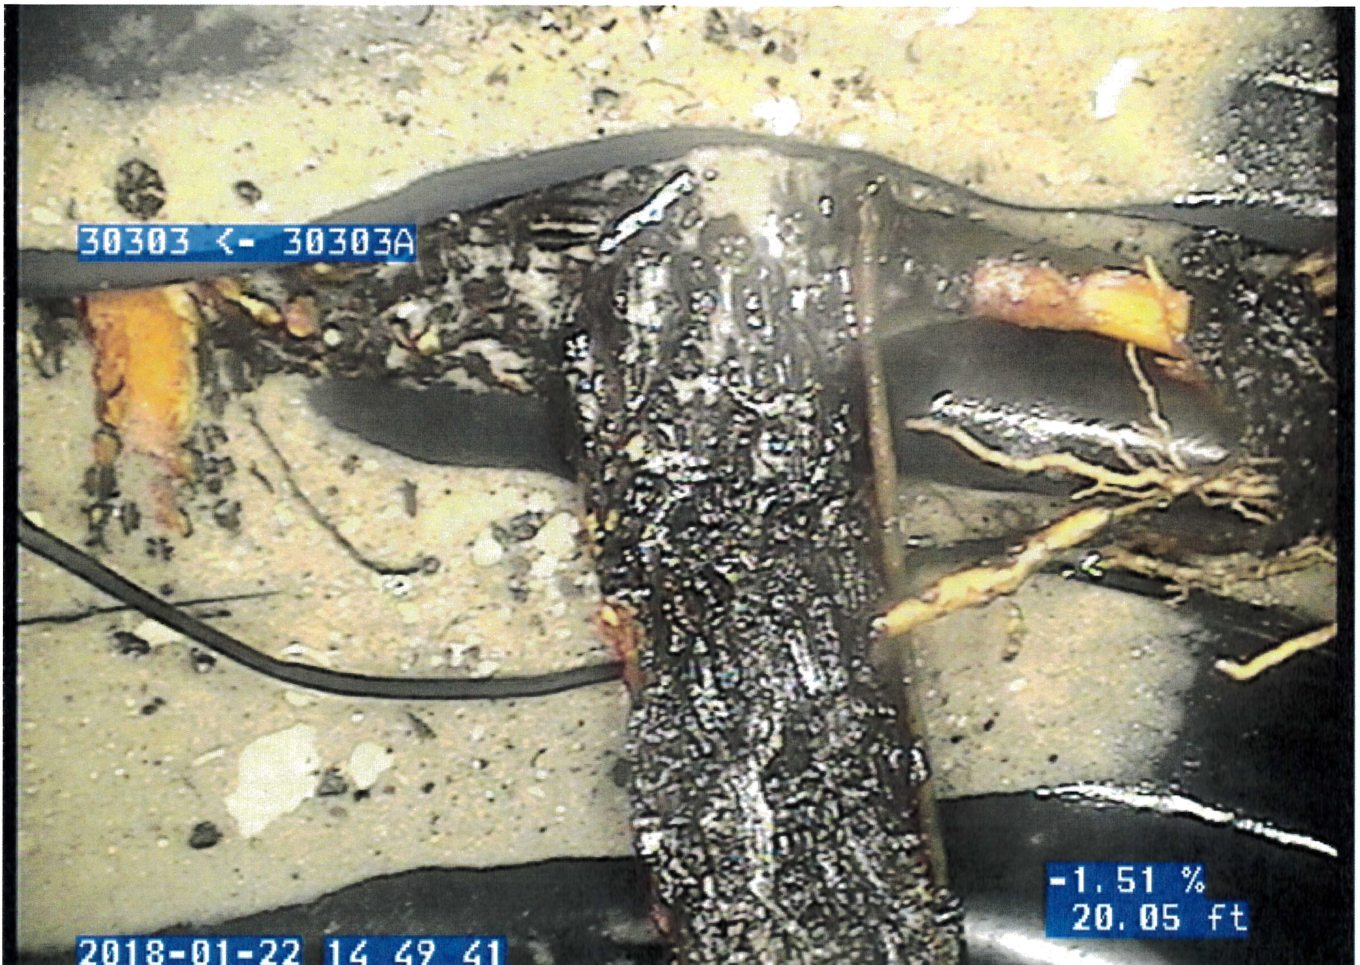
30303 - 30303A (2)\_0000

1 : 200	POSITION	DG	CODE	OBSERVATION	VIDEO POS	PHOTO
	0.00 ft		MGO	Reversal Inspection, 30303 - 30303A	00:00:02	
	0.00 ft		AEP	End of Pipe, 30303A	00:00:04	
	6.92 ft		H	Hole, at 12 o'clock	00:00:27	0000
	20.04 ft		RMJ	Roots Medium Joint, at 7 o'clock, 5 % lost, within 8 inch	00:01:26	0001
	20.43 ft		MSA	Survey Abandoned, Can't get by root. Survey incomplete.	00:01:58	0002
