Subject: Project Order Form  
Contract No. 13-0607, Storm Water Pipe/Water Quality Unit  
Cleaning, Video Recording and Related Services  
Purchase Order No. 20150035

PROJECT NAME: 16-17/B	CREATED: 2017.01.24	CATALOG NAME: NASSCO PACP-4
CUSTOMER: Lake County	PROJECT LEADER: James Rash	CONTRACTOR: Estep Construction Inc

## Section Protocol

SECTION NAME: <b>1 - 2</b>	SECTION NUMBER: <b>1</b>	CATALOG NAME: <b>NASSCO PACP-4</b>
CUSTOMER: <b>Lake County</b>	PROJECT LEADER: <b>James Rash</b>	CONTRACTOR: <b>Estep Construction Inc</b>

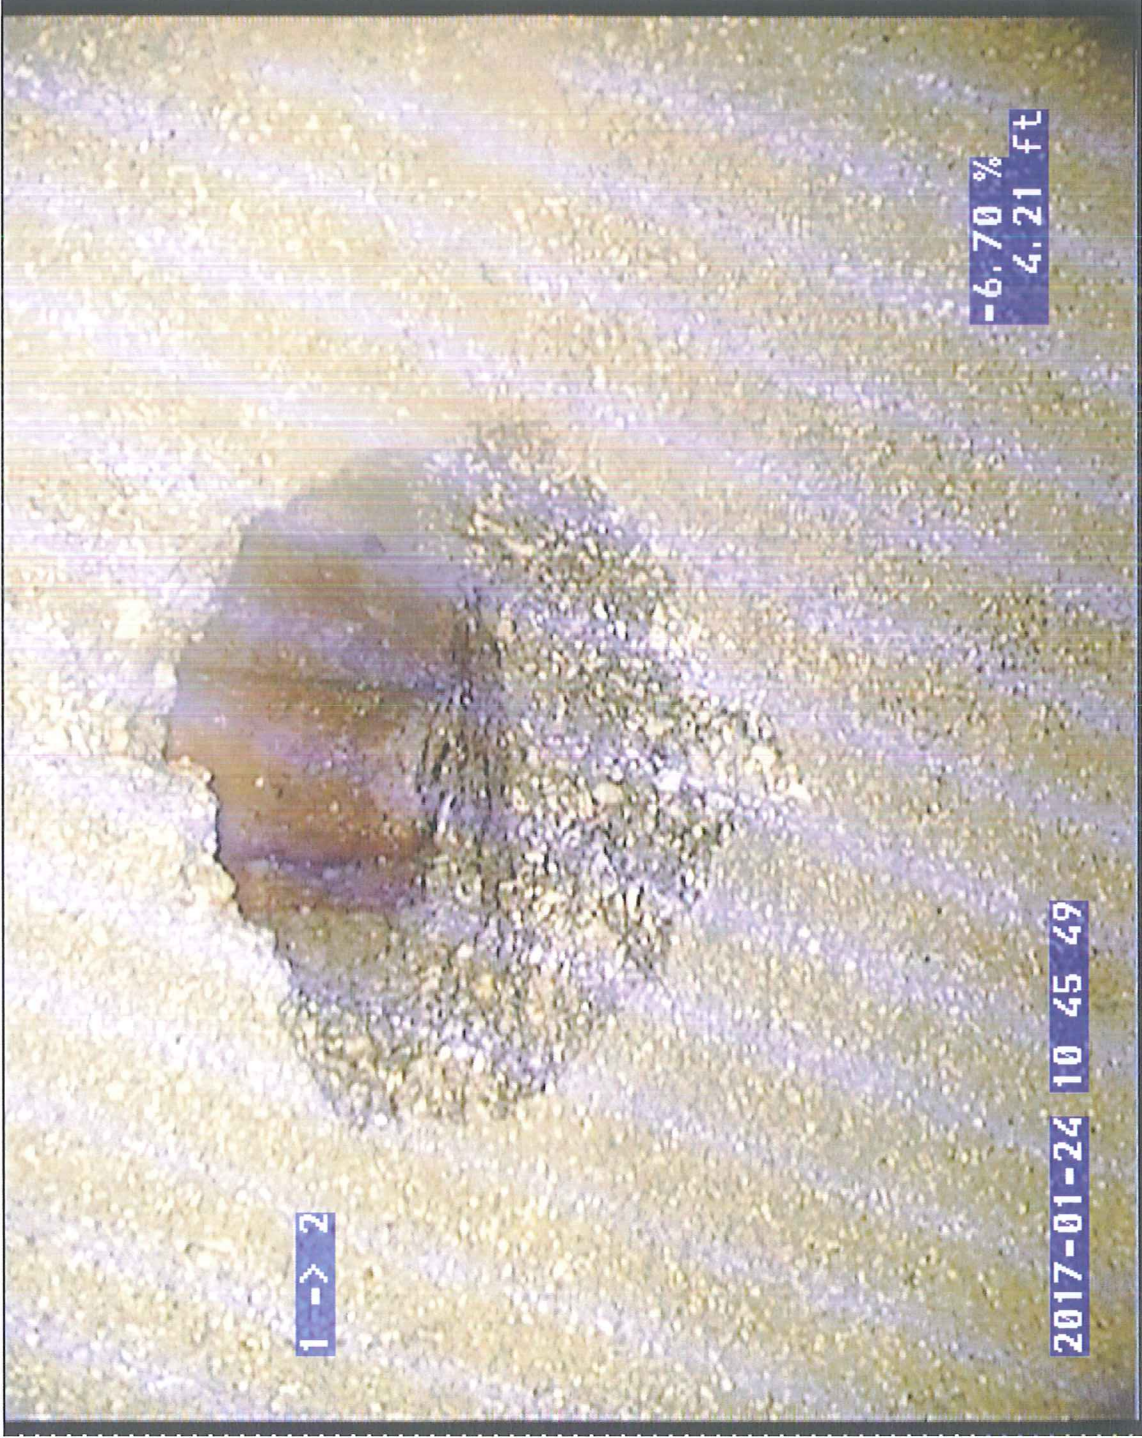
1 -> 2

1 : 350	POSITION	DG	CODE	OBSERVATION	VIDEO POS	PHOTO
	0.00 ft		ACB	Catch Basin, 1. Floor not even with pipe, starting inside pipe.	00:00:04	
	4.20 ft		H	Hole, at 12 o'clock, Start, Patched lift hole in each sectin of pipe	00:00:15	0000
	19.91 ft		H	Hole, at 12 o'clock, Finish, Patched lift hole in each sectin of pipe	00:01:32	
	24.14 ft		AEP	End of Pipe, 2	00:01:57

-6.70 %  
4.21 ft
