**Contamination Screening Evaluation Report
Minneola Corridor Study
Minneola, Lake County, Florida**

July 16, 2008
File No. 07-6515A

Subject: Contamination Screening Evaluation Report
Minneola Corridor Study
Minneola, Lake County, Florida

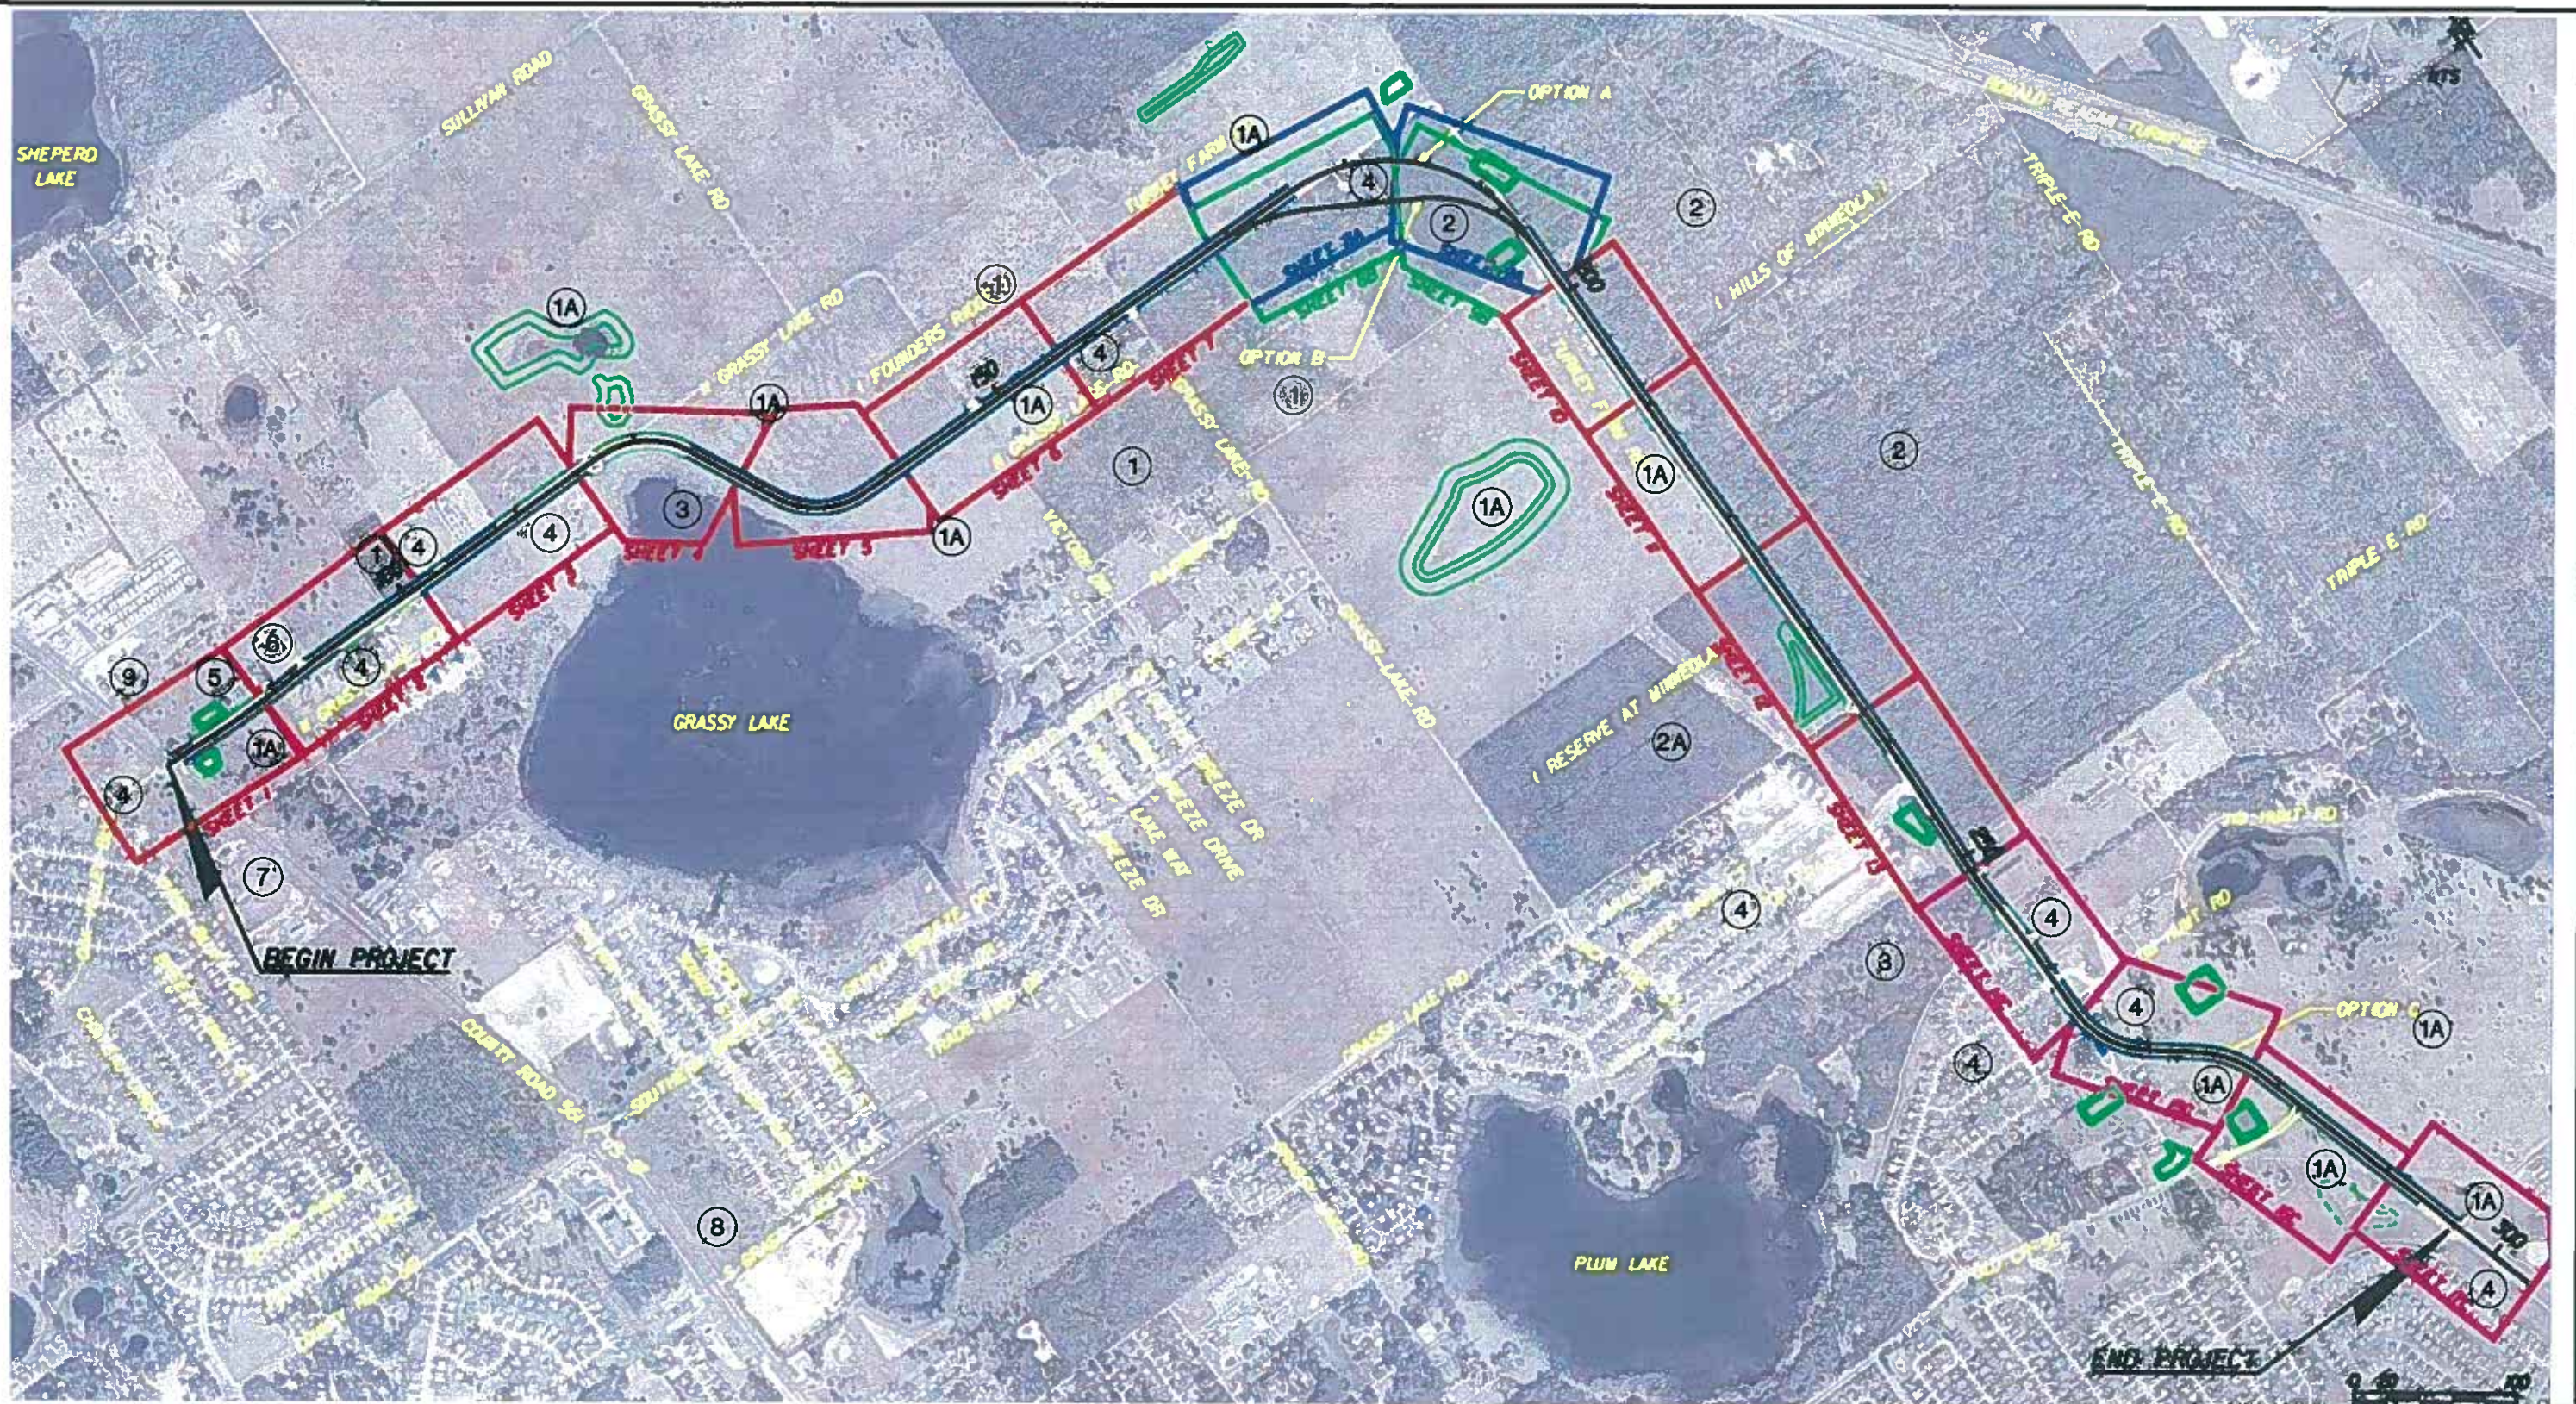
DRAWN BY: CD	CHECKED BY:	DATE: 07/01/08
FILE NO. 07-6515A	APPROVED BY:	FIGURE: 2

During our drive through of adjacent properties, development surrounding the project corridor was observed for potential contamination sources that could affect the area. The corridor begins at the intersection of U.S. Highway 27 and North Grassy Lake Road (a.k.a Citrus Grove Road) and runs east towards Turkey Farm Road (a.k.a. Hancock Road) and then runs south along Turkey Farm Road just south of Old C.R. 50. Development along the project corridor consisted primarily of pastureland, citrus groves and residential properties. A table including the property uses observed along the alignment is provided as Table 1. The Map I.D. included on Table 1 corresponds to the numbers on Figure 2.

- SECO Properties (Map I.D. 6) The FirstSearch report places this facility at the northeast corner of North Grassy Lake Road and US Hwy 27 and the STCM database coordinates place the property further east on the north side of North Grassy Lake Road, where the current Crown Marine facility is located. Based on the fact that this facility appears to be located within the project alignment and the tanks may have been removed prior to tank closure requirements, and because no assessment information is available on FDEP's Oculus website and the location of the former tanks is not known, a "high" risk rating was given to this facility. We note that the property mapped as Map I.D. 6 was also formerly a citrus grove. Assessment and possible remedial action may be needed if a portion of the property is planned to be acquired or if excavation and/or dewatering is planned.

- Fields Equipment Co. (Map I.D. 7) and Lykes Bros. Inc. (Map I.D. 9). These properties were reported as having had fuel storage tanks and were similar to the SECO property because there was no closure report documented on FDEP's Oculus website. Therefore, these properties were given a "high" risk rating. These sites are farther from the proposed roadway project than the SECO property; therefore they are less likely to be a concern for this project. However, if any portions of these properties are planned to be acquired or if excavation and/or dewatering is planned on or adjacent to these properties, assessment and possible remedial action may be needed.

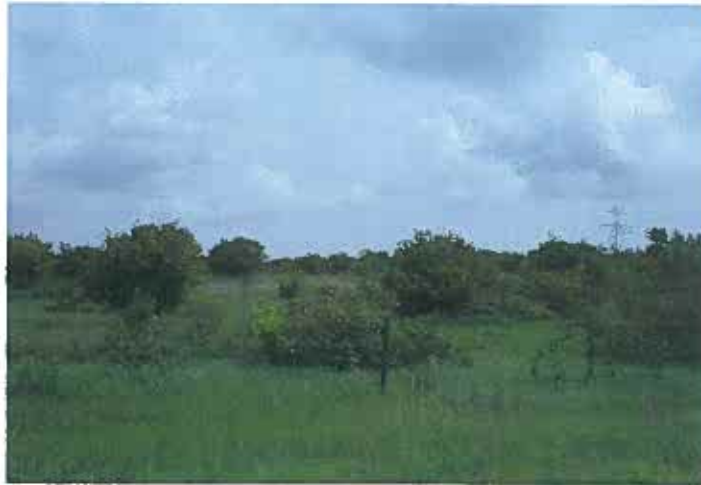
Citrus Grove Typical of Area

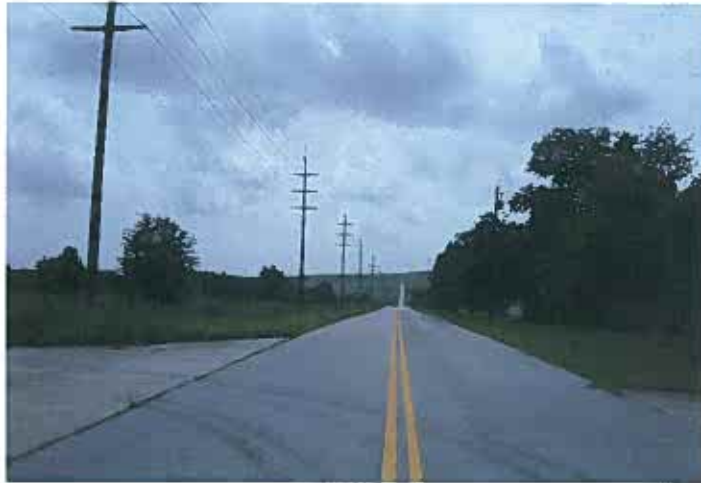
Facing East on North Grassy Lake Rd.

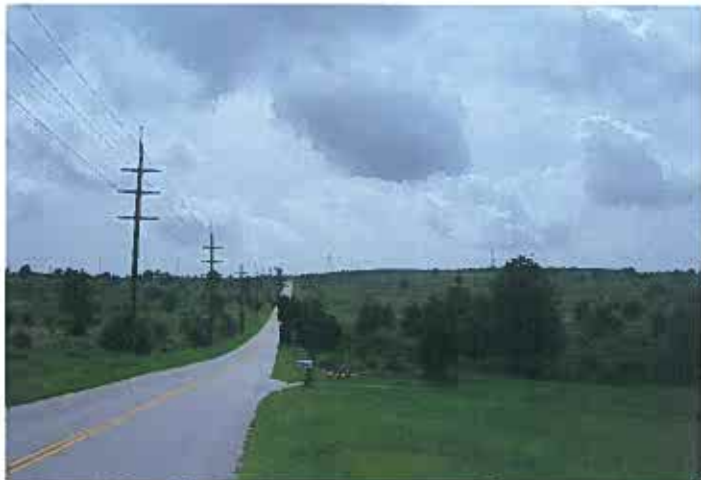
Facing South on Turkey Farm Rd.
