Priority Project #6

Replace/Update Signage at Drop-off / Pick-up Loops

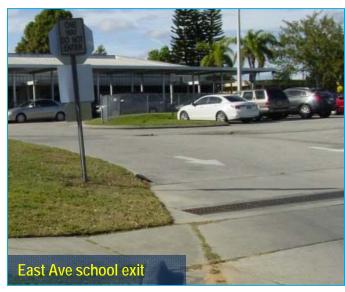
- Existing signs at exit of front drop-off / pick-up loop to East Ave is worn
- ✓ Sign noting times of left turn prohibition is not legible
- "Do Not Enter" signs at both drop-off / pick-up loop exits is non-standard

- ✓ Replace signs at East Ave driveway exit
- ✓ Use standard MUTCD R5-1 "Do Not Enter" signage at both drop-off / pick-up exit driveways
