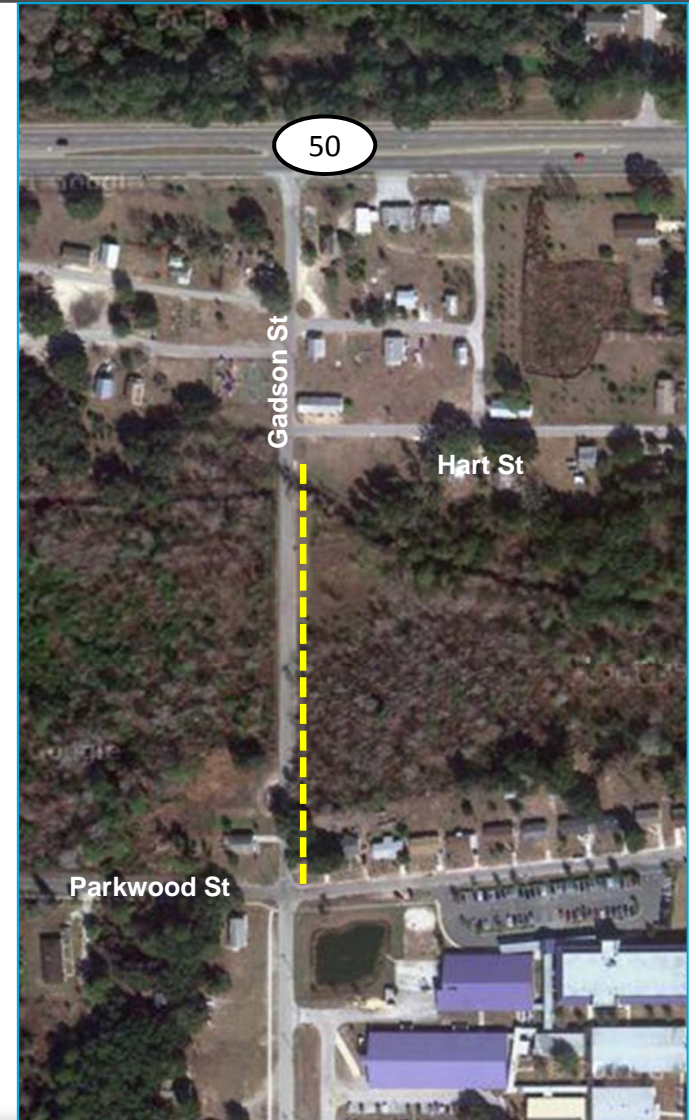
- ✓ Several students were observed to walk home north on Gadson St
- ✓ Existing sidewalk stops just south of Hart St and is of substandard width located at the edge of the roadway

- ✓ Reconstruct Gadson St sidewalk north of Parkwood St (east side of road) to 5 ft with roadway buffer
