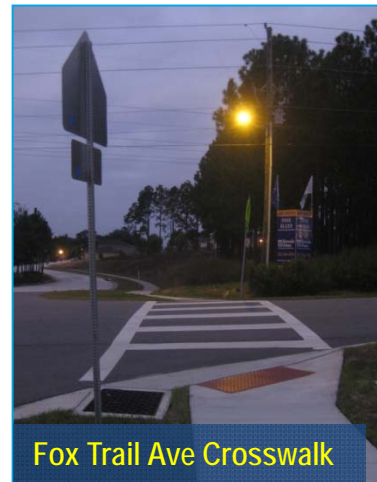
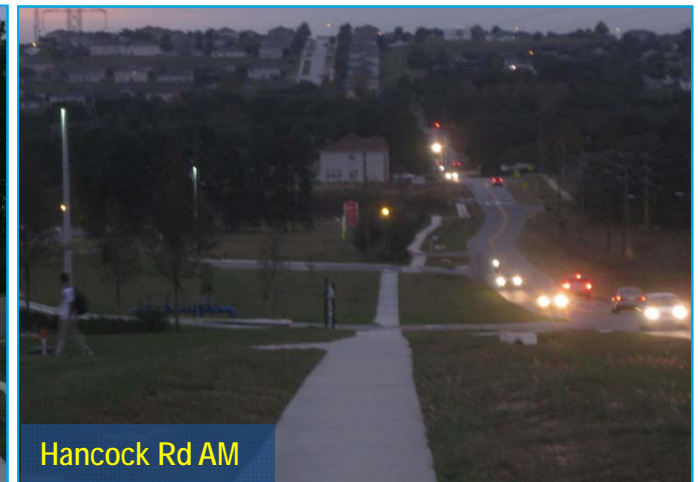
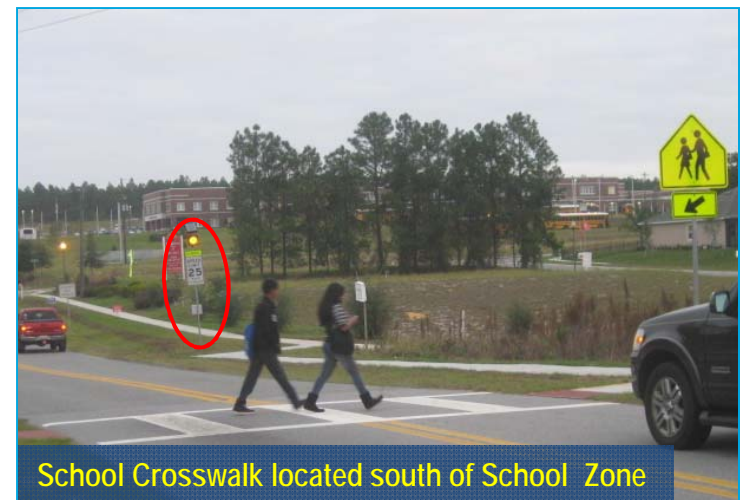
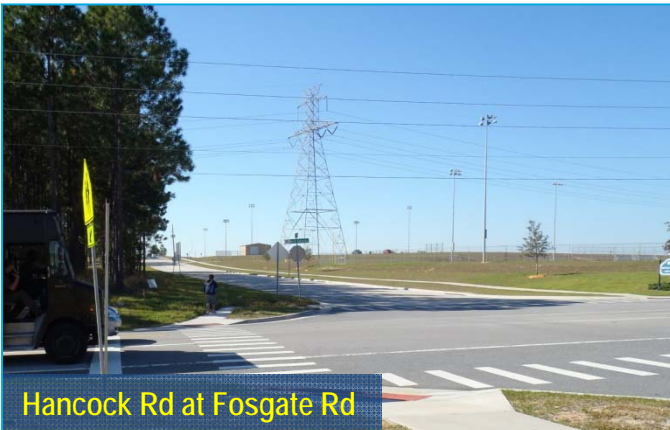
- ✓ Conditions in the morning are often dark, and lighting is generally poor along existing Hancock Rd sidewalk and at marked crosswalks
- ✓ No crossing guards at crosswalks adjacent to school
- ✓ Posted speed limit on Turkey Farm Rd (northbound) changes from 30 mph to 45 mph to 25 mph (during school speed zone periods)
- ✓ School 25 mph speed zone begins just north of school crosswalk on Hancock Rd between Brimming Lake Rd and Big Sky Dr – posted speed is 45 mph at crosswalk

- ✓ Move southern Hancock Rd school speed zone signs further south of existing crosswalk (*completed by Lake Co.*)
- ✓ Re-visit posted speed limit along Turkey Farm Rd/Hancock Rd with potential reduction of 45 mph section to 30 mph
- ✓ Add sufficient lighting at all marked crosswalks at Hancock Rd/Turkey Farm Rd and at Fosgate Rd/Grassy Lake Rd; also add advance yield lines (30 ft prior to crosswalk) and yield here to pedestrians signs at uncontrolled locations
 - ✓ Hancock Rd at Fosgate Rd (all-way stop)
 - ✓ Hancock Rd at Fox Trail Ave (uncontrolled)
 - ✓ Hancock Rd south of Big Sky Dr (uncontrolled)
 - ✓ Turkey Farm Rd at Brimming Lake Rd (uncontrolled)

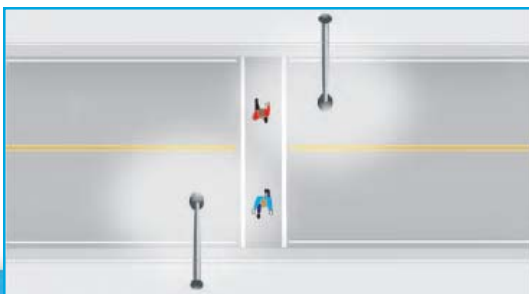
Proper placement of crosswalk illumination
(Credit: Michele Weisbart, *Model Design Manual for Living Streets*, Los Angeles County, 2011)
