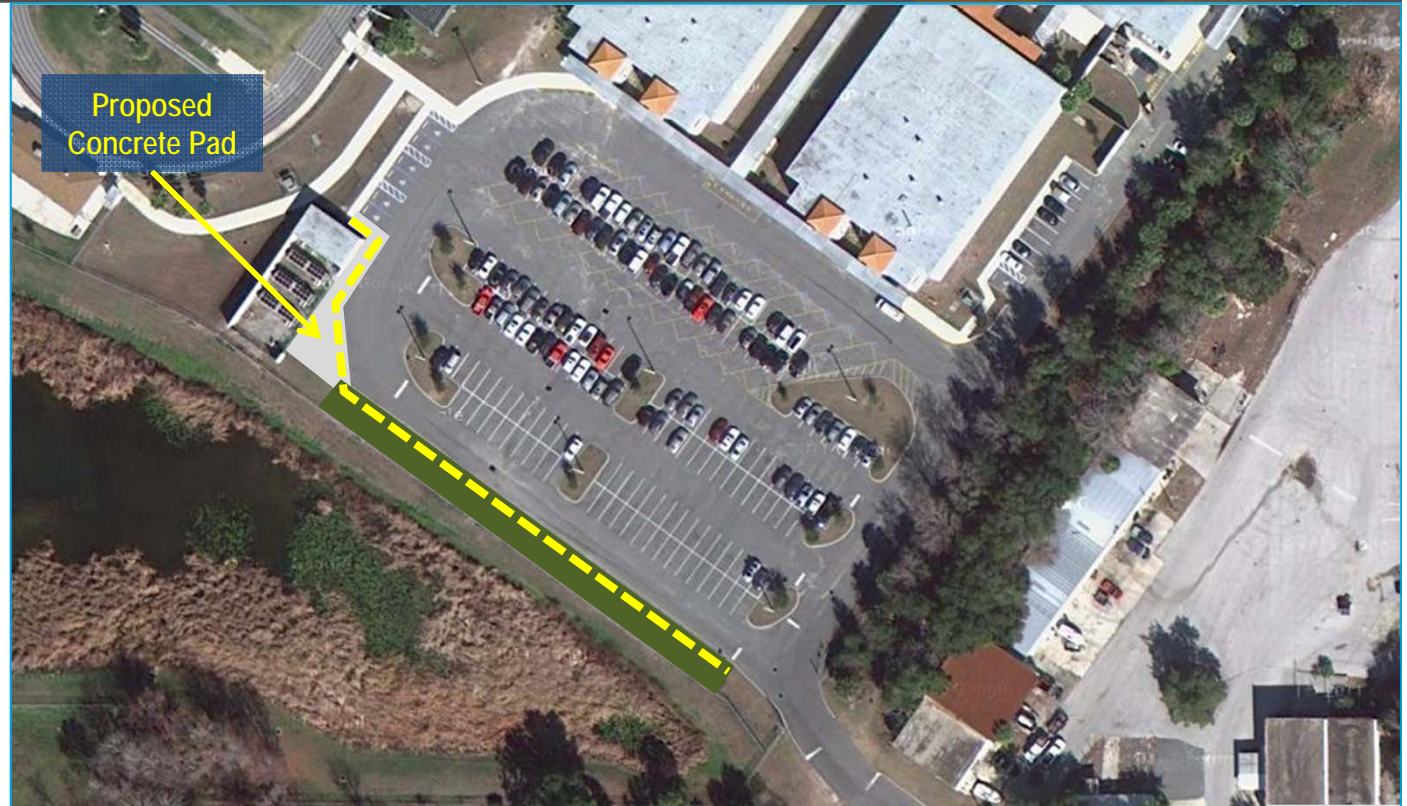
- ✓ Pedestrian walkway is currently painted on the pavement
- ✓ Buses line up like a “horseshoe”

- ✓ Extend the sidewalk in front of the chillers; provide driveway on “diagonal” portion to allow access to the chillers
- ✓ Extend the sidewalk from the chillers to the bus loop exit; permanently remove parking spaces currently marked with painted walkway (i.e. fill in with grass and raised curbing)
