**SIGNAL WARRANT ANALYSIS**

CR 44 AT APIARY ROAD

LAKE COUNTY DEPARTMENT OF PUBLIC WORKS  
Work Order: 11

May 20, 2005

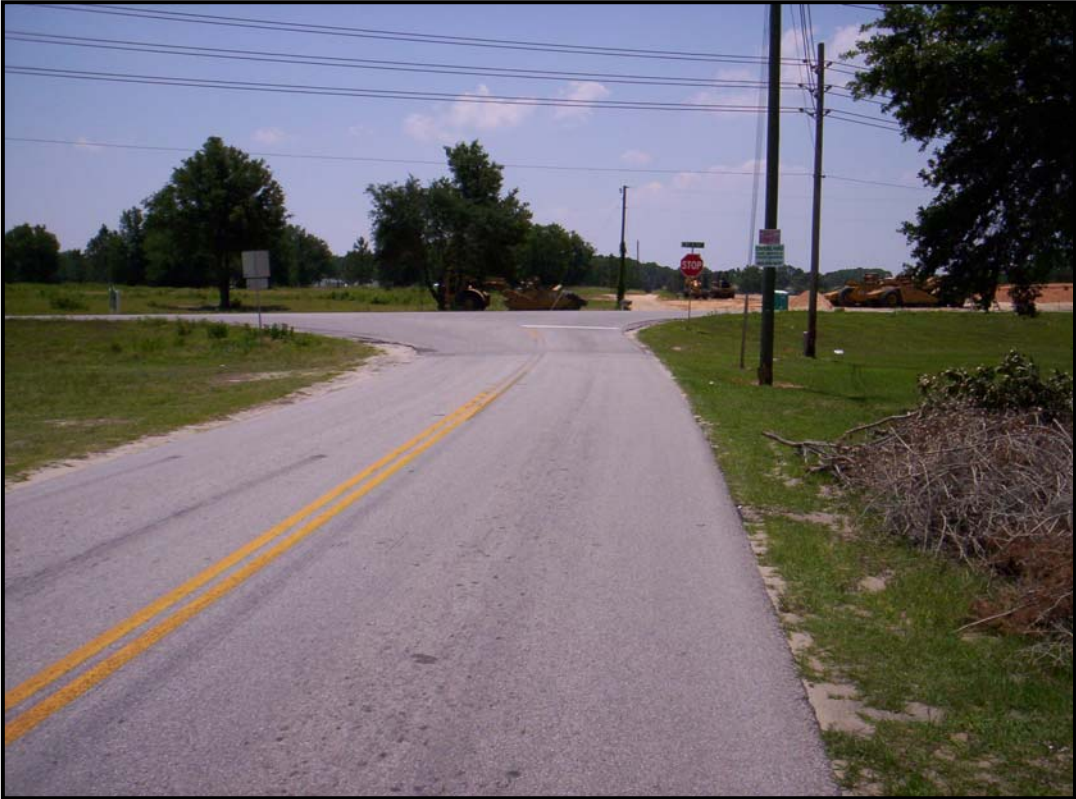
**Exhibit 1-North Approach Photographs**

**Looking South into the intersection along Apiary Road**

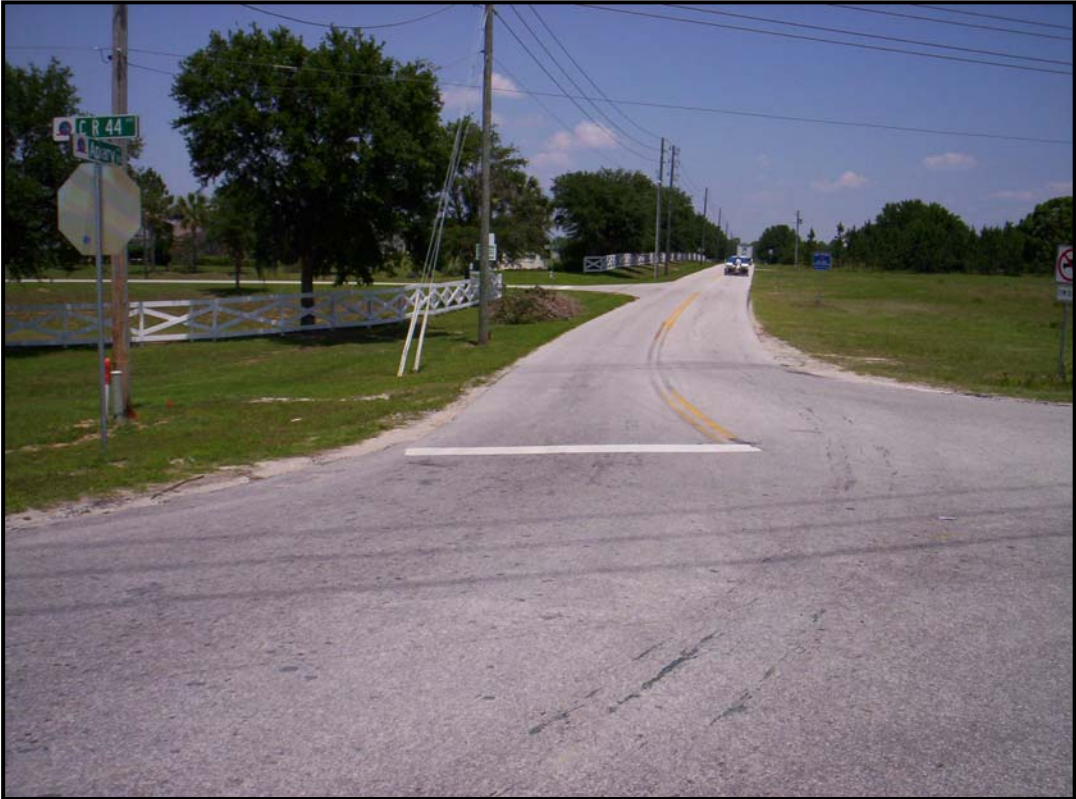
**Looking North from the intersection along Apiary Road**

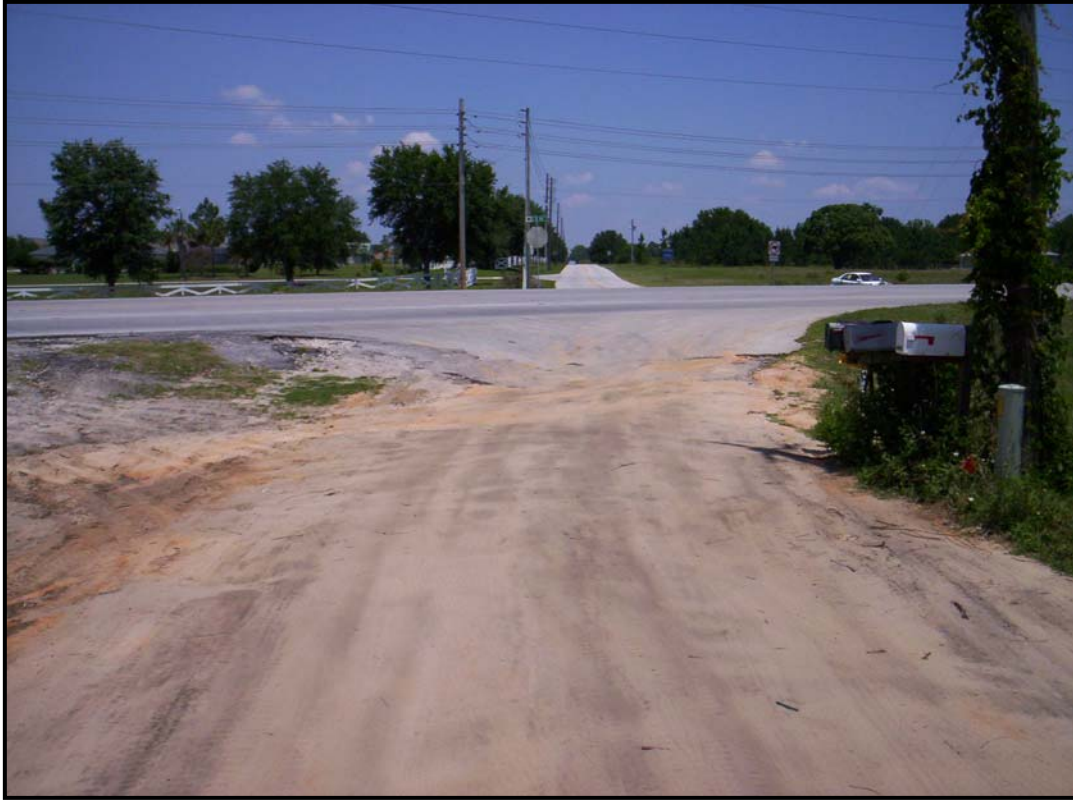
**Exhibit 2-South Approach Photographs**

**Looking North into the intersection along Apiary Road**

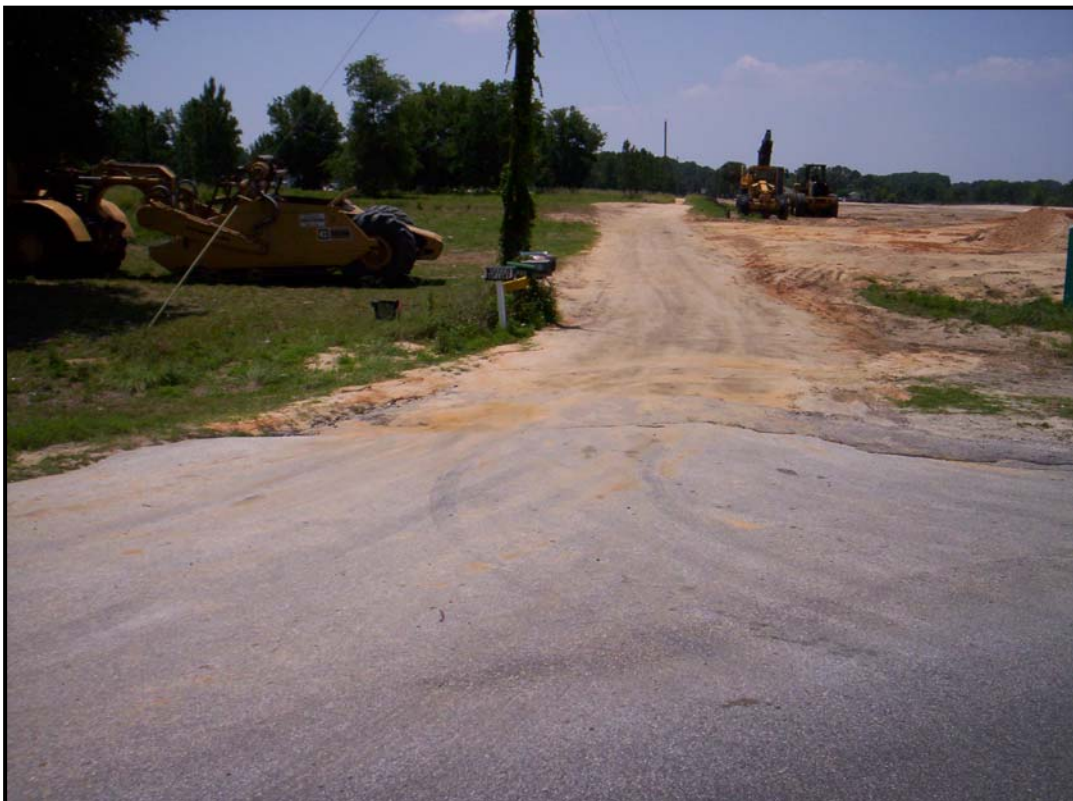
**Looking South from the intersection along Apiary Road**

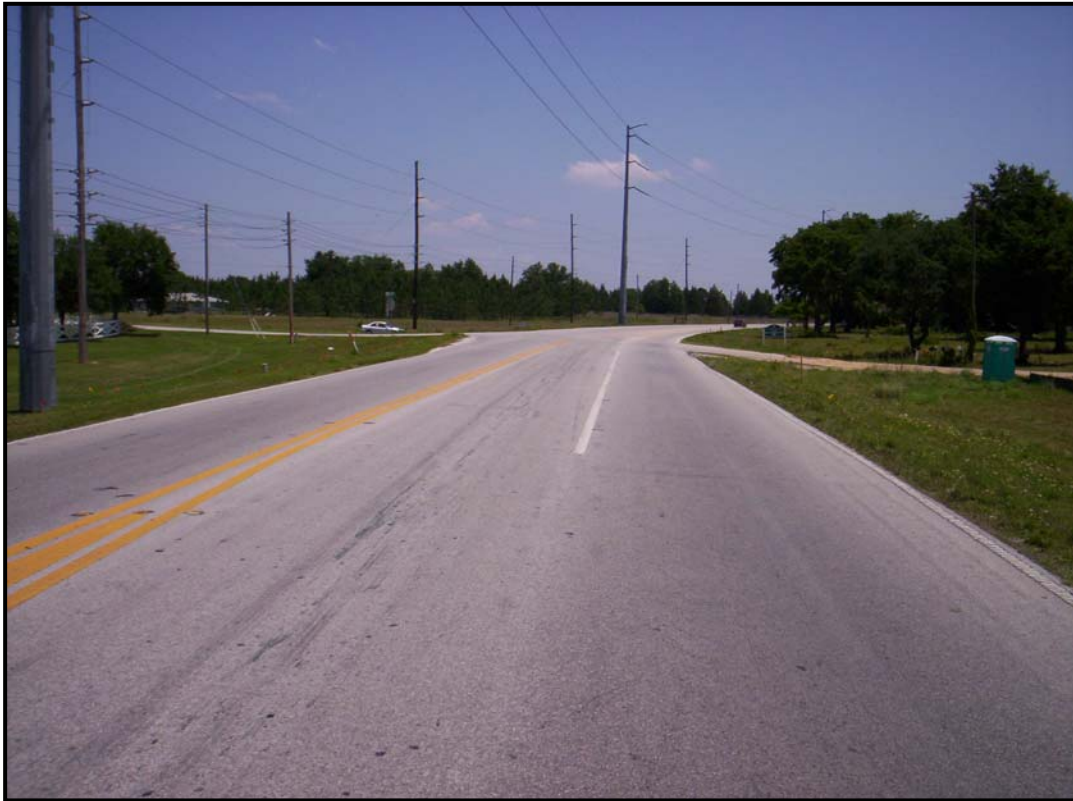
**Exhibit 3-West Approach Photographs**

**Looking East into the intersection along CR 44**

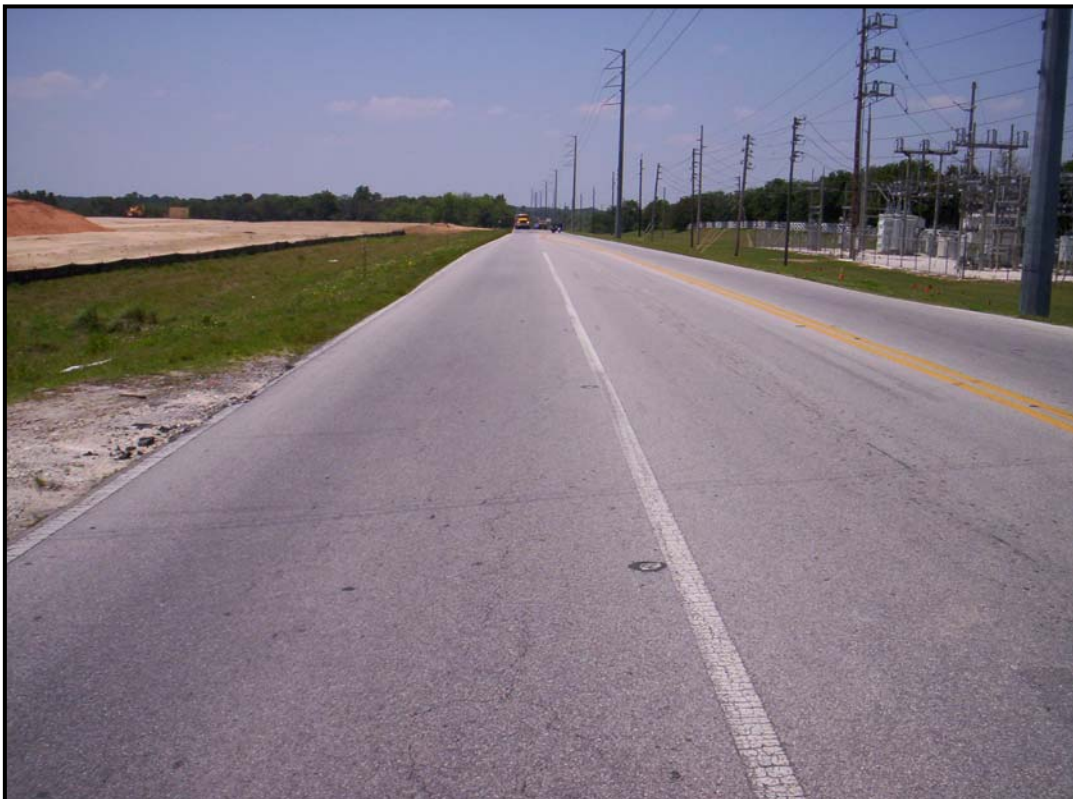
**Looking West from the intersection along CR 44**

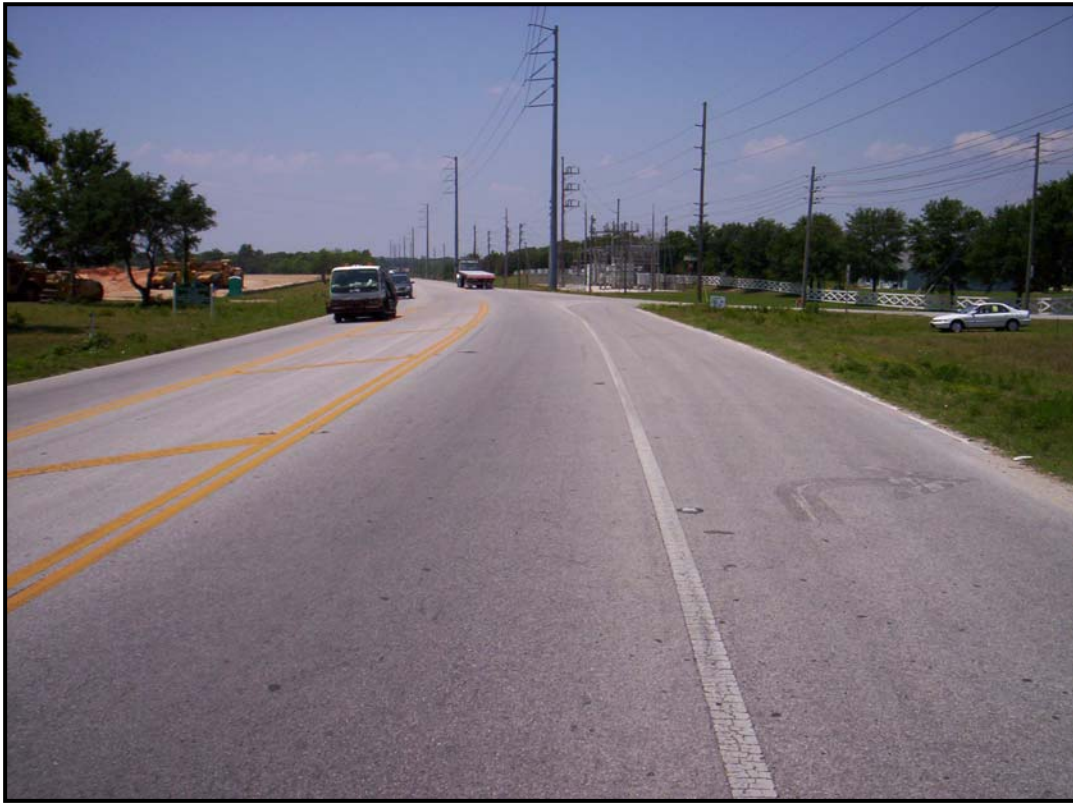
**Exhibit 4-East Approach Photographs**

**Looking West into the intersection along CR 44**

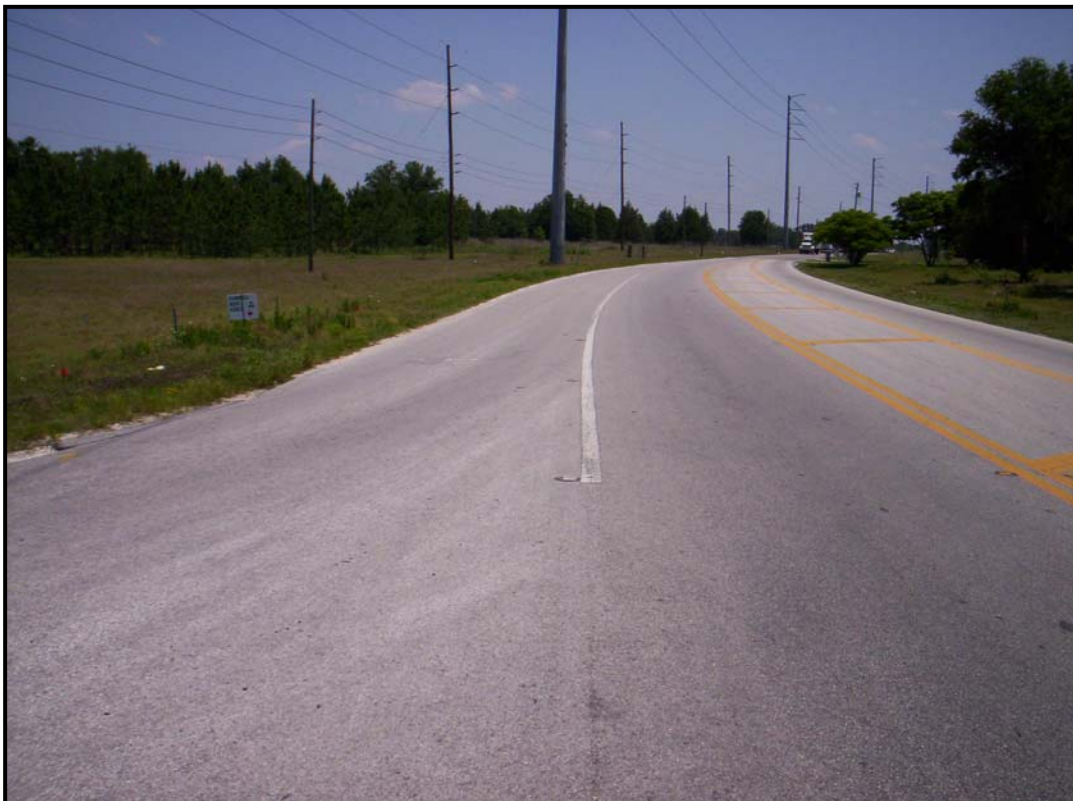
**Looking East from the intersection along CR 44**

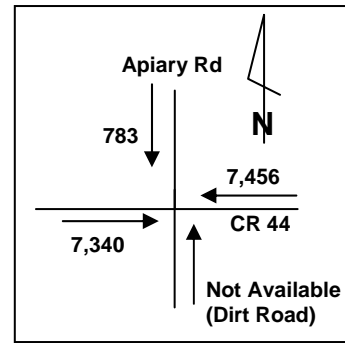
Twenty-Four Hour Volumes

Twenty-four hour machine approach counts were collected on the approaches to the intersection. These counts are summarized in the adjacent figure.

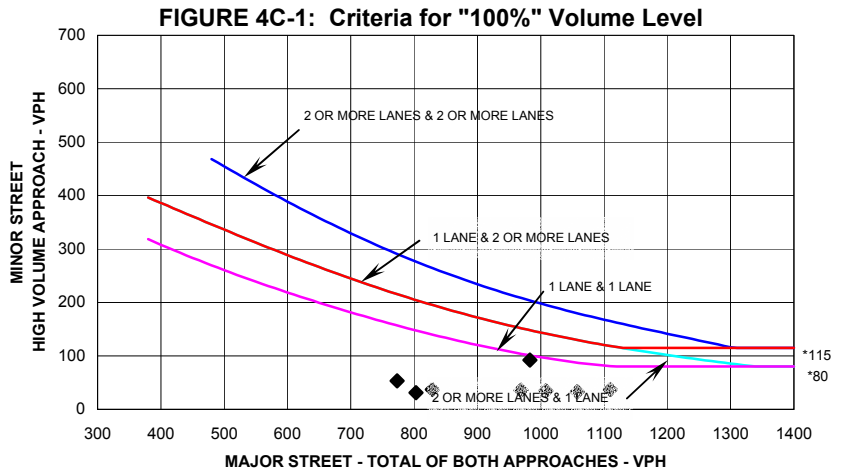
*If all four points lie above the appropriate line, then the warrant is satisfied.*

\* Note: 115 vph applies as the lower threshold volume for a minor street approach with two or more lanes and 80 vph applies as the lower threshold volume threshold for a minor street approach with one lane.

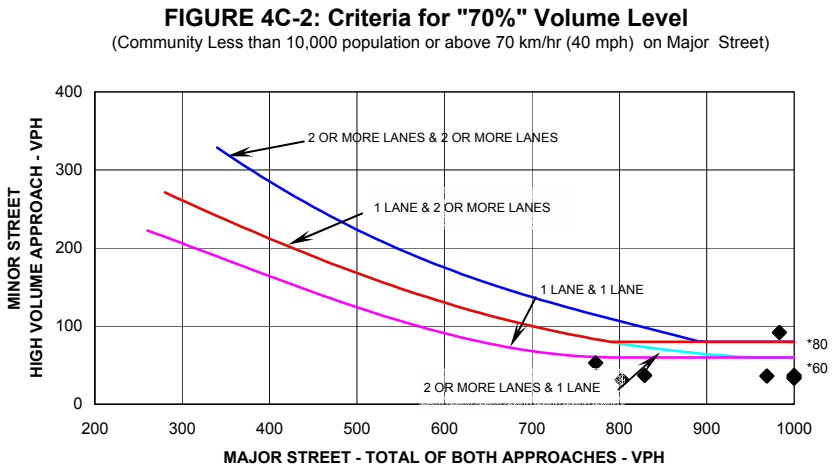
\* Note: 80 vph applies as the lower threshold volume for a minor street approach with two or more lanes and 60 vph applies as the lower threshold volume threshold for a minor street approach with one lane.

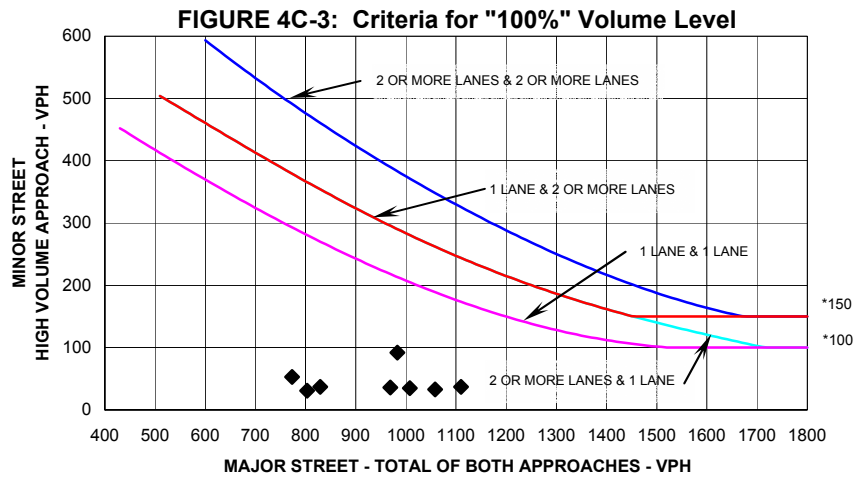
If all three criteria are fulfilled or the plotted point lies above the appropriate line, then the warrant is satisfied.

\* Note: 150 vph applies as the lower threshold volume for a minor street approach with two or more lanes and 100 vph applies as the lower threshold volume threshold for a minor street approach with one lane.

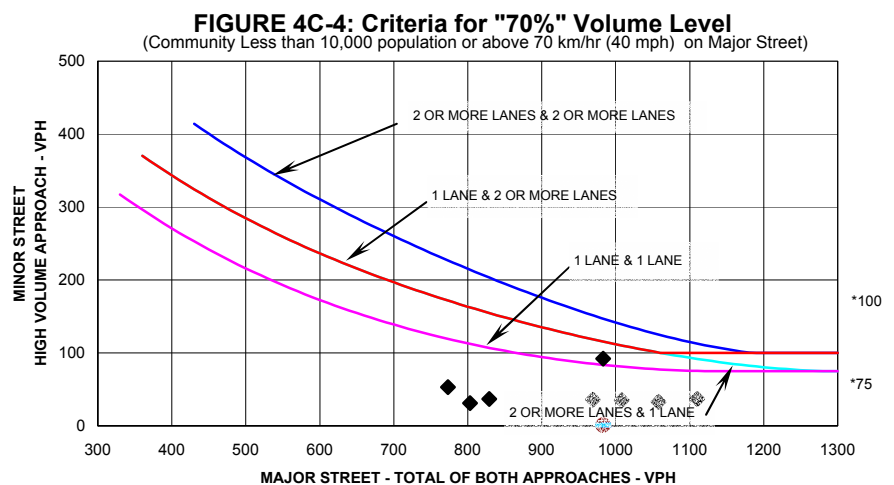
\* Note: 100 vph applies as the lower threshold volume for a minor street approach with two or more lanes and 75 vph applies as the lower threshold volume threshold for a minor street approach with one lane.
