Signal Warrant Study

SR 44 at CR 42

STUDY 2
LAKE COUNTY
SECTION 11110
MILEPOST 23.703

Continuing Services for Traffic Engineering
Contract Number C-8L68
Financial Project No. 237987-1-32-12
Work Order No. 20
FDA No. 336.0202

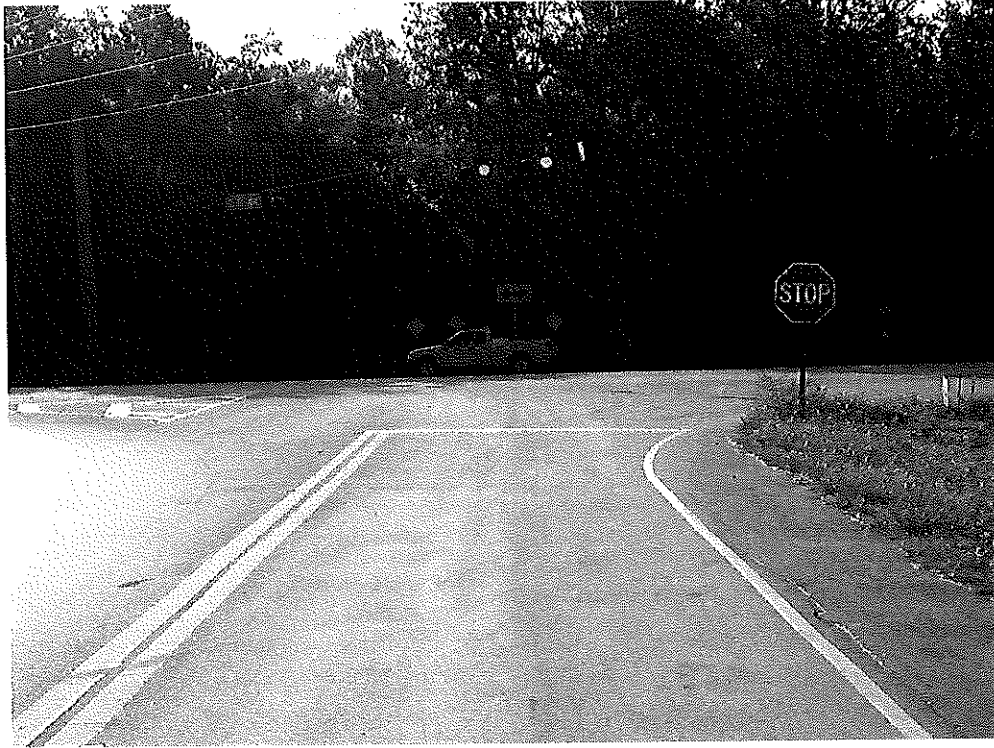
Exhibit 1-North Approach Photographs

Looking south into the intersection along CR 42

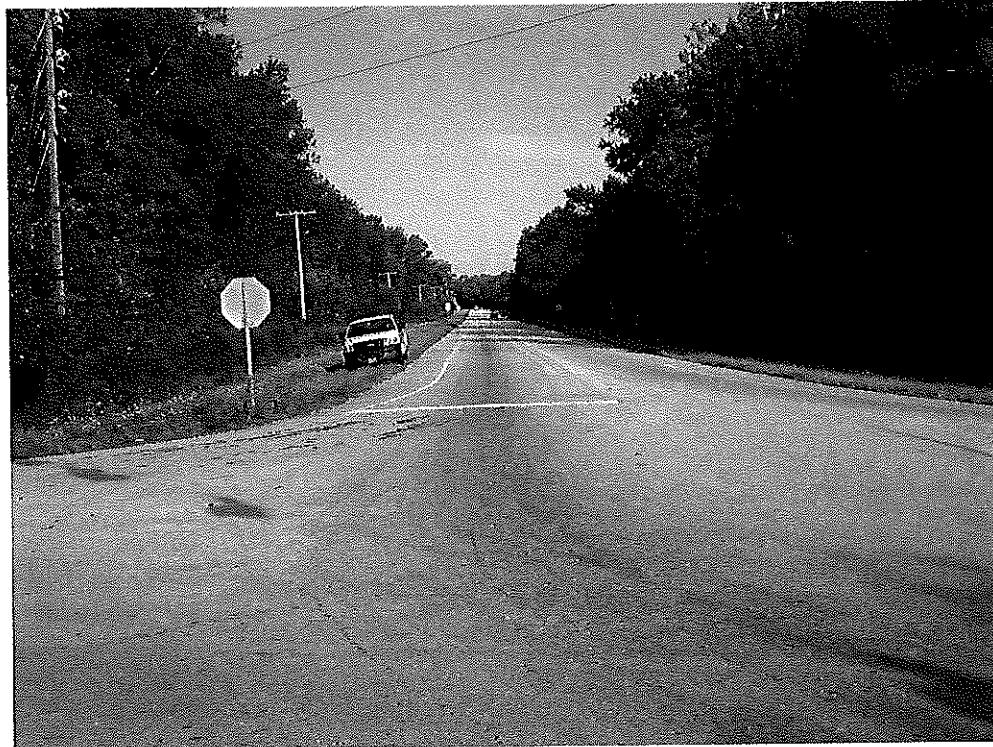
Looking north from the intersection along CR 42

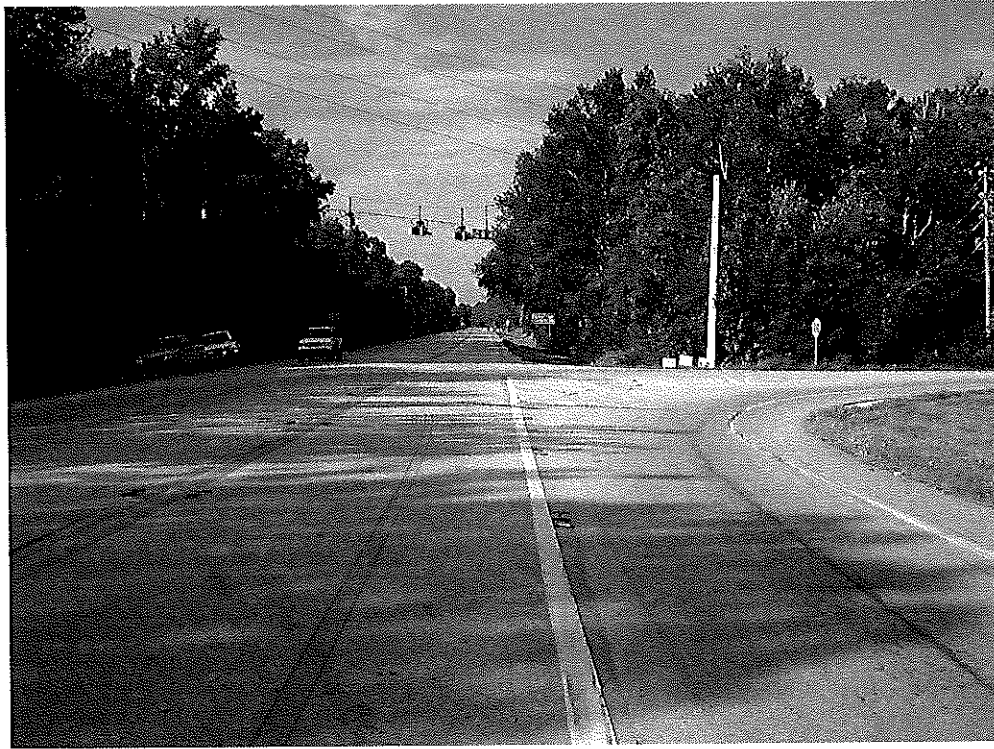
Exhibit 2-East Approach Photographs

Looking west into the intersection along SR 44

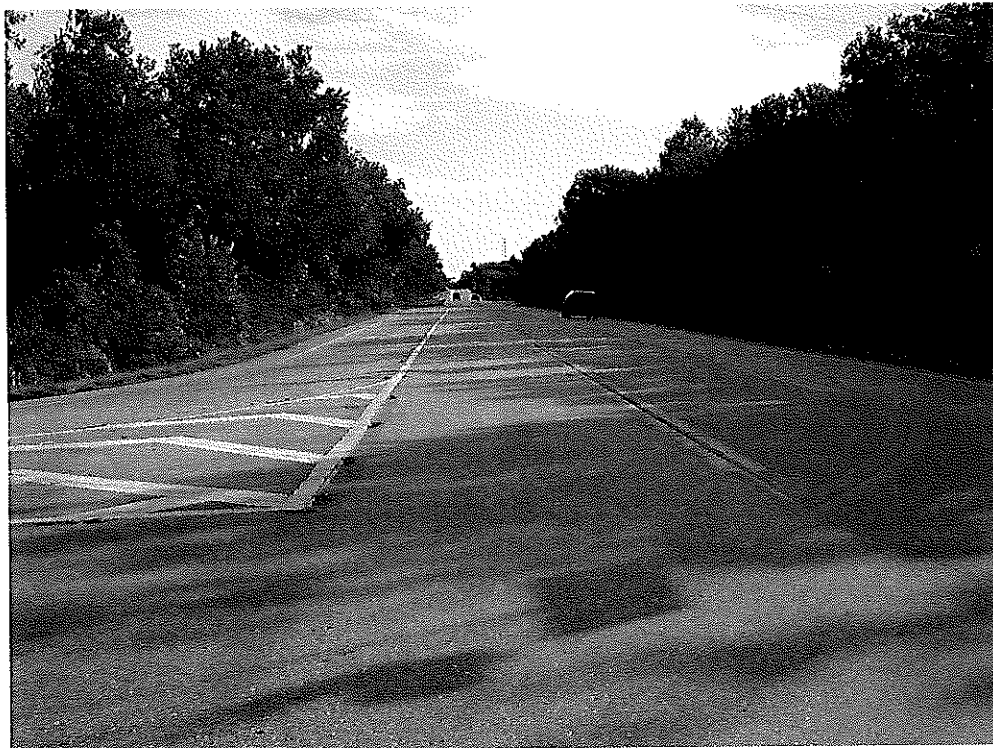
Looking east from the intersection along SR 44

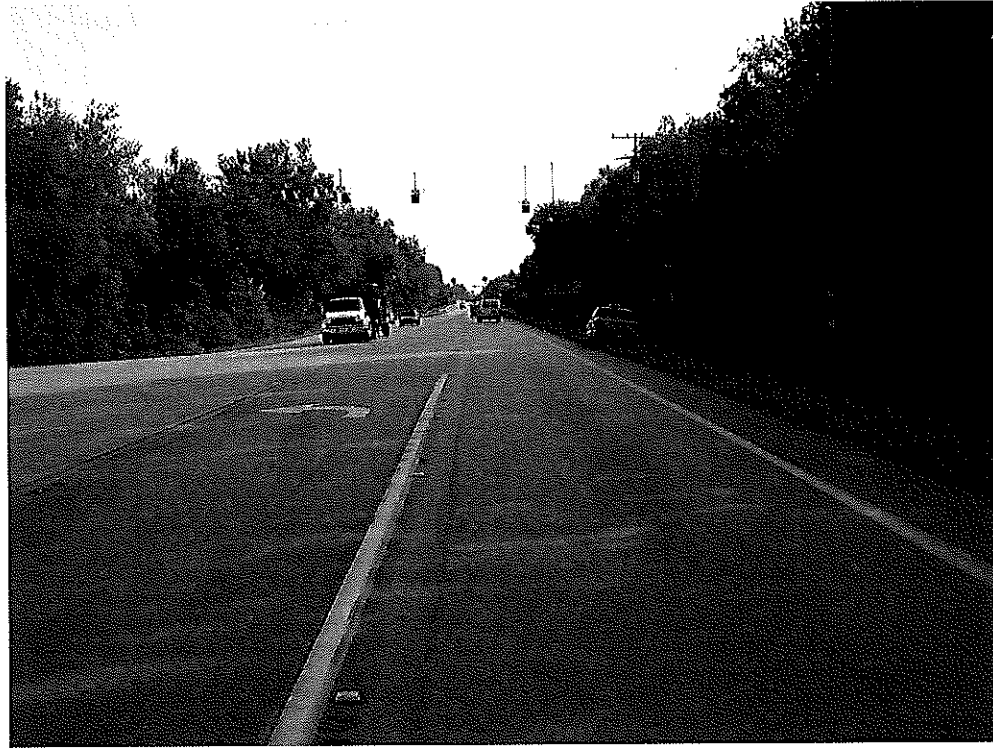
Exhibit 3-West Approach Photographs

Looking east into the intersection along SR 44

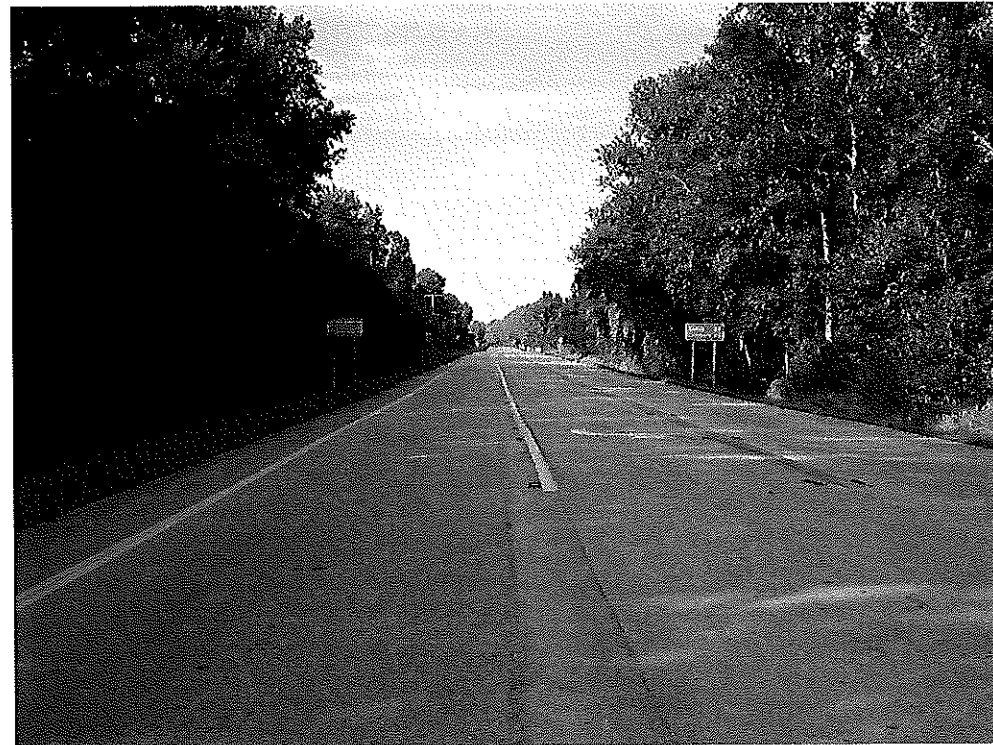
Looking west from the intersection along SR 44

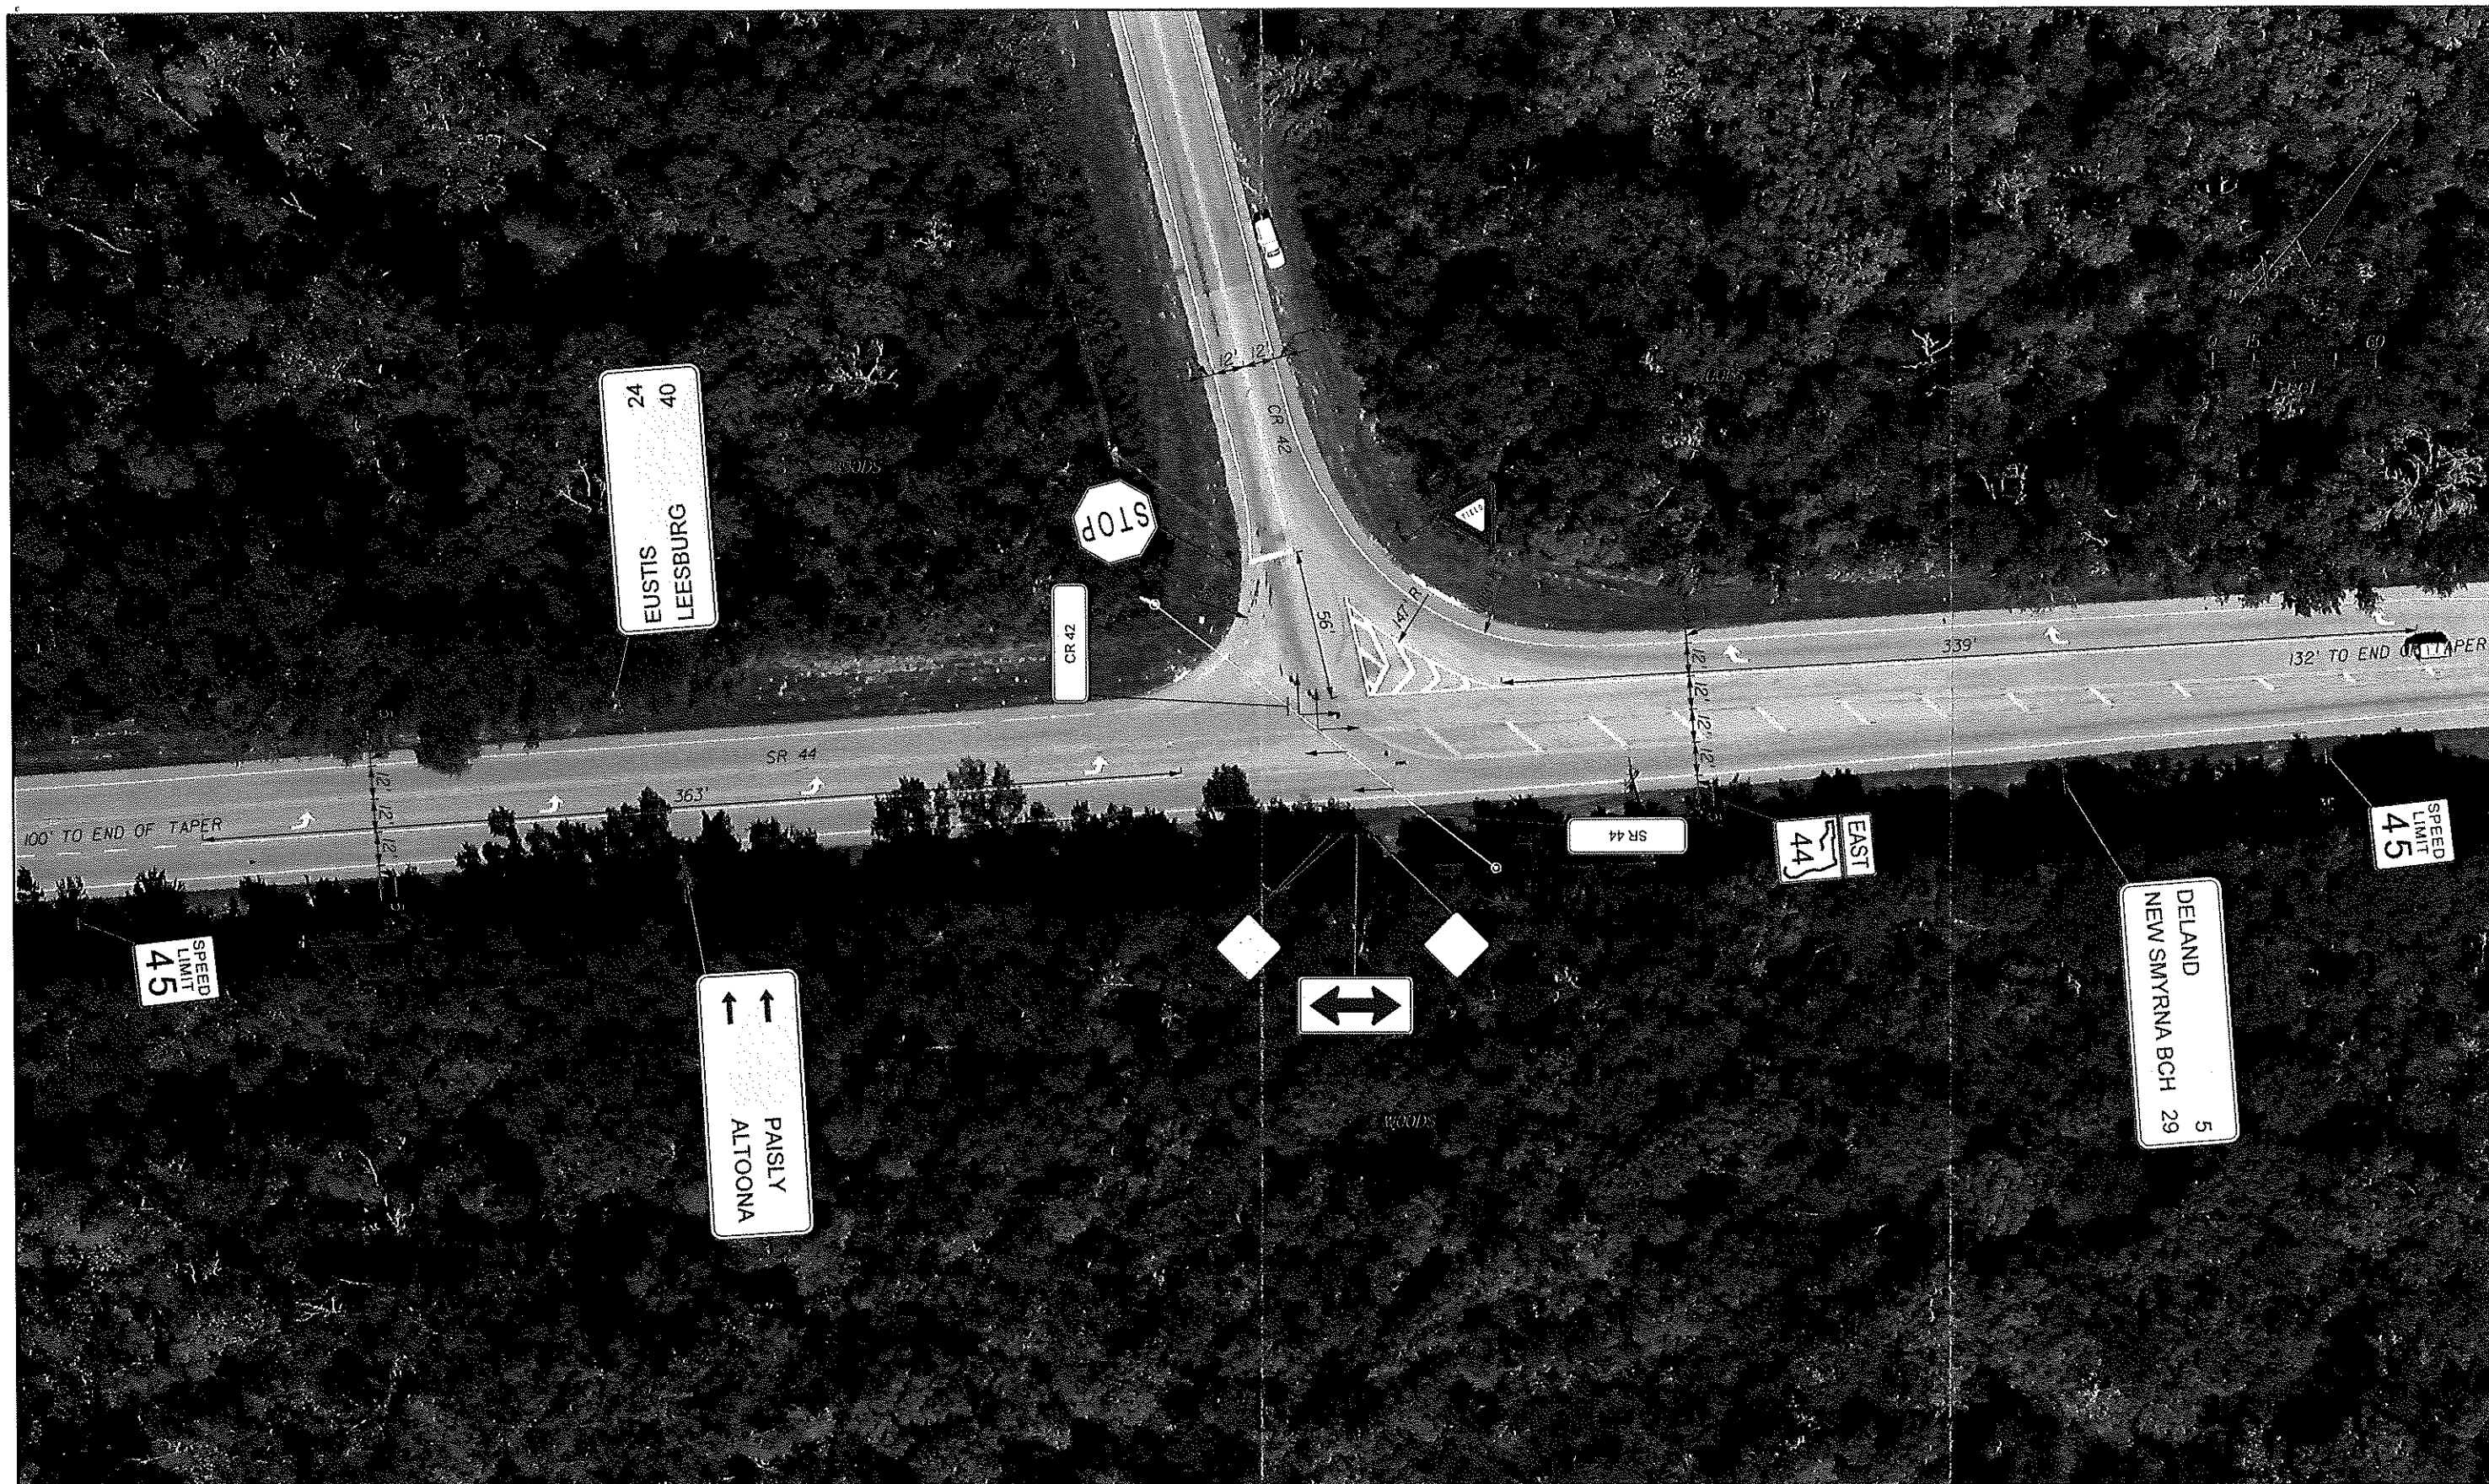
FIGURE 2
CONDITION DIAGRAM
CONTINUING SERVICES FOR TRAFFIC ENGINEERING

CONTROLLER CABINET		DELINEATOR		DITCH BOTTOM INLET		GUARDRAIL
	TRAFFIC SIGNAL POLE		POWER POLE		MANHOLE		FENCE
	SIGNAL HEAD		LIGHT POLE		MITERED END SECTION		TREE/SHRUB
	SIGN		HYDRANT		DRAINAGE INLET		BUILDING

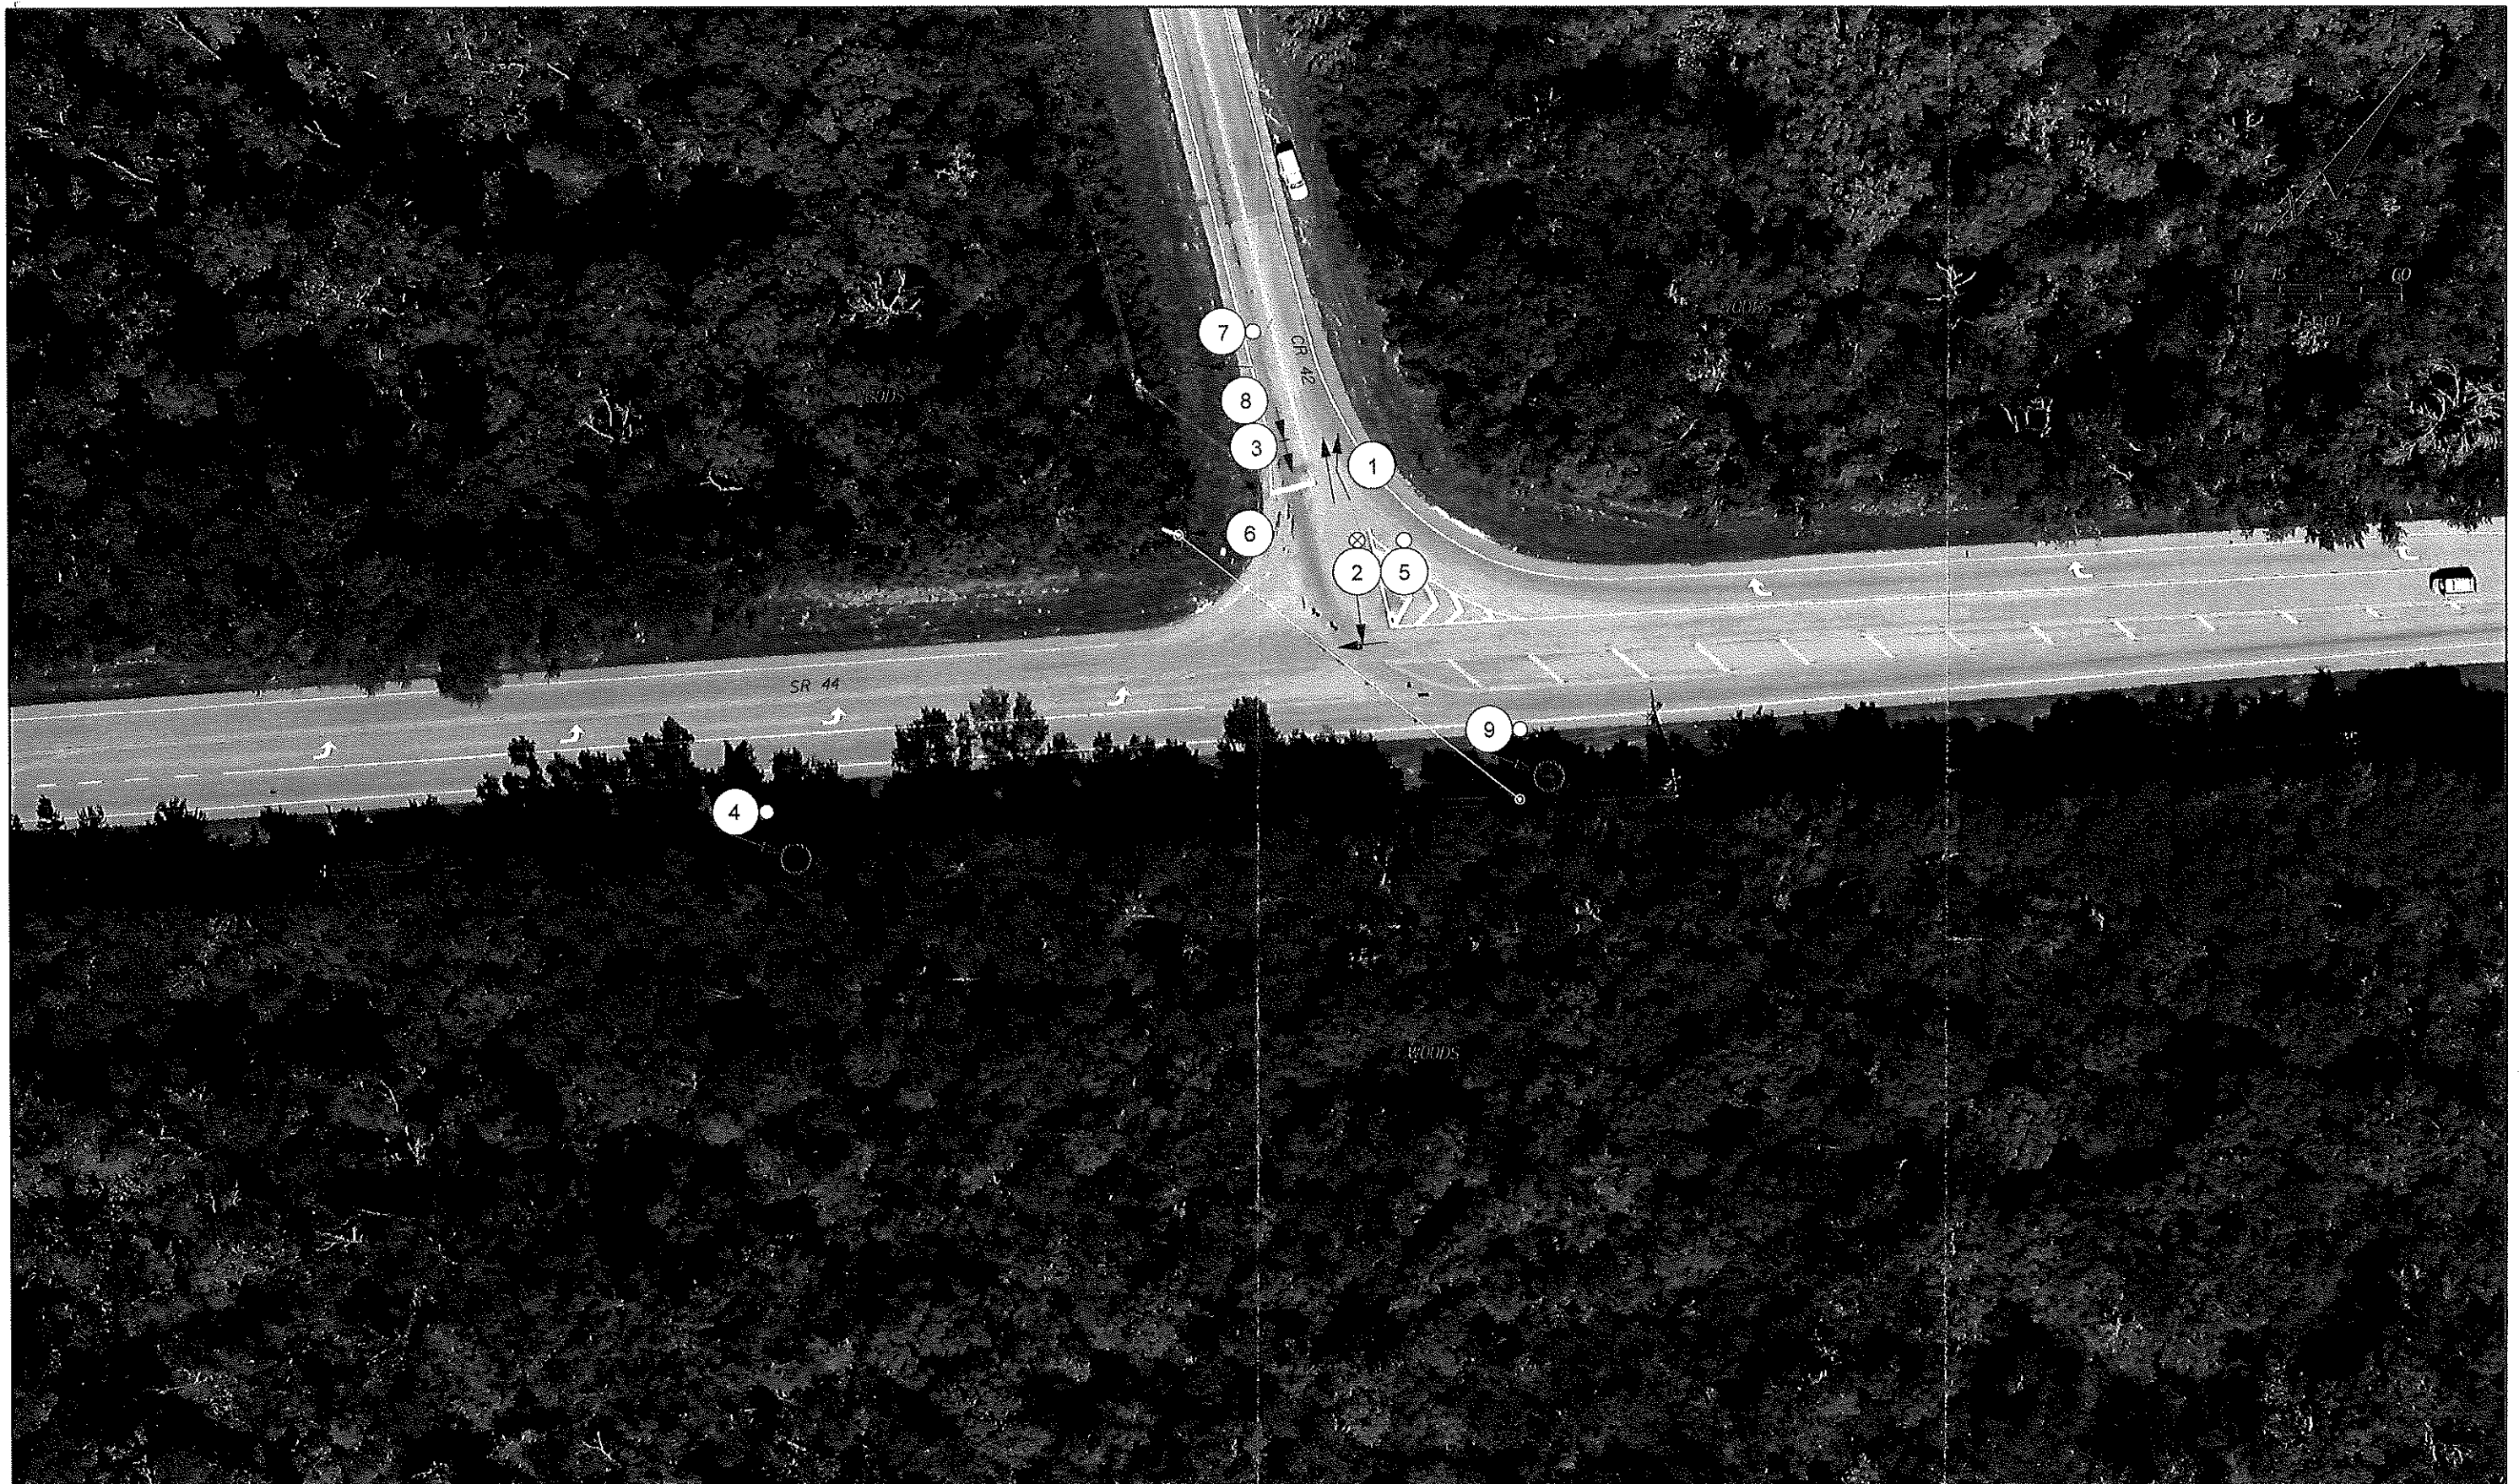
⊗ FATAL ○ INJURY (XX) COLLISION NUMBER	←←← REAR END ←←← SIDESWIPE ←←← OUT OF CONTROL ←←← BACKED INTO	→→→ RIGHT TURN →→→ HIT PEDESTRIAN ↓ ANGLE	↙ LEFT TURN ← OVERTURNED →← HEAD ON ← HIT MOVEABLE OBJECT	○ HIT TREE → HIT SIGN → HIT UTILITY POLE → HIT DITCH	<i>Faller, Davis & Associates, Inc.</i>	FIGURE 3 COLLISION DIAGRAM CONTINUING SERVICES FOR TRAFFIC ENGINEERING	PAGE NO. 9
---	--	---	--	---	---	--	---------------

Crash data was provided by the Florida Department of Transportation for the intersection of SR 44 at CR 42 for the 12-month period ending June 1, 2007. Nine collisions occurred at the intersection including two angle collisions, two rear end collisions, two hit tree/shrub collisions, one sideswipe collision, one hit utility pole collision, and one ran into ditch/culvert collision. The collisions resulted in one fatality, seven injuries, and an estimated \$58,100 in property damages.

- Crash data was provided by the Florida Department of Transportation for the intersection of SR 44 at CR 42 for the 12-month period ending June 1, 2007. Nine collisions occurred at the intersection resulting in one fatality, seven injuries, and an estimated \$58,100 in property damage.

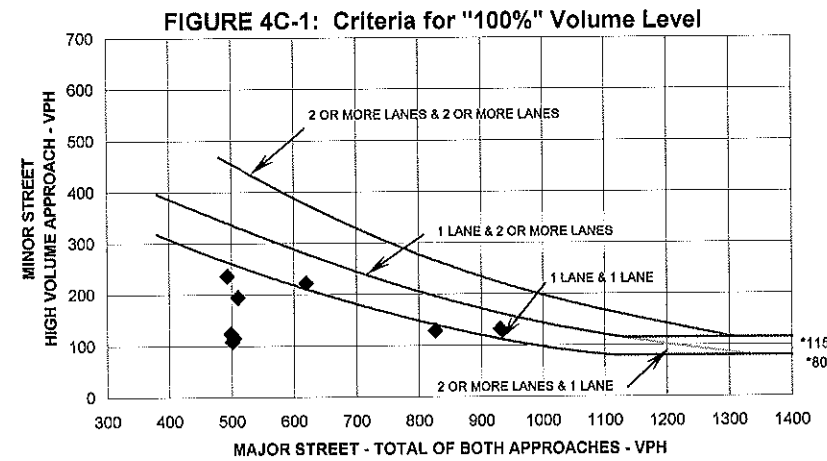
Plot four volume combinations on the applicable figure below.

* Note: 115 vph applies as the lower threshold volume for a minor street approach with two or more lanes and 80 vph applies as the lower threshold volume threshold for a minor street approach with one lane.

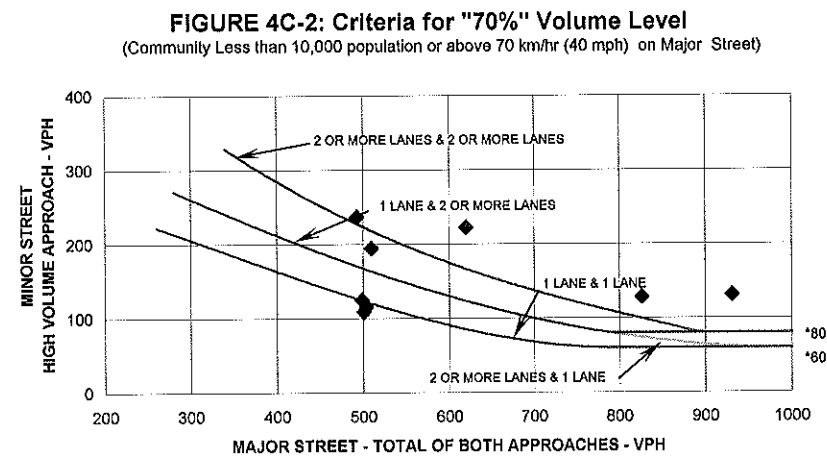
* Note: 80 vph applies as the lower threshold volume for a minor street approach with two or more lanes and 60 vph applies as the lower threshold volume threshold for a minor street approach with one lane.

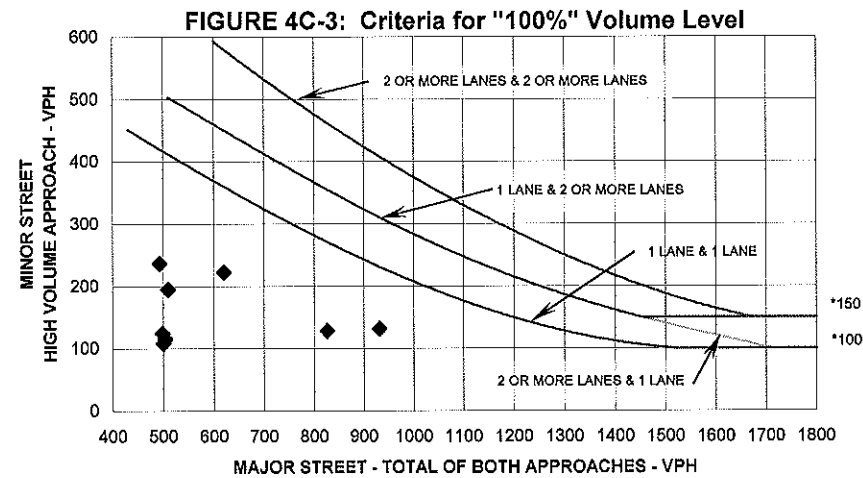
Plot volume combination on the applicable figure below.

* Note: 150 vph applies as the lower threshold volume for a minor street approach with two or more lanes and 100 vph applies as the lower threshold volume threshold for a minor street approach with one lane.

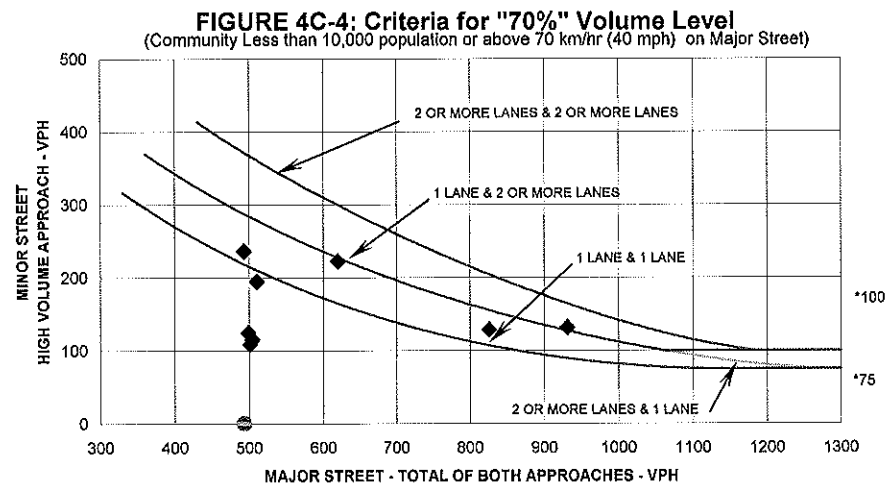
* Note: 100 vph applies as the lower threshold volume for a minor street approach with two or more lanes and 75 vph applies as the lower threshold volume threshold for a minor street approach with one lane.

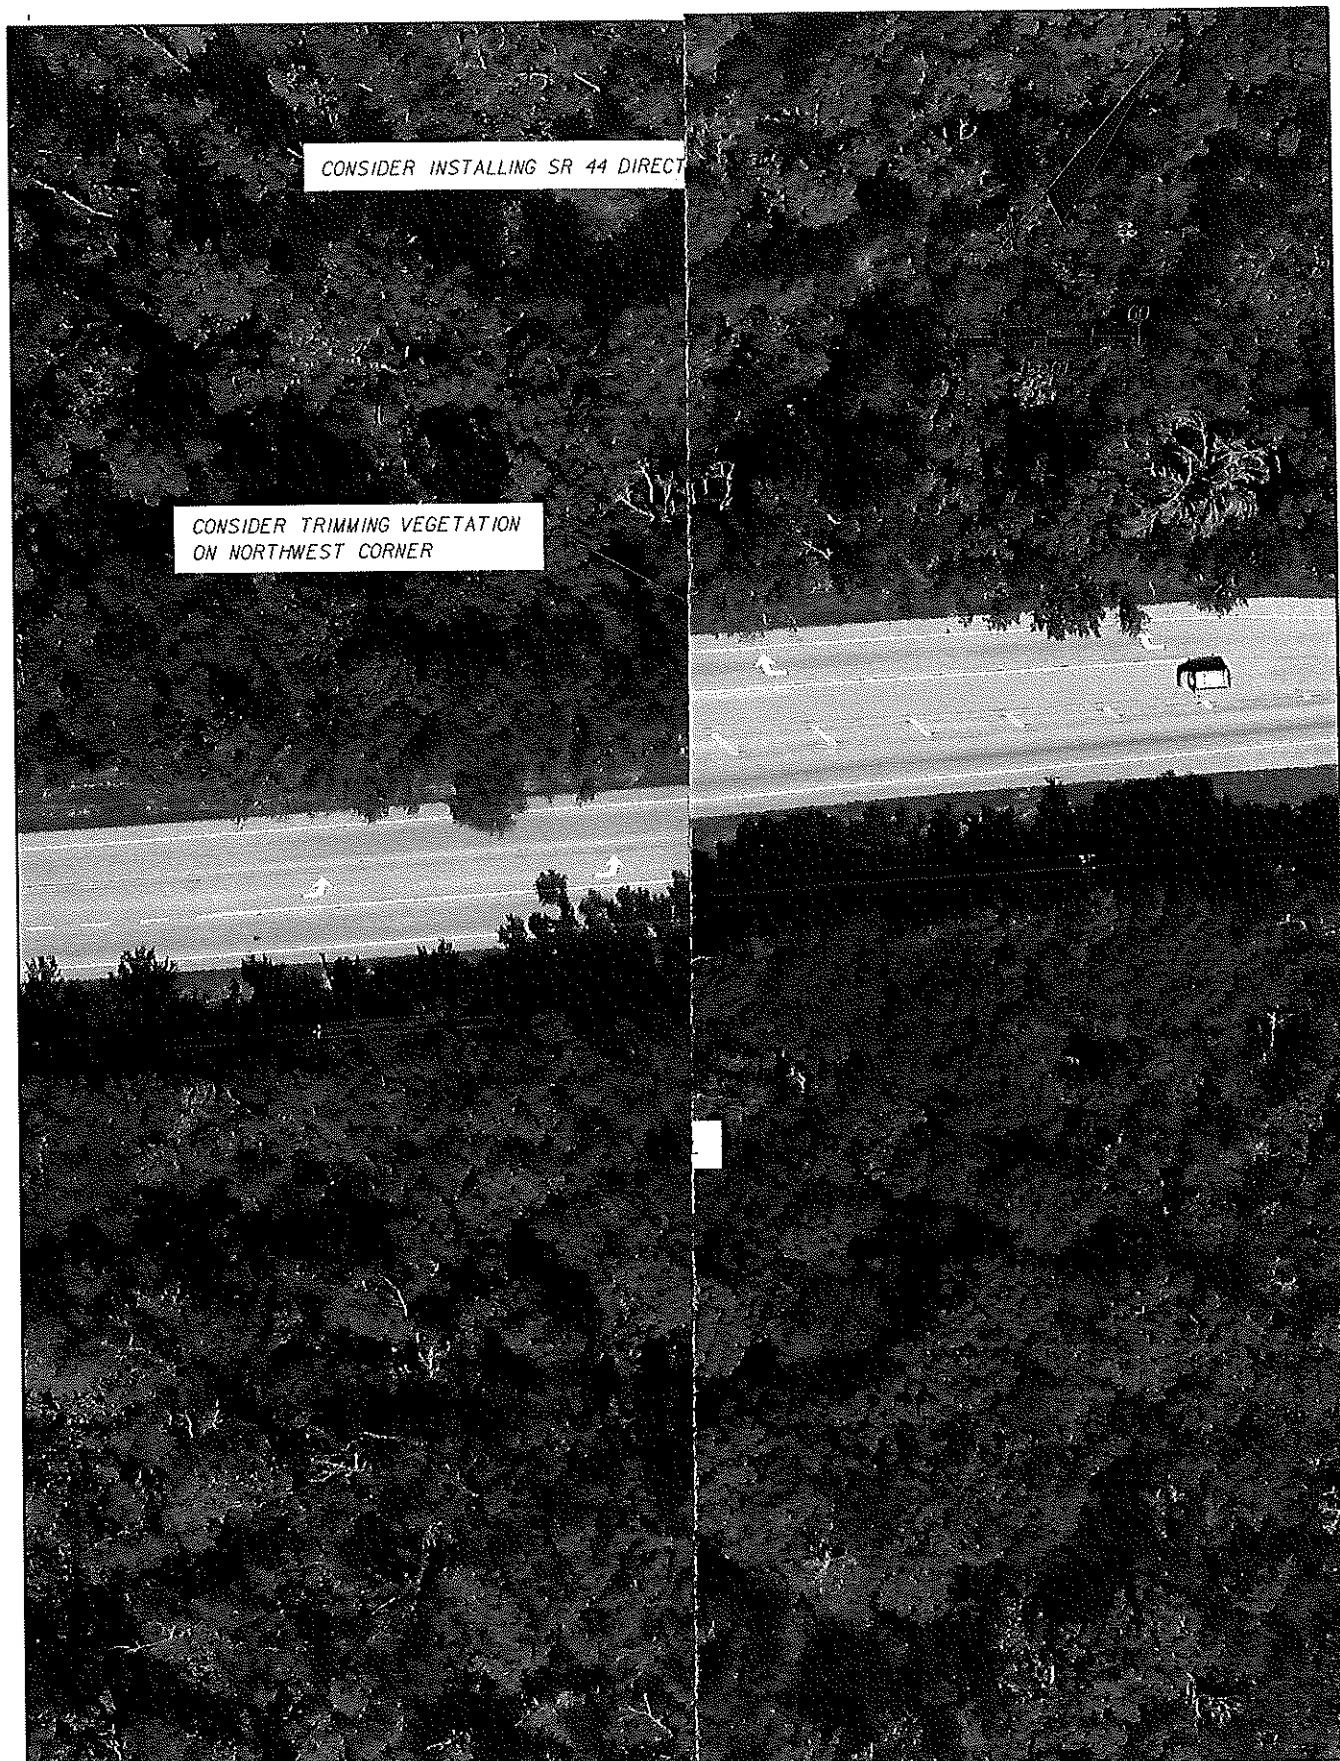
A conceptual improvement diagram has been developed to further depict the recommended improvements and is included on the following page.

CONSIDER INSTALLING SR 44 DIRECT

CONSIDER TRIMMING VEGETATION ON NORTHWEST CORNER

3. Consideration should be given to trimming the vegetation within the right of way on the northwest corner.
4. Consideration should be given to installing a yield line for the westbound right turn movement.
