COUNTY ROAD 437 IMPROVEMENTS LAKE COUNTY, FLORIDA

ENVIRONMENTAL ASSESSMENT REPORT

January 2017

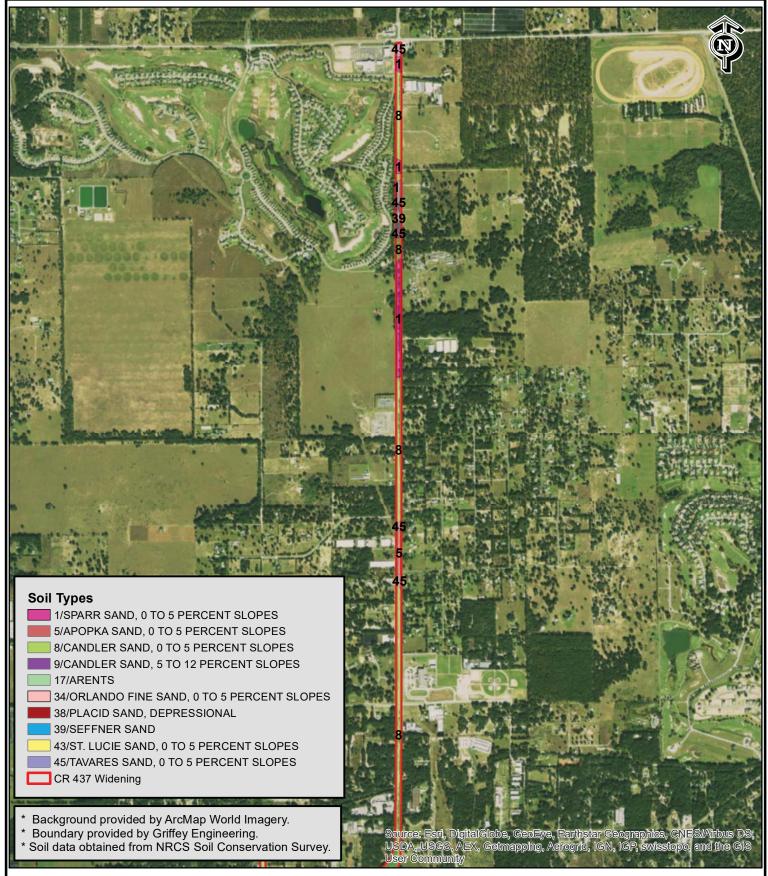
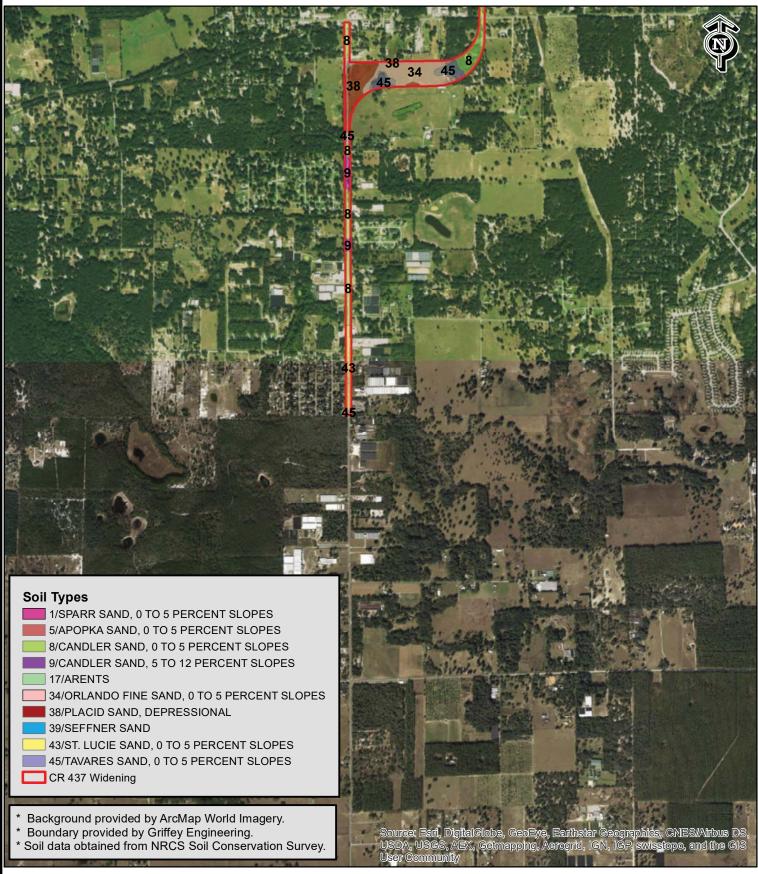
Figure 3- Soil Type Map Sections 7,18, 19, 30, and 31, T19S, R28E and Sections 25 and 36, T19S, R27E Lake County, Florida

According to the Natural Resource Conservation Service's (NRCS) *Soils Survey of Lake County, Florida*, (1990), the Project Corridor contains ten (10) soil map units (**Figure 3**). The soil types are described below in more detail; the descriptions are excerpts from the SCS *Soils Survey of Lake County*.

Sparr sand, 0 to 5 percent slopes (1) is a nearly level to sloping, somewhat poorly drained sandy soil that has a sandy clay loam subsoil. It is found on the upland ridge. Typically, the surface layer of this soil type is very dark gray sand about 7 inches thick. The water table for this soil type is at a depth of 40 to 60 inches for more than 6 months each year. During the wet season, it is a depth of 15 to 40 inches for 1 to 2 months. Permeability of this soil type is rapid in the sandy surface and subsurface layers and moderate in the loamy subsoil.

Apopka sand, 0 to 5 percent slopes (5) is a nearly level to gently sloping, well drained sandy soil that has a sandy clay loam subsoil at a depth of about 55 inches. Typically, the surface layer is dark gray sand about 6 inches thick. The water table is at a depth of more than 84 inches. Permeability of this soil type is rapid in the sandy surface and subsurface layers and moderate or moderately rapid in the subsoil.

Candler sand, 0 to 5 percent slopes (8) is a nearly level to gently sloping, excessively drained soil found on rolling uplands of the central ridge. The surface layer generally consists of dark gray sand about 7 inches thick. The water table is at a depth of more than 120 inches. Permeability is very rapid throughout the profile of this soil type.

Candler sand, 5 to 12 percent slopes (9) is a sloping to strongly sloping, excessively drained soil found on rolling uplands of the central ridge. Typically, the surface layer consists of dark gray sand about 5 to 6 inches thick. The water table is at a depth of more than 120 inches. Permeability is very rapid throughout the profile of this soil type.

Orlando fine sand, 0 to 5 percent slopes (34) is a nearly level to gently sloping, well-drained soil. The surface layer is fine sand about 8 inches thick. The water table is at a depth of more than 80 inches. This soil type is rapidly permeable throughout.

Placid sand, depressional (38) is a nearly level, very poorly drained soil in low wet areas on the upland ridge and in the flatwoods. The surface layer consists of sand about 18 inches thick. The upper 12 inches is black and the lower 6 inches is very dark gray mottled with very dark grayish brown and dark grayish brown. The water table is at the surface for the most of the year. During extended dry periods it is within a depth of 15 inches. Shallow water covers many areas for 4 to 6 months in wet seasons. Permeability of this soil type is rapid throughout.

Seffner sand (39) is a nearly level, poorly drained soil. The upper portion of the surface layer generally consists of black sand about 7 inches thick. The water table is normally at a depth of 10 inches for about 2 months of the year and at a depth of 10 to 30 inches the rest of the year. Permeability is rapid throughout the profile of this soil type.

St. Lucie fine sand, 0 to 5 percent slopes (43) is a deep, nearly level to gently sloping, and excessively drained soil in uplands. The slopes generally are uniform and range from 0 to 5 percent. Typically, this soil has a surface layer of gray fine sand about 2 inches thick. The upper part of underlying material, to a depth of about 6 inches, is light gray fine sand. The lower part to a depth of about 80 inches of more is white fine sand. A seasonal high water table is at a depth of 72 inches or more. Permeability is very rapid. The available water capacity is very low. Natural fertility and the organic matter content are very low.

Tavares sand, 0 to 5 percent slopes (45) is a nearly level to gently sloping, moderately well-drained soil. It has a very dark grayish-brown sandy surface layer approximately 7 inches thick. Below this layer are 4 levels of sand beginning at 7 inches, 25 inches, 34 inches, and 61 inches. The water table is at a depth of 40 to 60 inches for more than 6 months out of the year and below 60 inches during dry periods. This soil is rapidly permeable throughout.

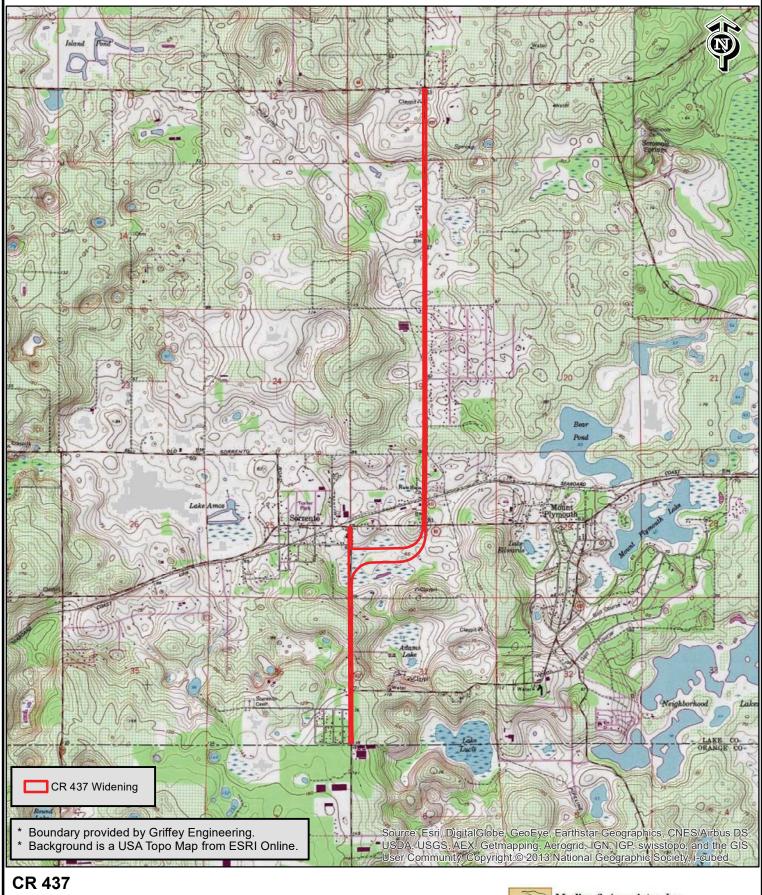
TOPO Map

Review of topographic information for the study areas reveals that the Project Corridor ranges between 56 and 139 feet elevation (**Figure 4**). The high point of approximately 139 feet is mapped in the southern extent of the Project Corridor near the intersection of County Road 437 and Adair Avenue. From this high point, the elevation of the Project

Corridor slopes downward toward its intersection with SR 46. In general, the topography mapped by the USGS appears to be consistent with the observed site conditions.

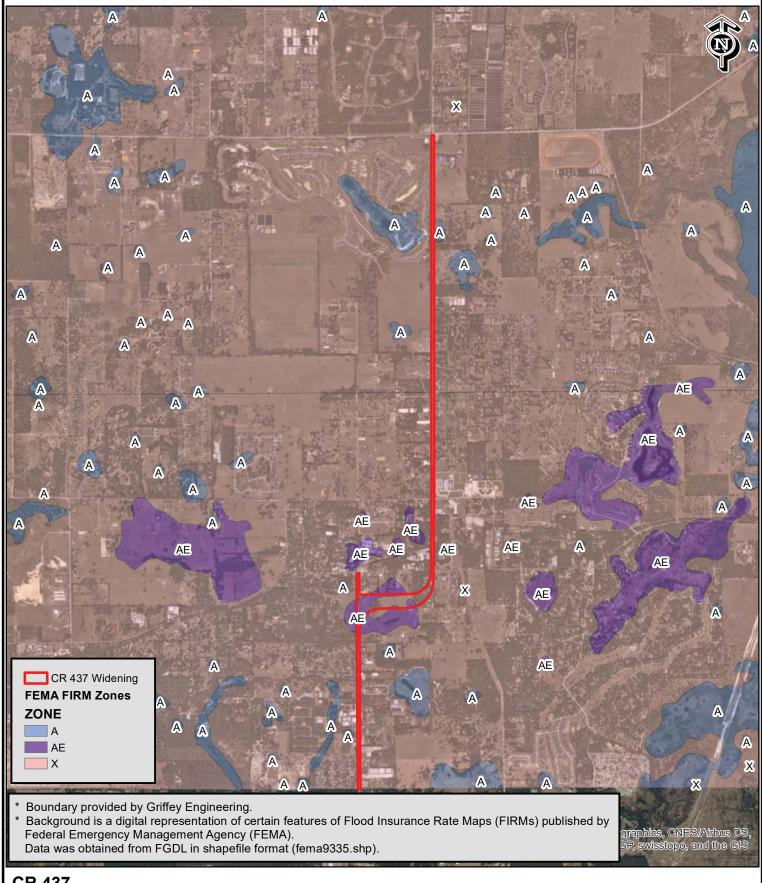
FEMA FIRM ZONES Sections 7,18, 19, 30, and 31, T19S, R28E and Sections 25 and 36, T19S, R27E Lake County, Florida

According to the FEMA Flood Probability Area Map, the majority of Project Corridor is mapped as Zone "X" (**Figure 5**). Zone X indicates low flood probability areas determined to be outside the 500-year floodplain. Zone "A," which indicates special flood hazard areas inundated by the 100-year flood for which no base flood elevations have been determined, is mapped surrounding the Project Corridor. Zone "AE" indicates special flood hazard areas inundated by the 100-year flood and in most instances flood elevations derived from detailed analyses are shown at selected intervals for these zones, and is mapped within some limits of the Project Corridor. In Lake County, any development in the floodplain requires a Building Permit as well as a Floodplain Construction Authorization Permit.

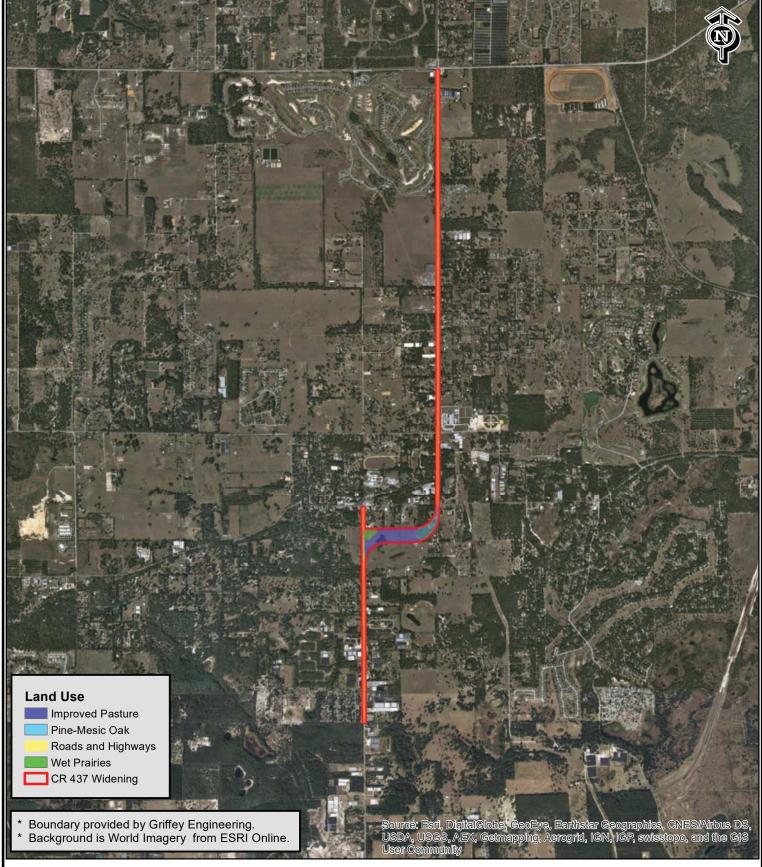
Land Use Map Sections 7,18, 19, 30, and 31, T19S, R28E and Sections 25 and 36, T19S, R27E Lake County, Florida

Site reconnaissance conducted by Modica & Associates staff biologists revealed the presence of multiple land uses within the Project Corridor. Each land use identified within the project site was mapped utilizing the Florida Land Use, Cover and Forms Classification System (FLUCFCS, FDOT 1999). A description of each land cover type is provided below and is depicted on the attached Land Use Map (**Figure 6**).

The majority of the central portion of the Project Corridor consist of improved pasture. A variety of pasture grasses make up this land use type.

A section of the Project Corridor located in the east central portion is best described as Pine-Mesic Oak. This community type is dominated by laurel oak (*Quercus laurifolia*) and slash pine (*Pinus elliottii*). Saw palmetto (*Serenoa repens*) is also scattered throughout the understory.

Review of aerial imagery and the National Wetlands Inventory revealed that there is an area of low elevation that may periodically hold water within the Project Corridor. This area is located within the central portion of the Project Corridor, along the eastern side of CR 437 just south of its intersection with SR 46. Site inspections confirmed that this area will likely be claimed as wetlands by the regulatory agencies.

The majority of the Project Corridor consists of the existing County Road 437, which is a paved two-lane road. Associated right-of-ways are included within this land use classification, which predominantly consist of maintained bahia grass and utility infrastructure.

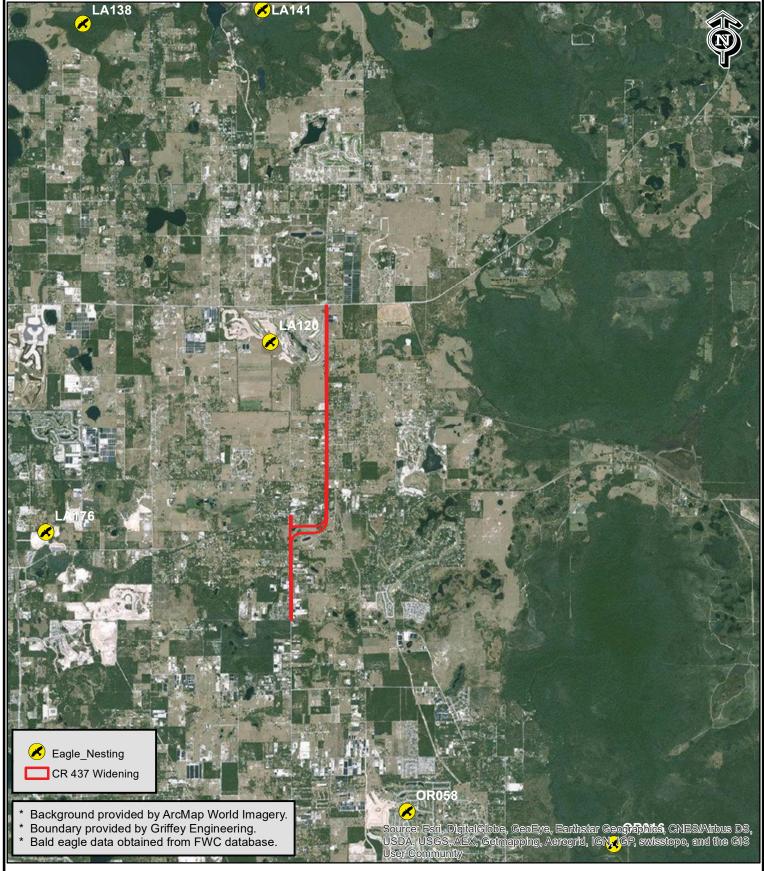
Bald Eagle Nest Location Map Sections 7 ,18, 19, 30, and 31 , T19S, R28E and Sections 25 and 36, T19S, R27E Lake County, Florida

An ArcViewTM GIS database containing bald eagle nest location data (collected and maintained by USFWS) was accessed to determine if there are any documented nests in close proximity to the project site. There are four (4) eagle nests within five (5) miles of the property (**Figure 8**). Nest ID LA120 lies 0.9 miles west of the project corridor, Nest ID LA176 is 3.9 miles west, Nest ID OR058 is 3.6 miles southeast, and Nest ID LA141 is 5 miles north. The management zones for these nests do not extend to or near the Project Corridor. No developmental constraints associated with the bald eagle are anticipated in association with this project. However, this information will need to be reverified during future permitting efforts.

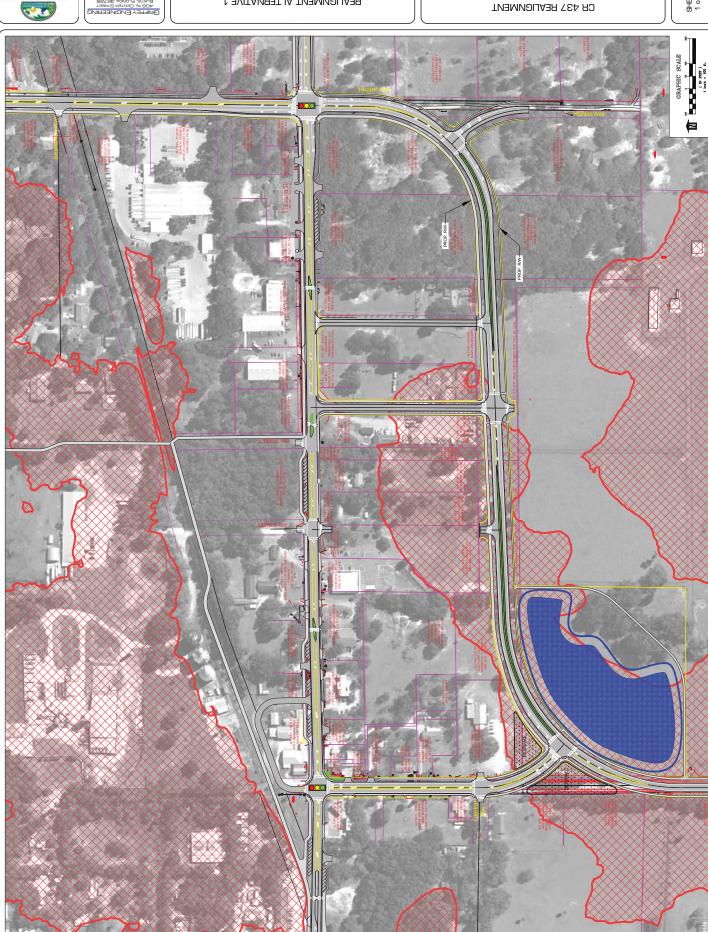
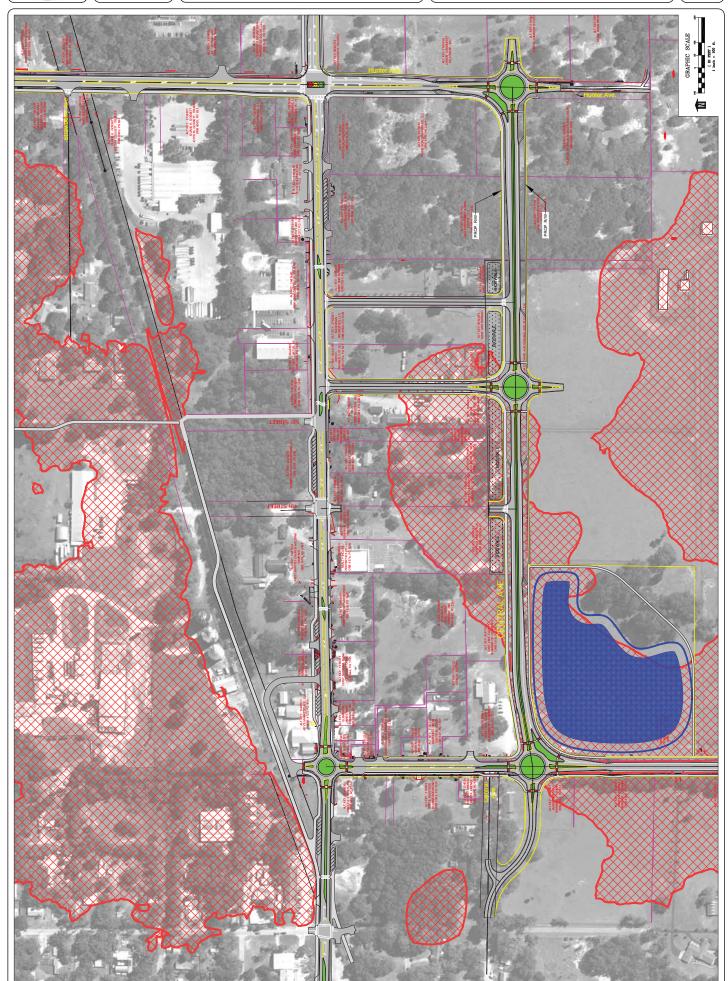
There are two realignment alternatives being considered for this project (Realignment Alternative 1 and 2A). The differences between these two alternatives is the presence of four roundabouts in Realignment Alternative 2A. Because the alignment of these alternatives is generally the same, there are no significant differences from an ecological standpoint.

When comparing project alternatives, there is not a distinct difference in gopher tortoise habitat between Realignment Alternative 1 and 2A (Exhibit A & B).

The differences between the two realignment alteratives occur in the area of the pasture and mesic oak communities in the central portion of the Project Corridor. As mentioned above, these areas lie almost entirely under 82 feet. Therefore, the potential for sand skink habitat is the same for Realignment Alternative 1 and 2A (Exhibit A & B).
