Limited Indoor Air Quality Assessment

Lake County

Umatilla Community Center

APTIM Project 631023227
December 2022

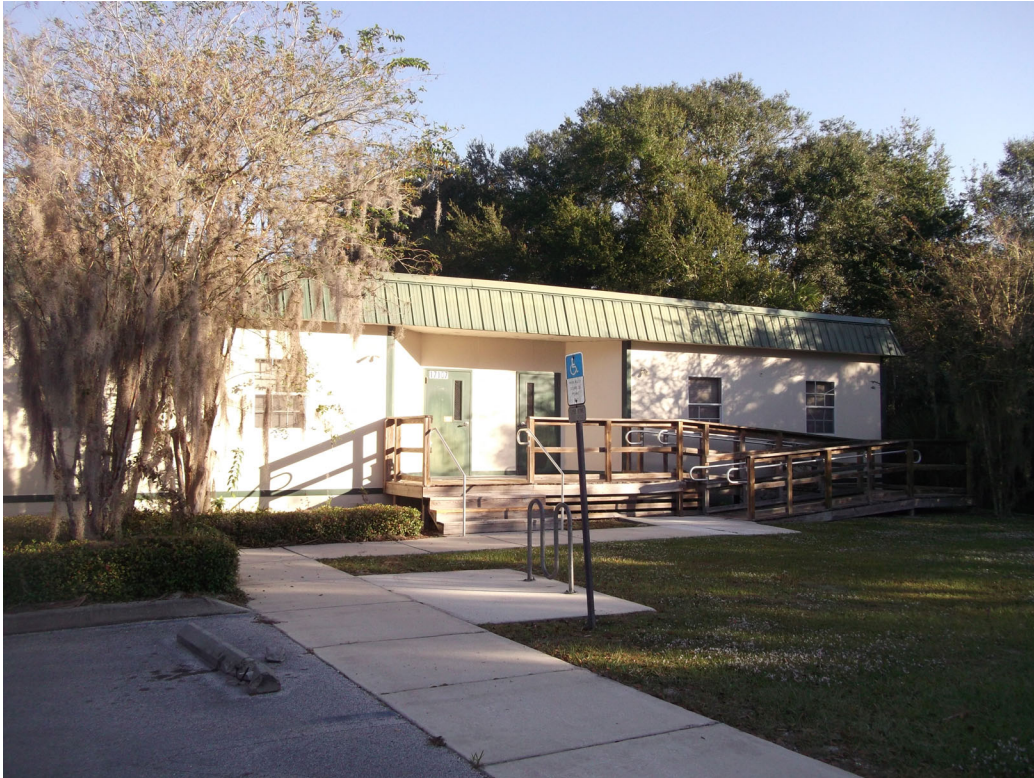
PHOTO 1 – 11/29/2022
PHOTO SHOWING THE EXTERIOR OF THE LAKE COUNTY UMATILLA COMMUNITY
CENTER LOCATED AT 17107 BALL PARK ROAD, UMATILLA, FL.
