# Priority Project #1

## Desoto Safety Improvements including crosswalks and school zone

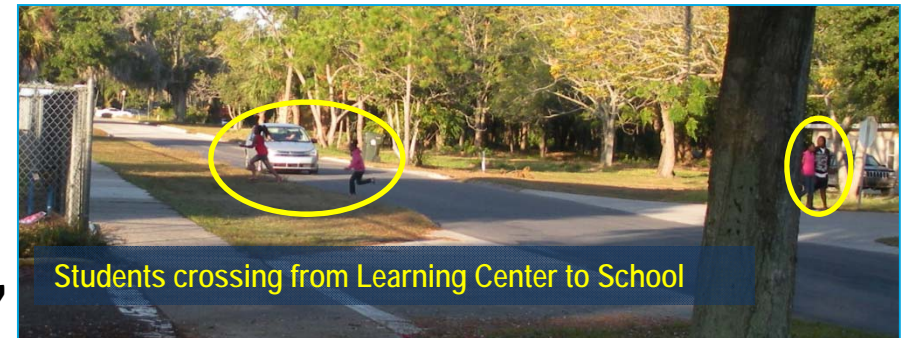
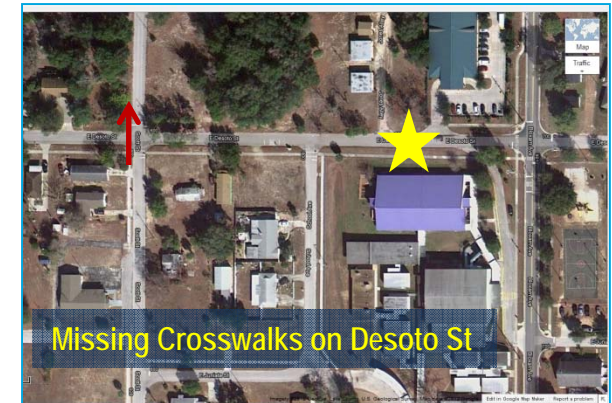
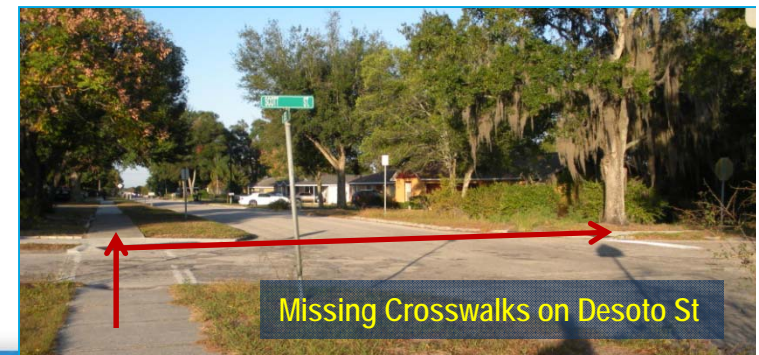
- ✓ There is a heavy amount of pedestrian traffic on Desoto St due to the confluence of the north gate pedestrian access, the Learning Center, and the breakfast provided by the Learning Center. Currently many students and parents cross midblock between the Learning Center and the north pedestrian gate
- ✓ Traffic accessing the Pre-K-2<sup>nd</sup> drop-off queues onto Desoto St, creating potential conflicts with pedestrians
- ✓ The Clermont officer who serves as a crossing guard stated that speeding is an issue on Desoto St during school times. Currently there is not a marked school zone on Desoto St, but it is the entrance to the Pre-K-2<sup>nd</sup> drop-off / pick-up and the north pedestrian access
- ✓ There is sidewalk on the south side of Desoto St and the west side of Scott St, but the crosswalks are either missing, or are very faded

- ✓ Establish and sign a school zone on Desoto St from School St to Bloxam Ave
- ✓ Install FDOT ladder style crosswalk and yield sign / striping on Desoto St between the Learning Center and the north pedestrian gate.
- ✓ Install FDOT ladder style crosswalks at appropriate locations on Desoto St at School St, Scott St and Disston Ave
- ✓ Construct sidewalk on the north side of Desoto St from the current Learning Center driveway to School Ave

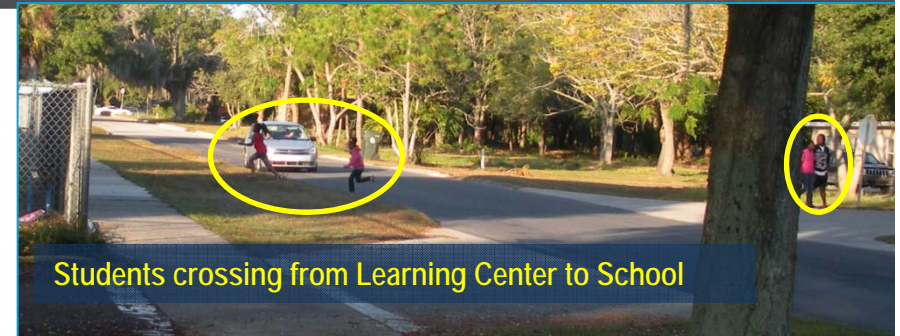
- ✓ There is a heavy amount of pedestrian traffic on Desoto St due to the confluence of the north gate pedestrian access, the Learning Center, and the breakfast provided by the Learning Center
