Priority Project #3

Westbound Right Turn Lane into Car Loop Driveway

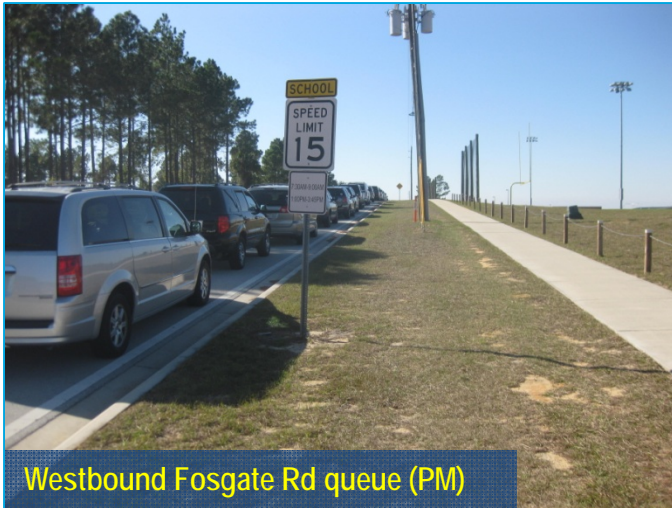
Westbound Fosgate Rd queue (PM)

- ✓ During dismissal, westbound vehicles waiting to enter the car pick-up loop were observed to queue back on Fosgate Rd for 900 feet
- ✓ There is a sight distance issue with the hill on Fosgate Rd east of the school
- ✓ Westbound through vehicles use center turn lane to pass queued vehicles; cross-over point creates conflicts & is a safety hazard
- ✓ Existing landscape strip is about 14 feet wide
- ✓ There are no drainage inlets along the curb in this area
- ✓ Some utility poles would need to be relocated

- ✓ Constructing a westbound right turn lane of 200-400 feet would help mitigate the safety hazard created by westbound through vehicles by moving the cross over point away from the driveway and other conflicting vehicles

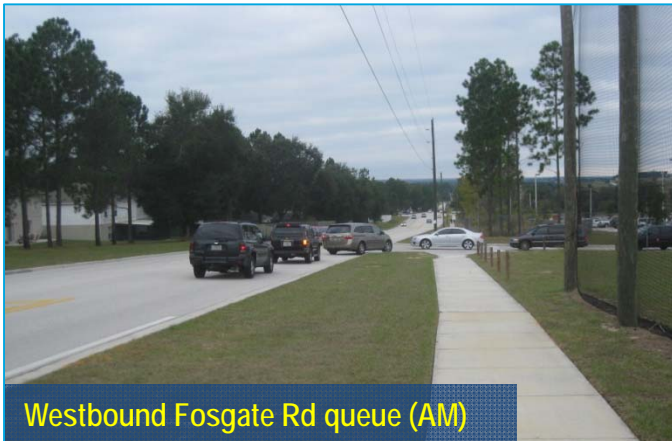
Westbound Fosgate Rd queue (AM)
