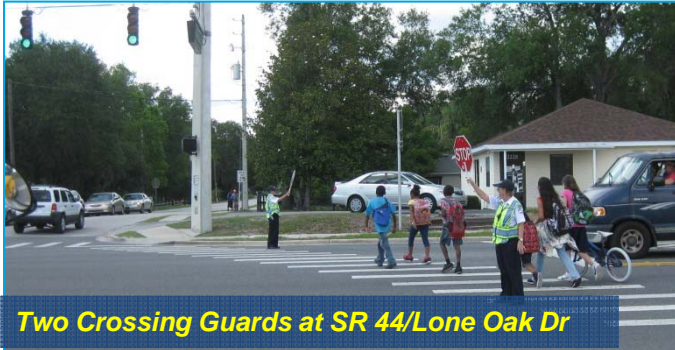
Two Crossing Guards at SR 44/Lone Oak Dr

- ✓ Crossing guards are required to press the pedestrian button each time they have students to cross in order to get the Walk signal phase
- ✓ At SR 44 / US 27, the walk + flashing don't walk pedestrian signal phase on the south leg of intersection is too short to complete the crossings safely, primarily due to the westbound left turns continuing into the walk phase.

- ✓ Set signals to recall pedestrian phases for both intersecting streets during AM and PM school ingress / egress hours
 - ✓ SR 44 / Lone Oak Dr
 - ✓ SR 44 / US 27
- ✓ Evaluate length of walk and flashing don't walk pedestrian signal phases at SR 44 / US 27 (east / west pedestrian movement), and extend as needed

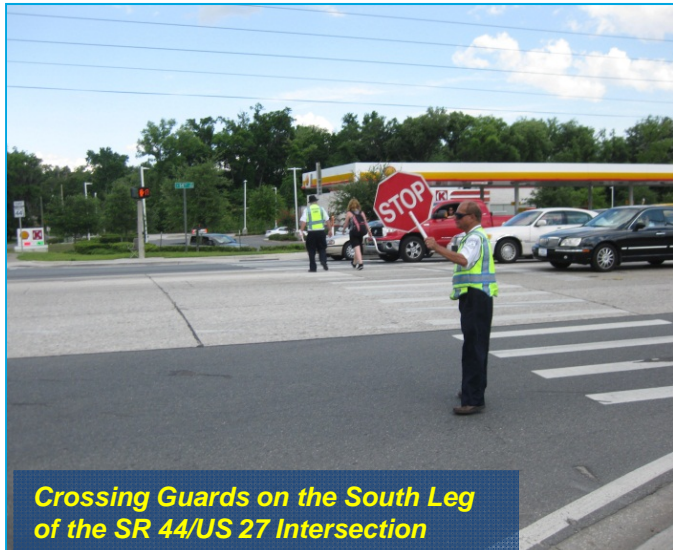
Crossing Guards on the South Leg of the SR 44/US 27 Intersection
