SafeAccess

A SAFE SCHOOLS TRANSPORTATION STUDY

Minneola Elementary Charter School

School Driveway Crosswalks

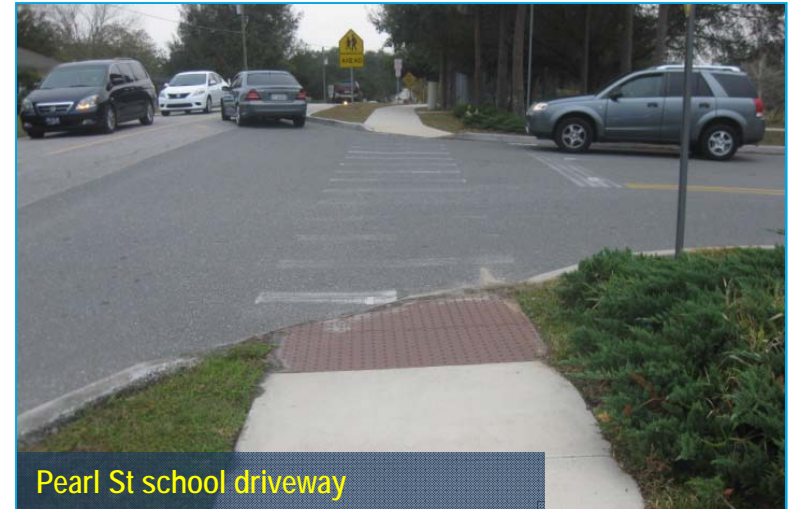
Pearl St school driveway

- ✓ Front school driveway on Pearl St has faded crosswalk markings and detectable warnings missing on west side of crosswalk
- ✓ Bus driveway on Grassy Lake Rd does not have a marked crosswalk

- ✓ Restripe crosswalk at Pearl St driveway and install missing detectable warnings
- ✓ Stripe crosswalk at Grassy Lake Rd bus driveway
