Priority Project #1A

Channelize & Improve Senior Lot Crosswalks

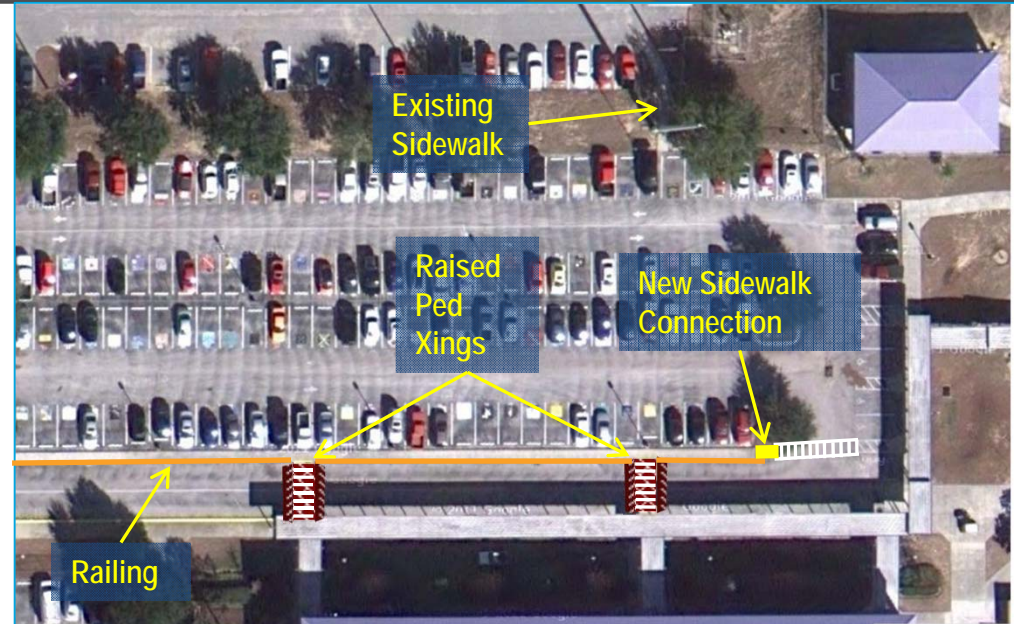
- ✓ Car loop is located in senior parking lot
- ✓ Students will cross car loop at most convenient location; cause disruption to traffic flow in AM
- ✓ School would like to channelize student crossing to existing marked crosswalks

- ✓ Install railing along parking lot side of car loop lane to channelize student crossings at the two existing marked crosswalks
- ✓ Construct raised pedestrian crossings at two existing marked crosswalks and provide detectable warning mats
- ✓ Extend existing sidewalk along parking lot side of car loop lane towards gym and provide new marked crosswalk connecting to existing handicap buffer area

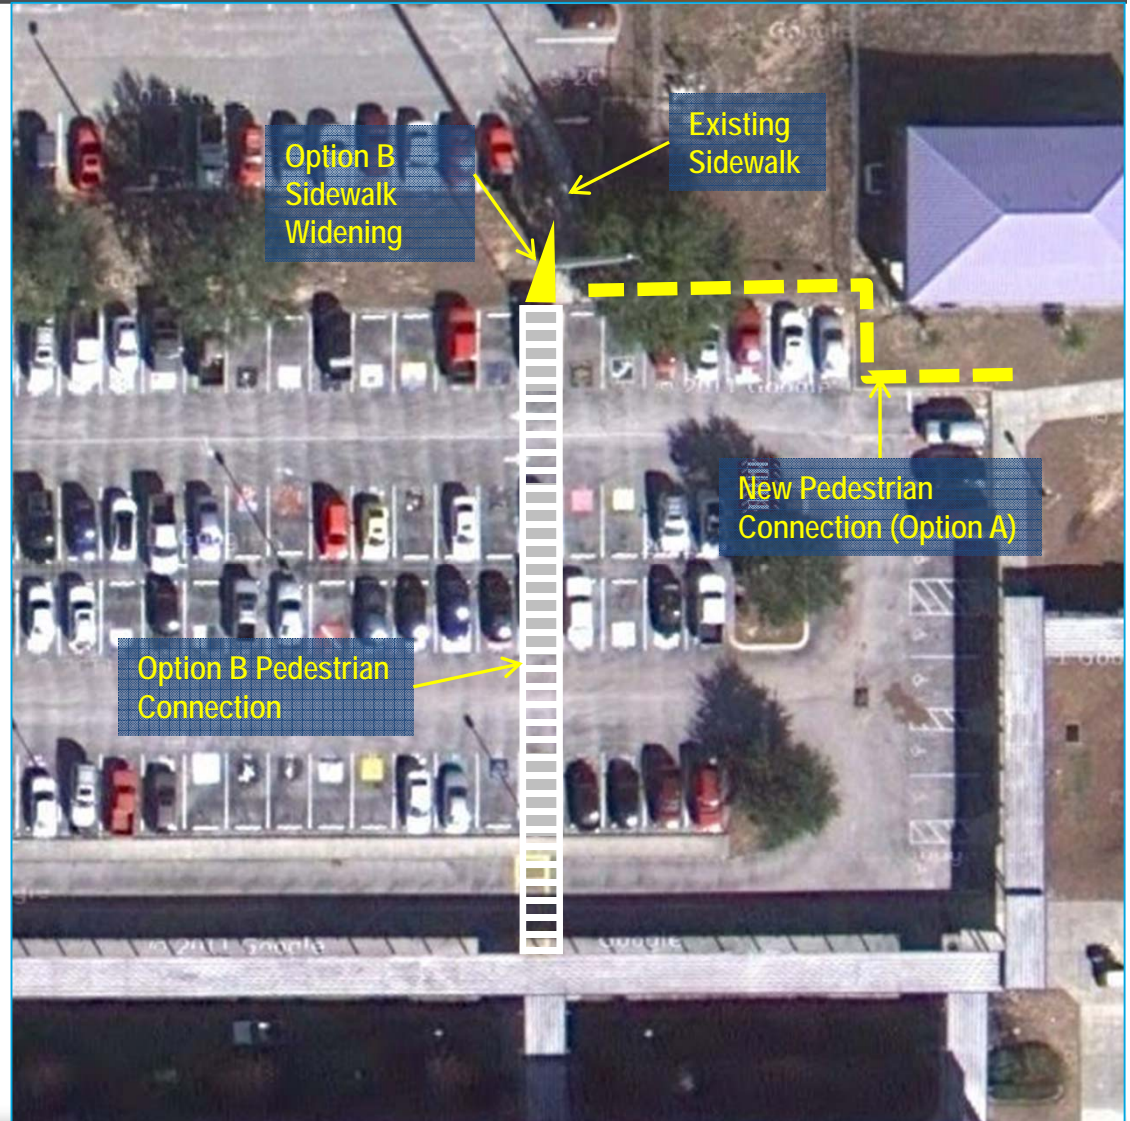
- ✓ Pedestrian connection between lots is incomplete
 - ✓ Students have to either walk through the senior lot or on grass to get to the campus

- A. Connect existing sidewalk from lower lot to existing sidewalk near gym
- B. Mark a pedestrian pathway from the lower lot sidewalk to the school through the senior parking lot
 - ✓ Includes minor widening of existing sidewalk from lower lot
 - ✓ Would result in loss of 4 parking spaces
