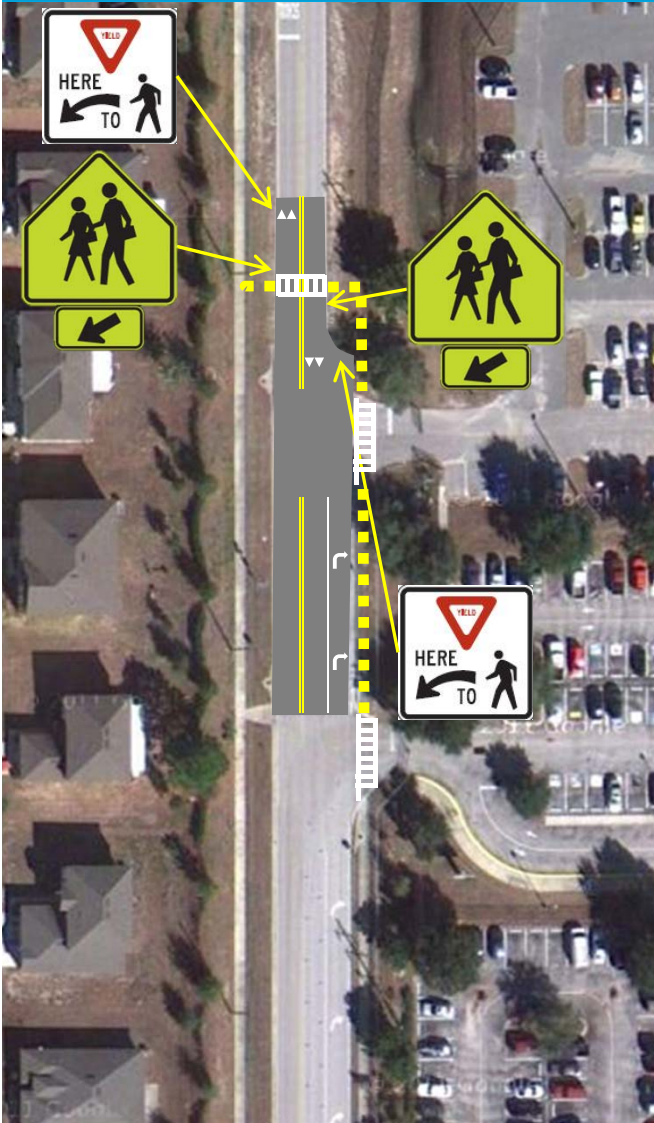
- ✓ Existing crosswalk is located between the student lots
- ✓ Observations were made of vehicles not yielding to pedestrians in the crosswalk
- ✓ Majority of traffic is coming from and going to the south (CR 565A)

- ✓ Relocate the existing crosswalk between the student lots to north of the underclassman parking lot and connect to existing sidewalk on east side of roadway
- ✓ Install lighting and update markings
- ✓ Install the standard treatment for a midblock crosswalk
