PIPE REPLACEMENT REQUEST

REQ #: MA3-12135-R

ROAD NAME: CR 439

Address: Next apron north of the entrance to 41121

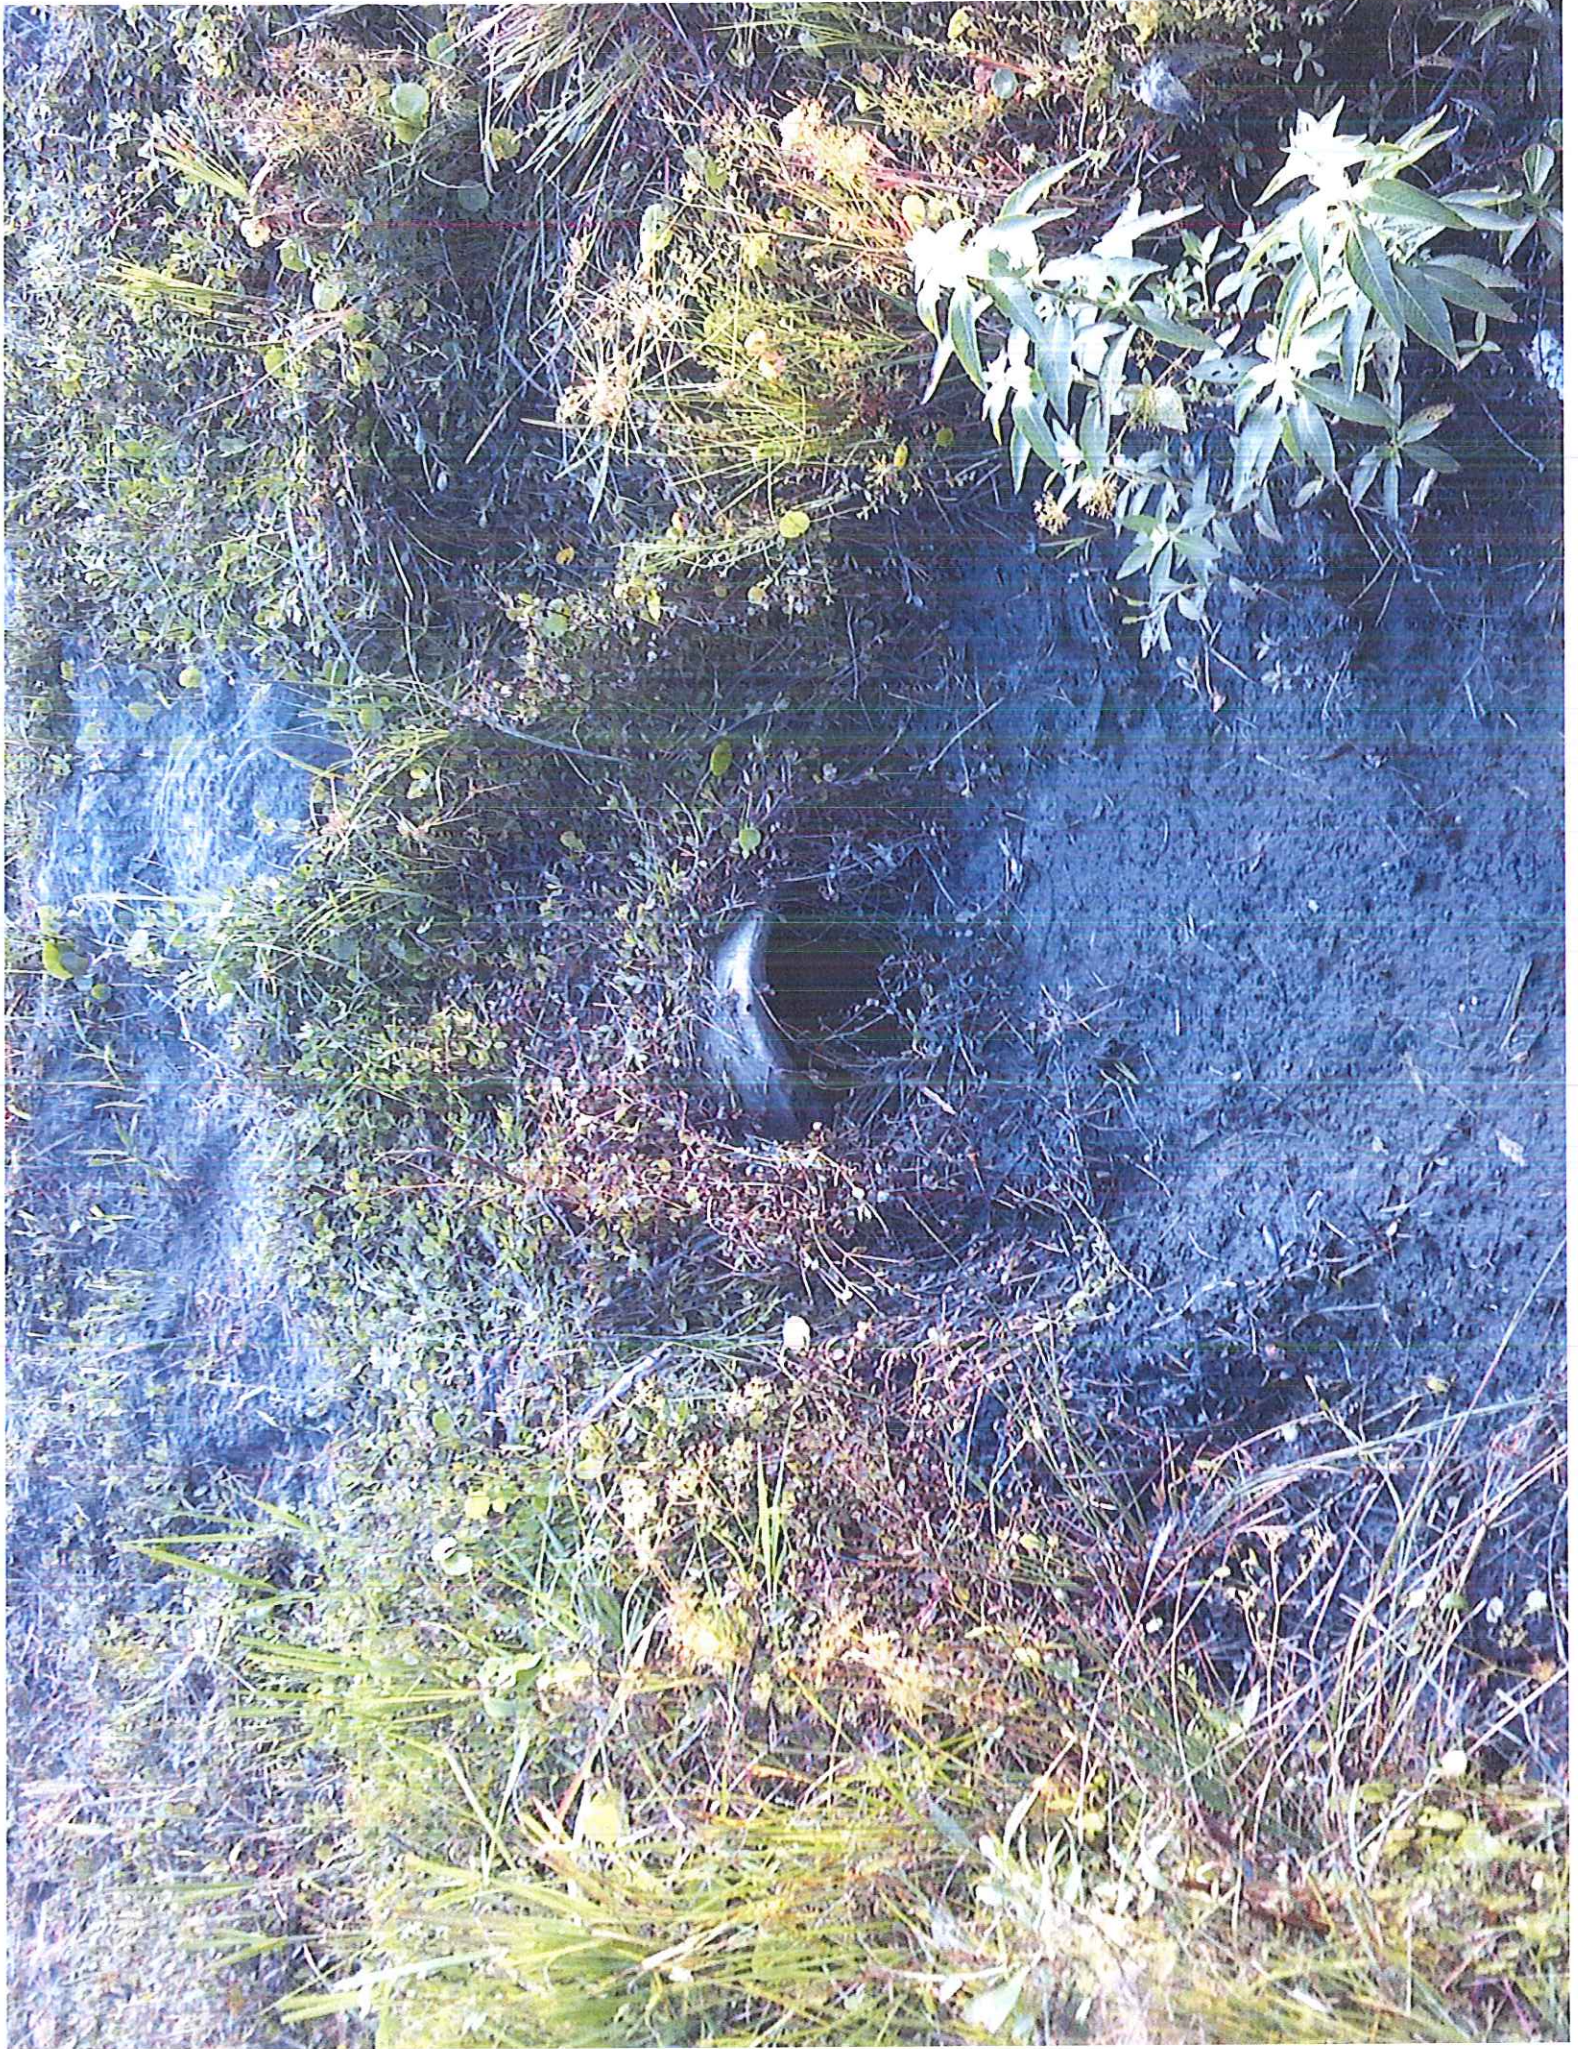
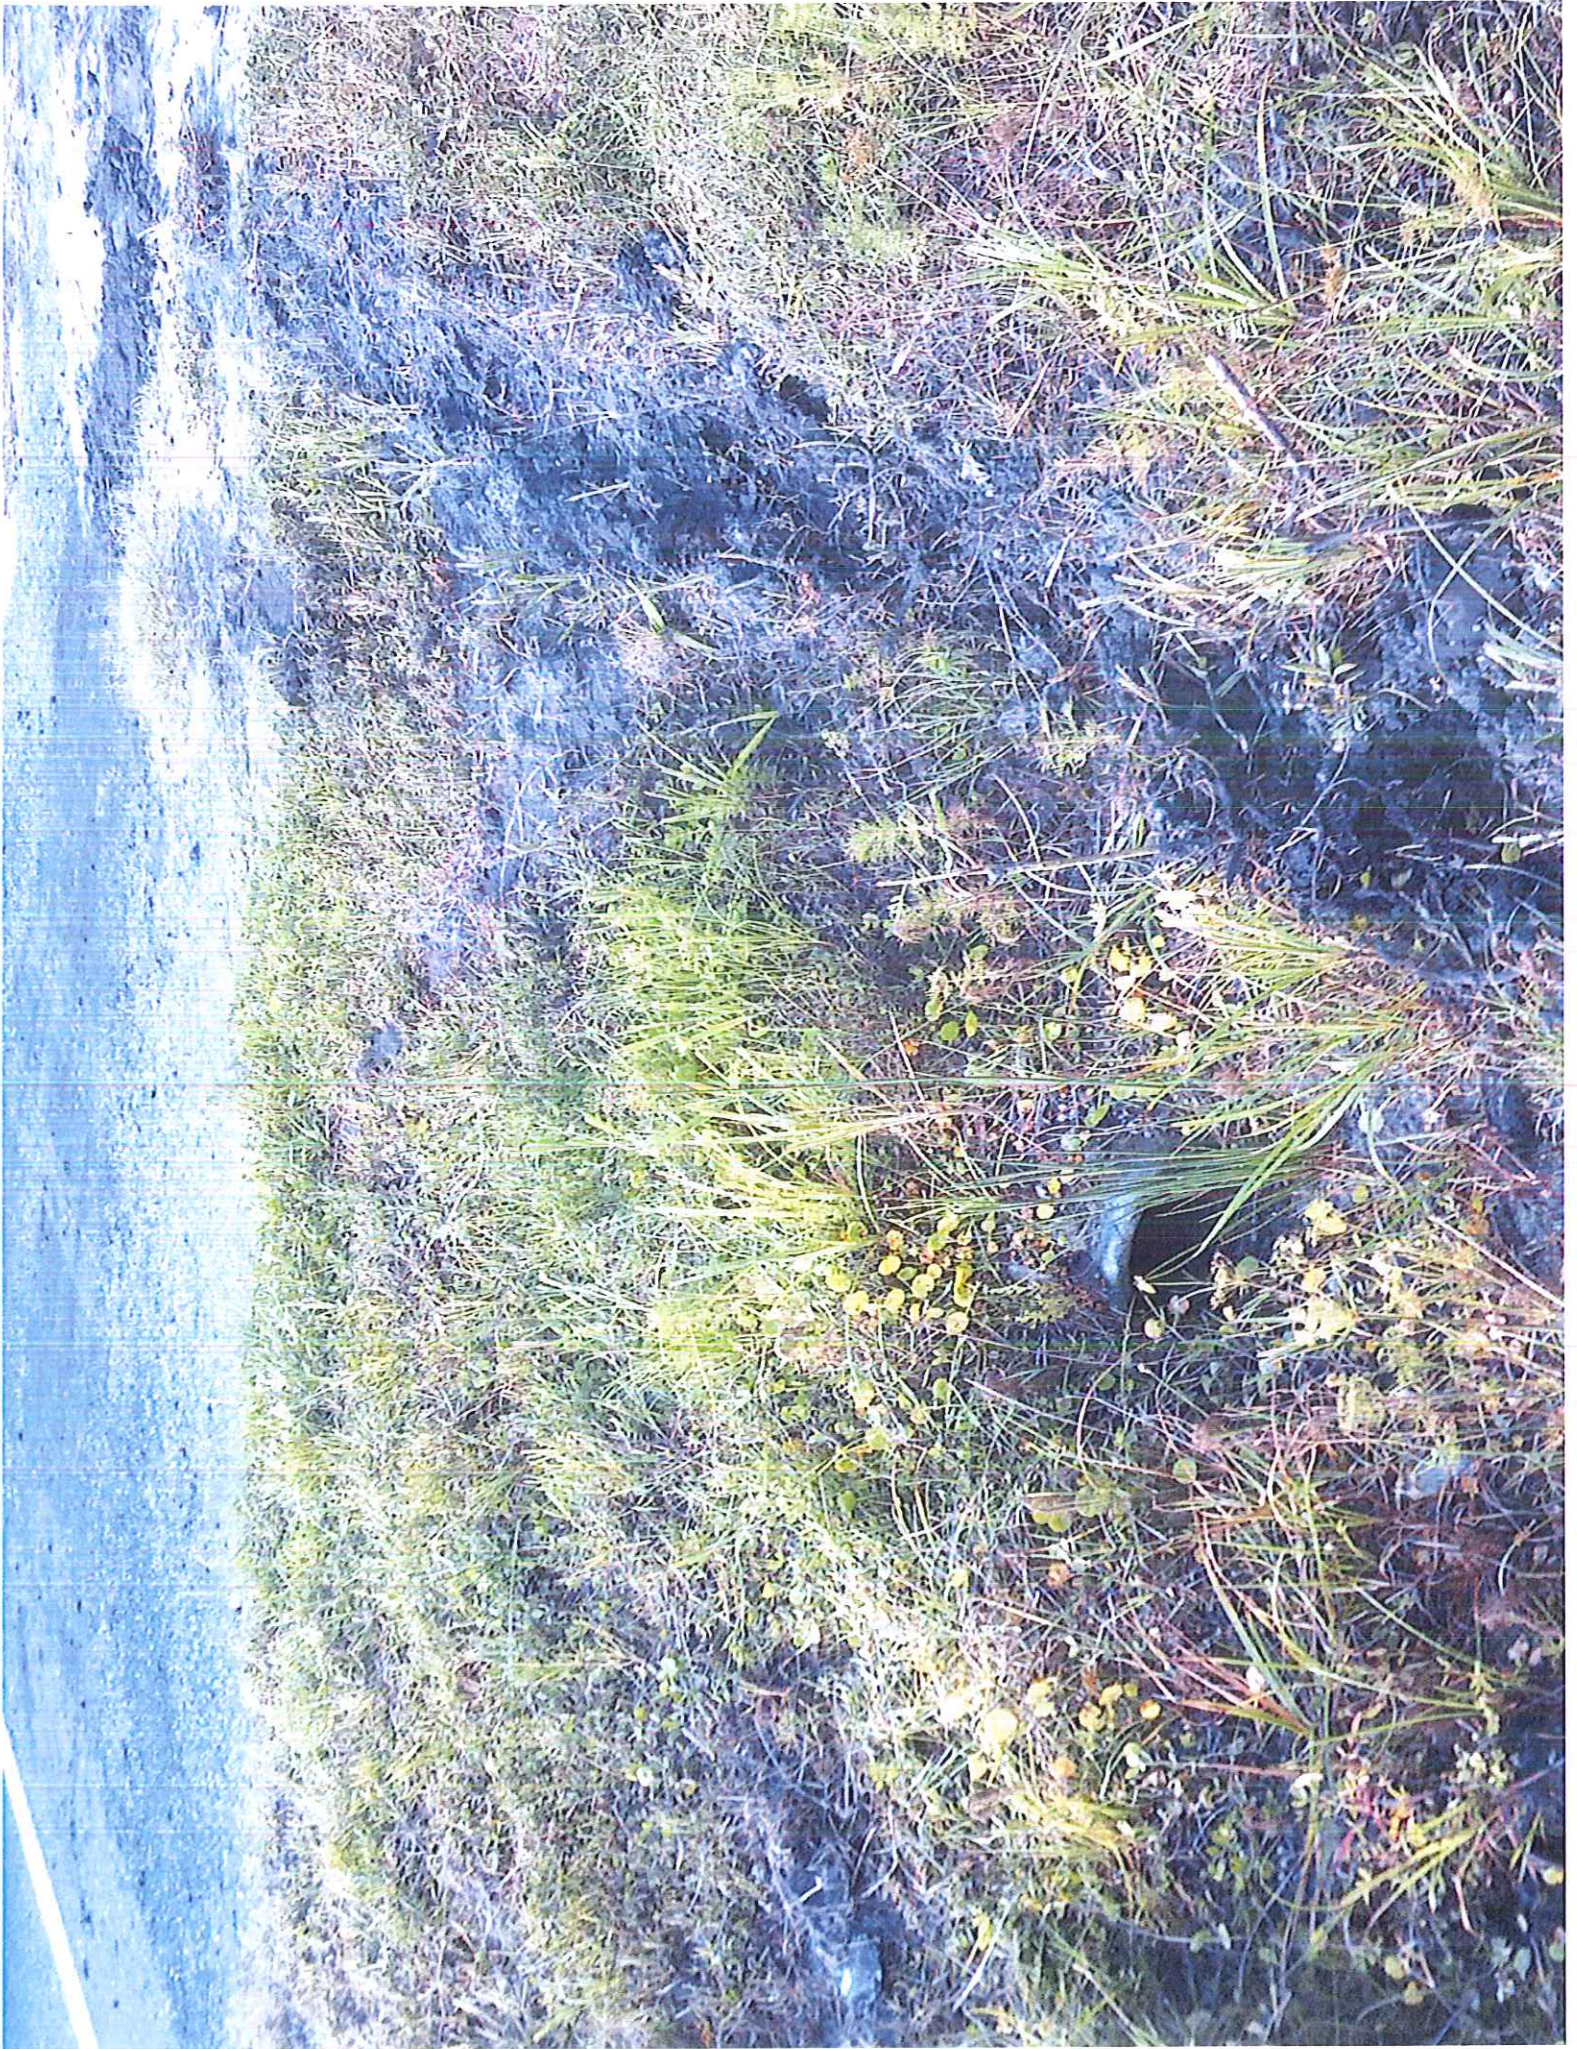
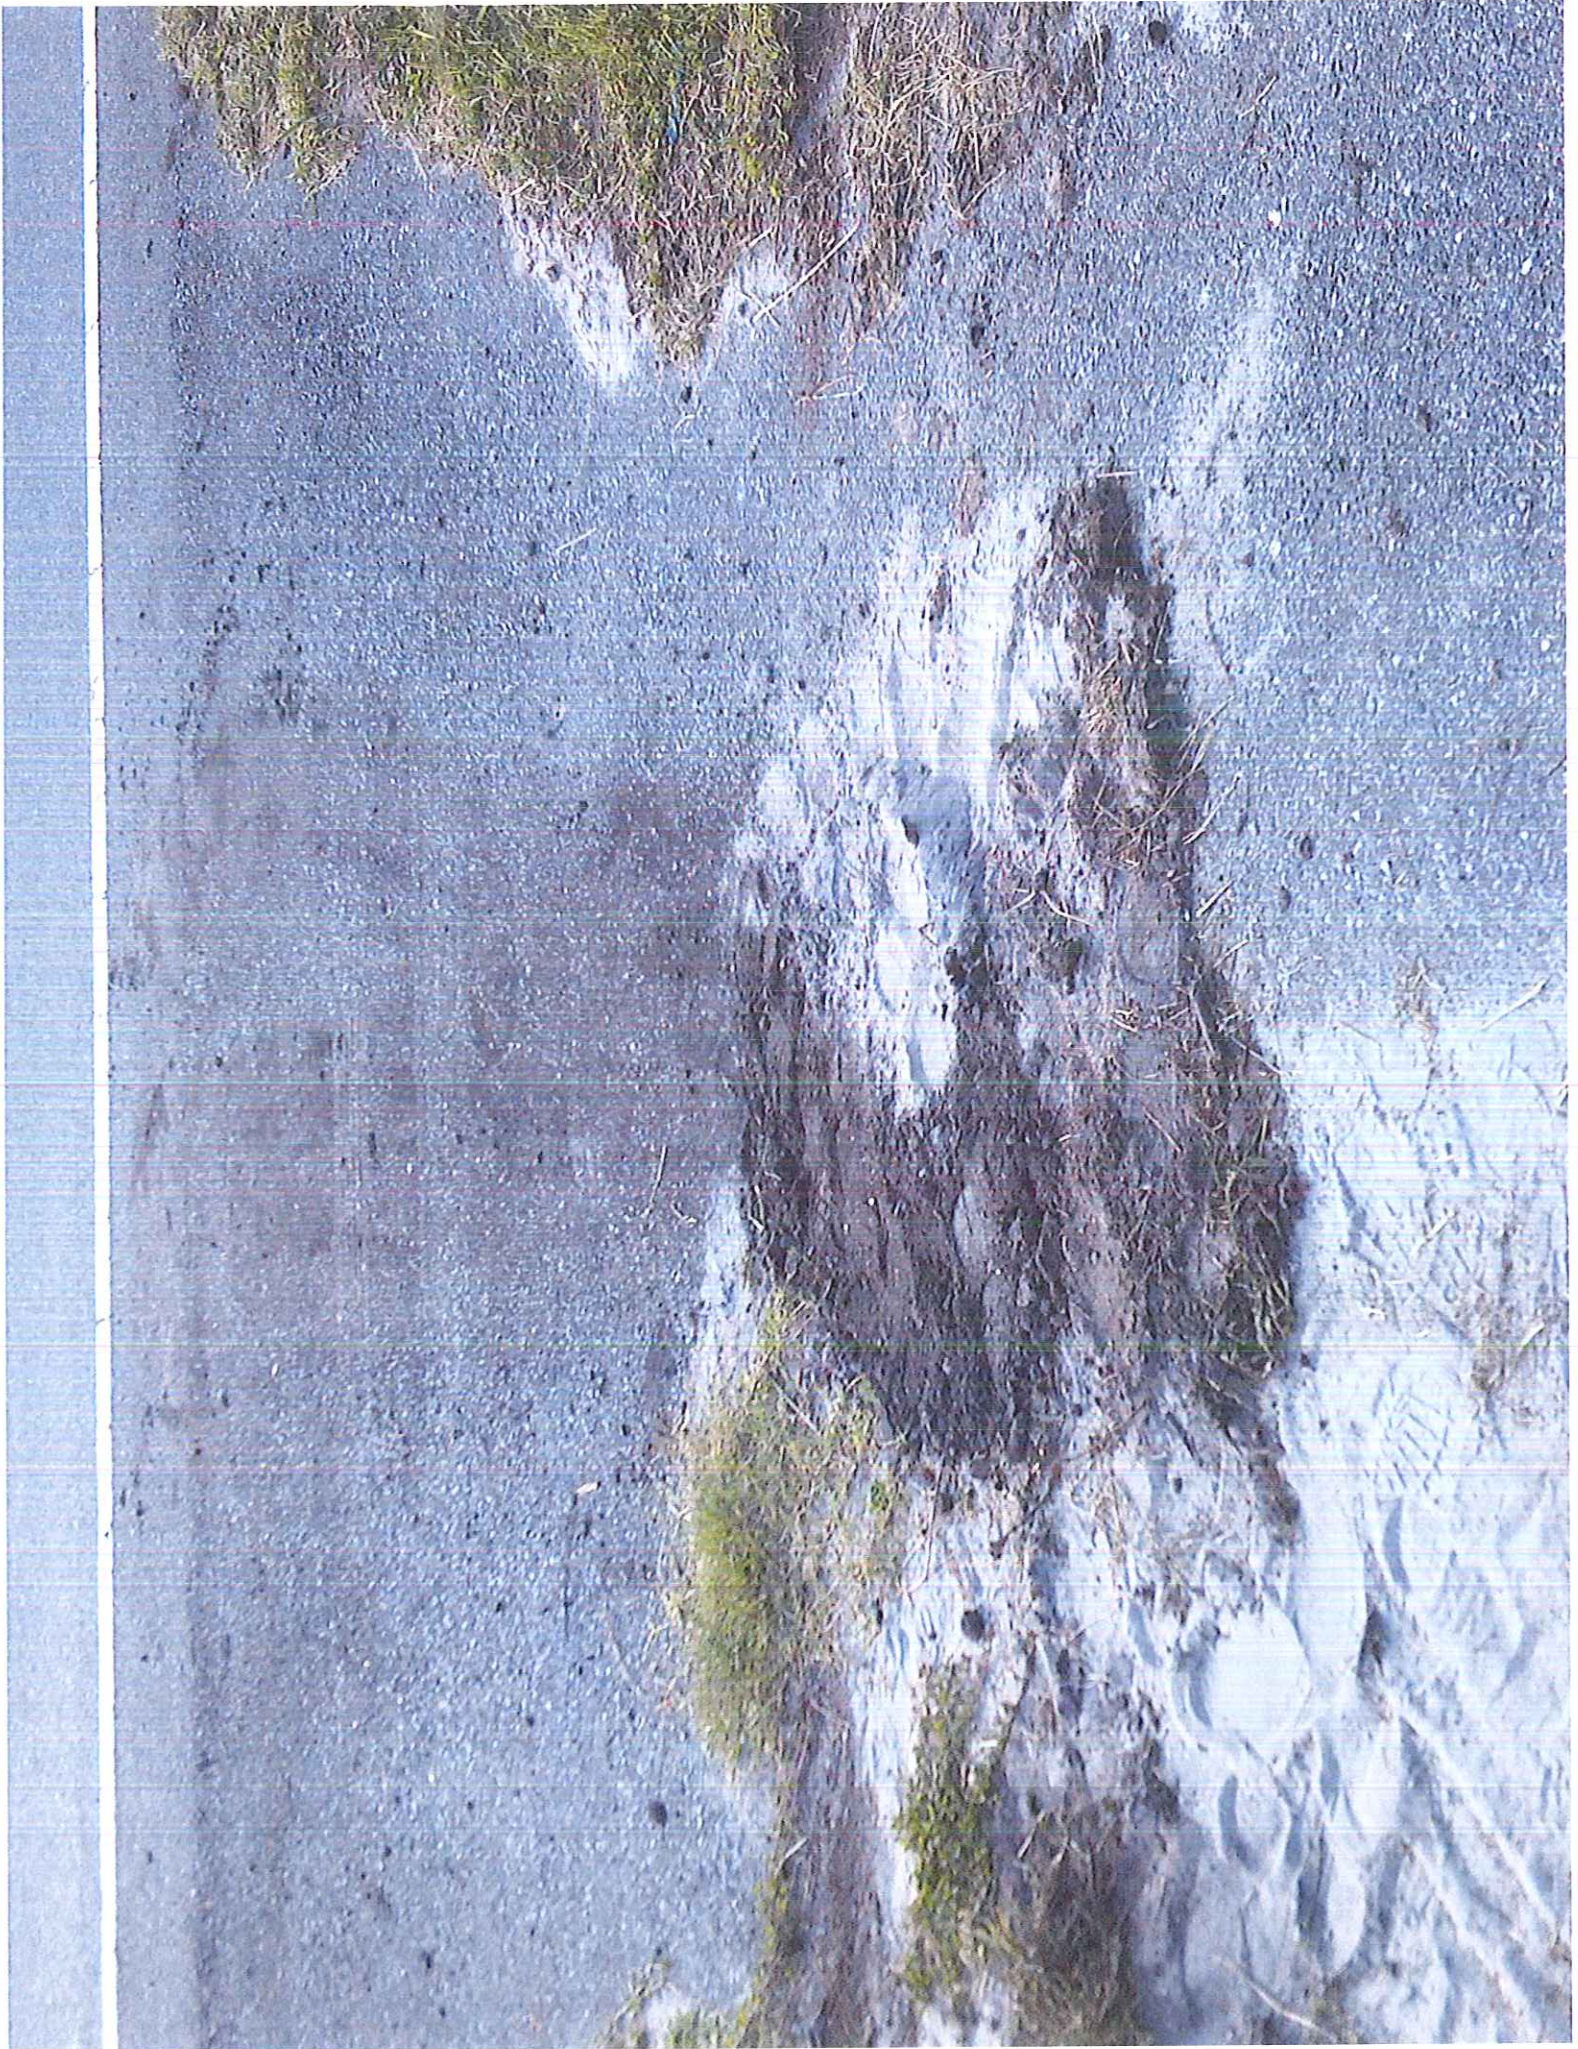
Description of Problem: Hole in the driveway apron due to pipe failure.

Description of Existing Pipe: 26' x 12" concrete

Pipe Required: 30' x 15"

Inlet/Outlet Ends: concrete mitered

Asphalt to be cut out and replaced: 11' W

Sod Required: Bahia
