REQ #: MA3-14871-R

ROAD NAME: CR 46A

Address: 28214 CR 46A, Sorrento

Request Details Report

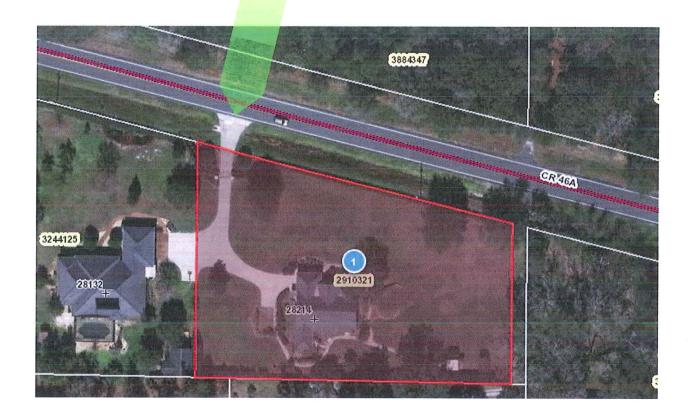
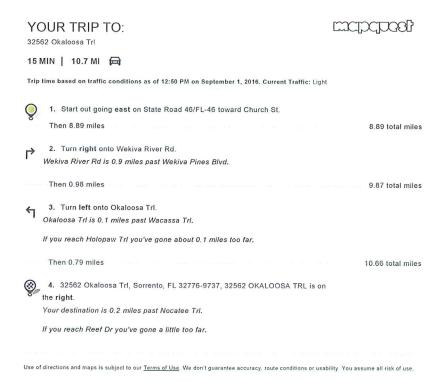
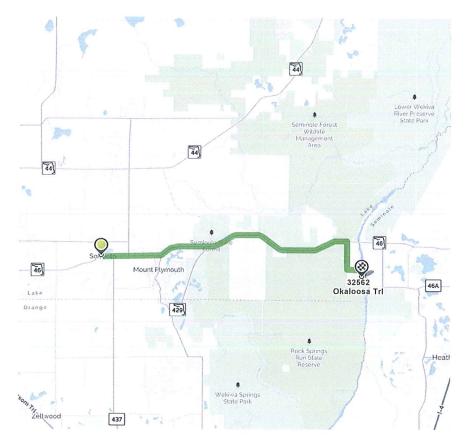
Description of Problem: Bottom of pipe is rusted out.

Description of Existing Pipe: 24" x 40' CMP

Pipe Required: 24' x 40' L

Inlet/Outlet Ends: mitered ends

Asphalt to be cut out and replaced: Concrete: 8'D x 21' 5" W

5. Sod Required: Bahia
